Village of Ashcroft

Water Master Plan

November 2014

URBAN
systems

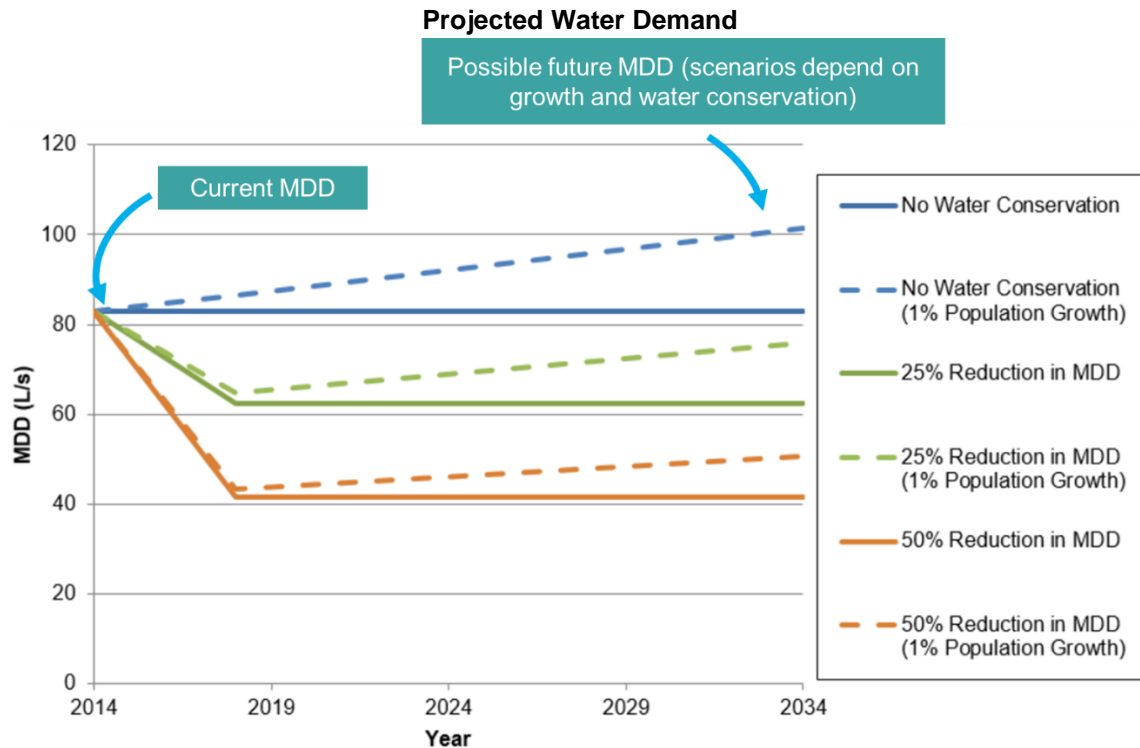
There is some uncertainty associated with future population growth and water use. Based on the per capita demands, projected population growth, and water conservation considerations outlined above, the below figure displays the range of projected future maximum day demands for the Village.

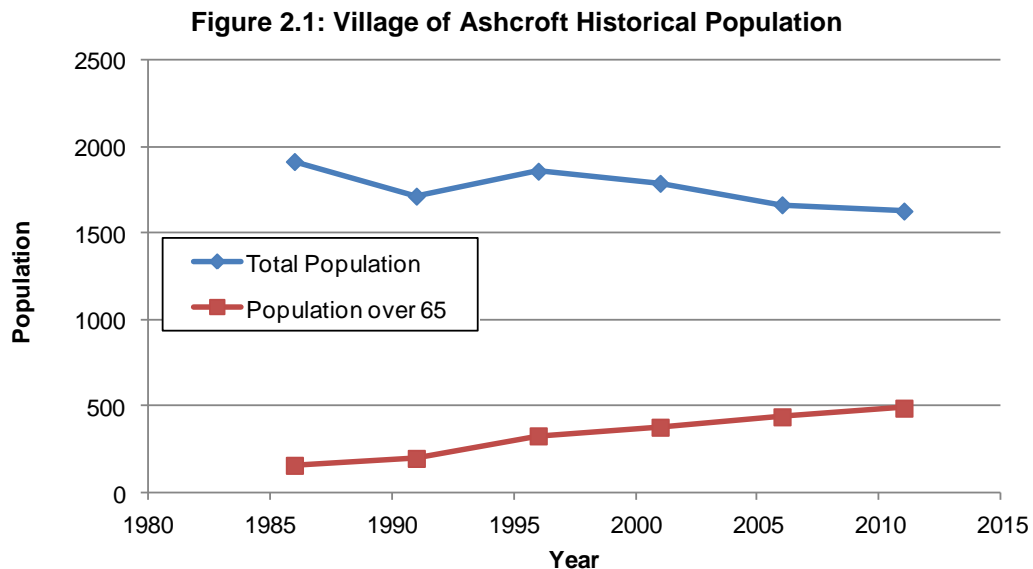
Based on a review of Statistics Canada census data, the Village's current population is 1,628. The historical population data from census data (1981 to 2011) is displayed in Figure 2.1.

Between 1981 and 2011 (30 years), the average annual growth rate is calculated to be -1.1%. Furthermore, the Village's population that is over 65 is increasing. Given the population trend over the past 30 years, it is recommended that a population growth factor of 1% be applied for population growth over the next 20 years.¹ With an ageing population affordability is an important consideration.

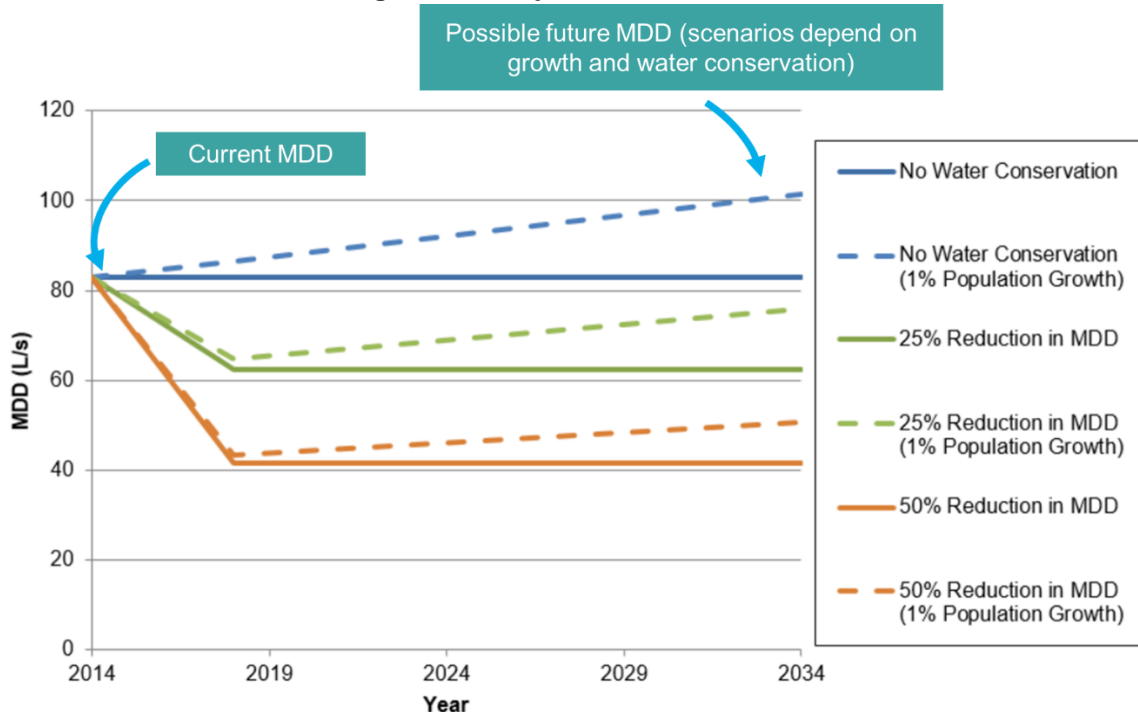
Figure 2.2: Projected Water Demand

There is some uncertainty associated with future population growth and water use. Based on the per capita demands, projected population growth, and water conservation considerations outlined above, Figure 2.2 displays the range of projected future maximum day demands for the Village.

The magnitude of the Village’s existing water use indicates that there are a number of opportunities to reduce water use. Since a reduction in MDD will have an impact on capital costs for future treatment infrastructure upgrades, as well as pump station upgrades, it is recommended that the Village select a suitable long-term water conservation factor to account for population growth and water use uncertainties.

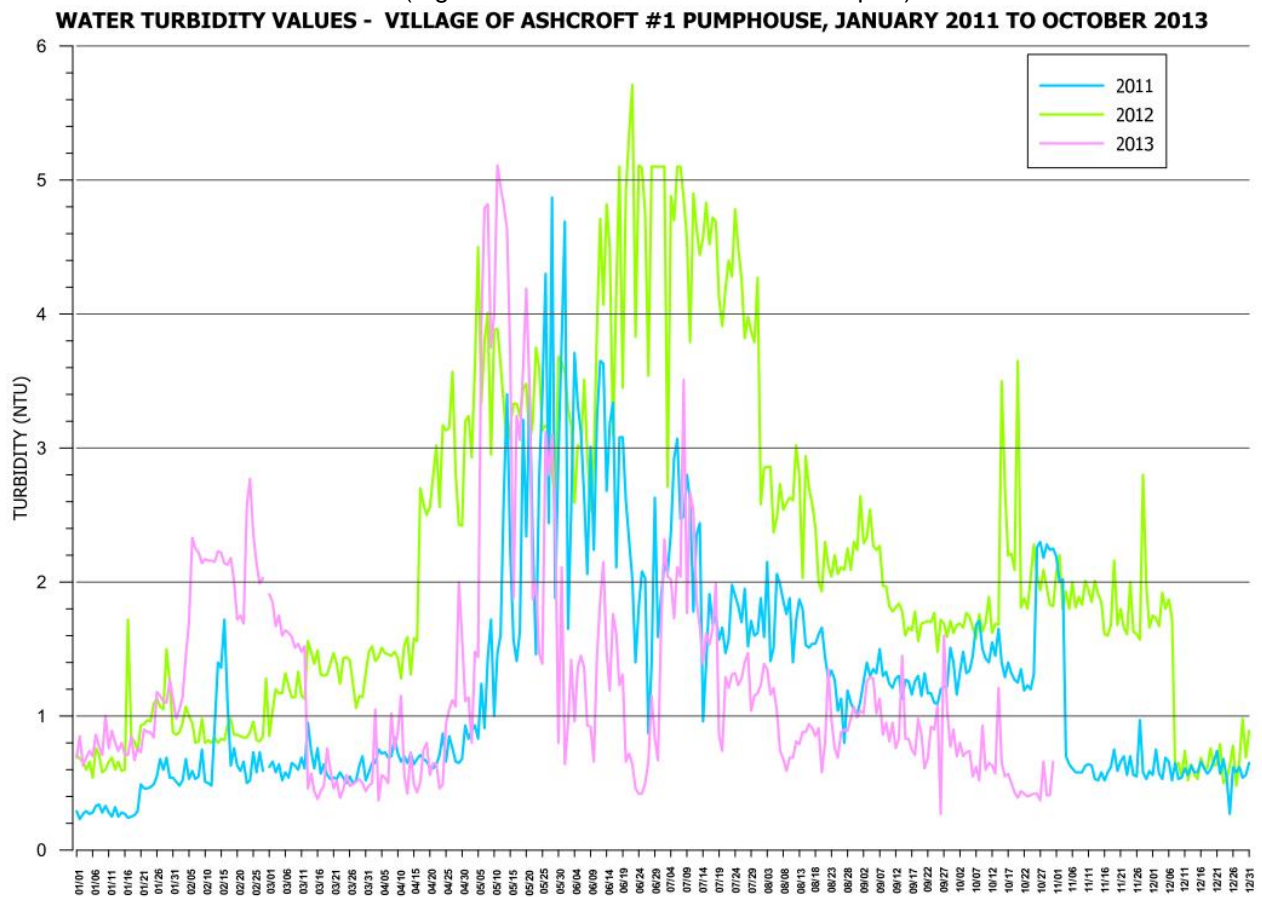
Figure 4.1: Historical Thompson River Turbidity
(Figure from M. Miles & Associates Report)

Section 4.3 (Two Methods of Treatment) of the MOH document provides a summary of the requirements for deferring filtration, and meeting the above treatment objectives using two forms of disinfection (for example, UV disinfection and chlorination). Figure 4.1 presents the results of turbidity sampling of the Village’s water supply at the Main Pump Station over the period January 1, 2011 to October 31, 2013. Turbidity is shown to be greater than 1 NTU every year for multiple months. The Thompson River water quality does not meet the turbidity requirements stated in the MOH document. Also, it would be extremely difficult to maintain a watershed control program to minimize fecal contamination in this source.

Figure 4.3.2: Water Turbidity Values - Village of Ashcroft #1 Pumphouse, January 1, 2011 to October 31, 2013.

The VOA routinely measures turbidity values along with other parameters in the raw water supplied to the #1 Pumphouse. These data have been extracted for the period between January, 2011 and October 2013 and the results are summarized on *Figure 4.3.2*. The seasonal variation in turbidity values generally follows the previously discussed seasonal variations in flow. Maximum observed values of ~5 NTU have occurred in May, June and July. To put these values in perspective, the maximum recommended drinking water turbidity values for treated water are summarized below, based on guidelines prepared by *Health Canada (2012)*.

The 'raw water' data shown on *Figure 4.3.2* periodically exceed the recommended 1.0 NTU treated water value.

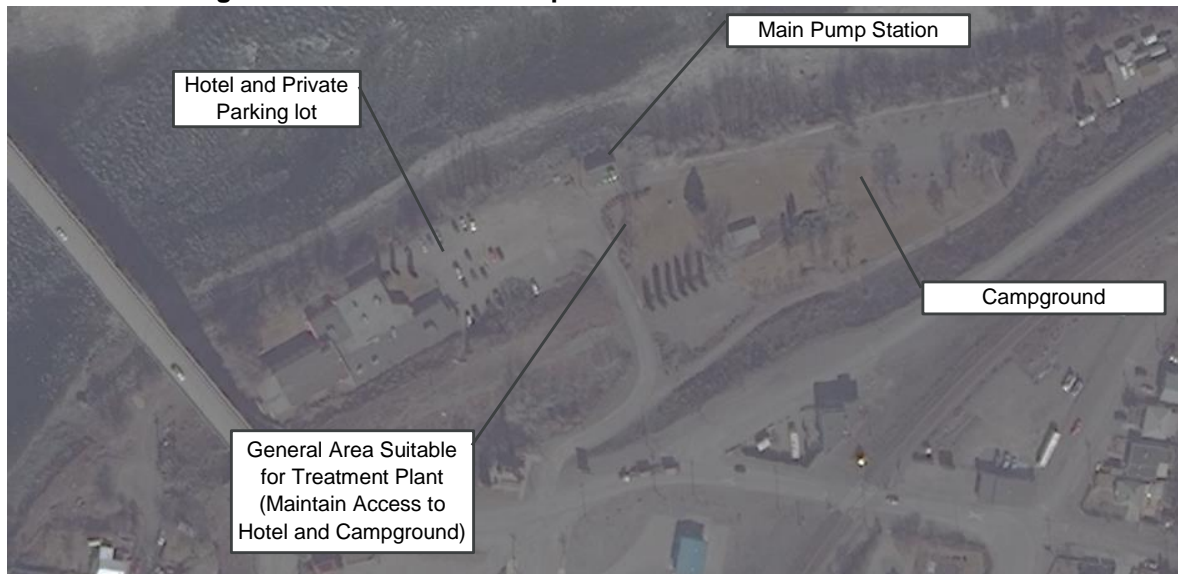
Figure 4.2: Overview of Pump Station and Treatment Plant Area

Figure 4.2 depicts the site and a potential allocation for a filtration facility. This location is above the 200 year flood level, and the river morphology review by M. Miles & Associates identified that the pump station area is situated along a stable river channel area.

The water system includes a dedicated water main between the Main Pump Station and the Zone 1 Reservoir. Therefore, the filtration plant could theoretically be installed along that trunk main route. While an in-depth analysis of topography, property acquisition or potential layout options were not undertaken at this master planning stage, it is reasonable to assume that properly organizing the site beside the Main Pump Station to accommodate the treatment plant and surrounding activities is a more practical solution than developing a new site along the trunk main route. However, further review of technical issues and public consultation should be undertaken during predesign to confirm this approach and the final layout.

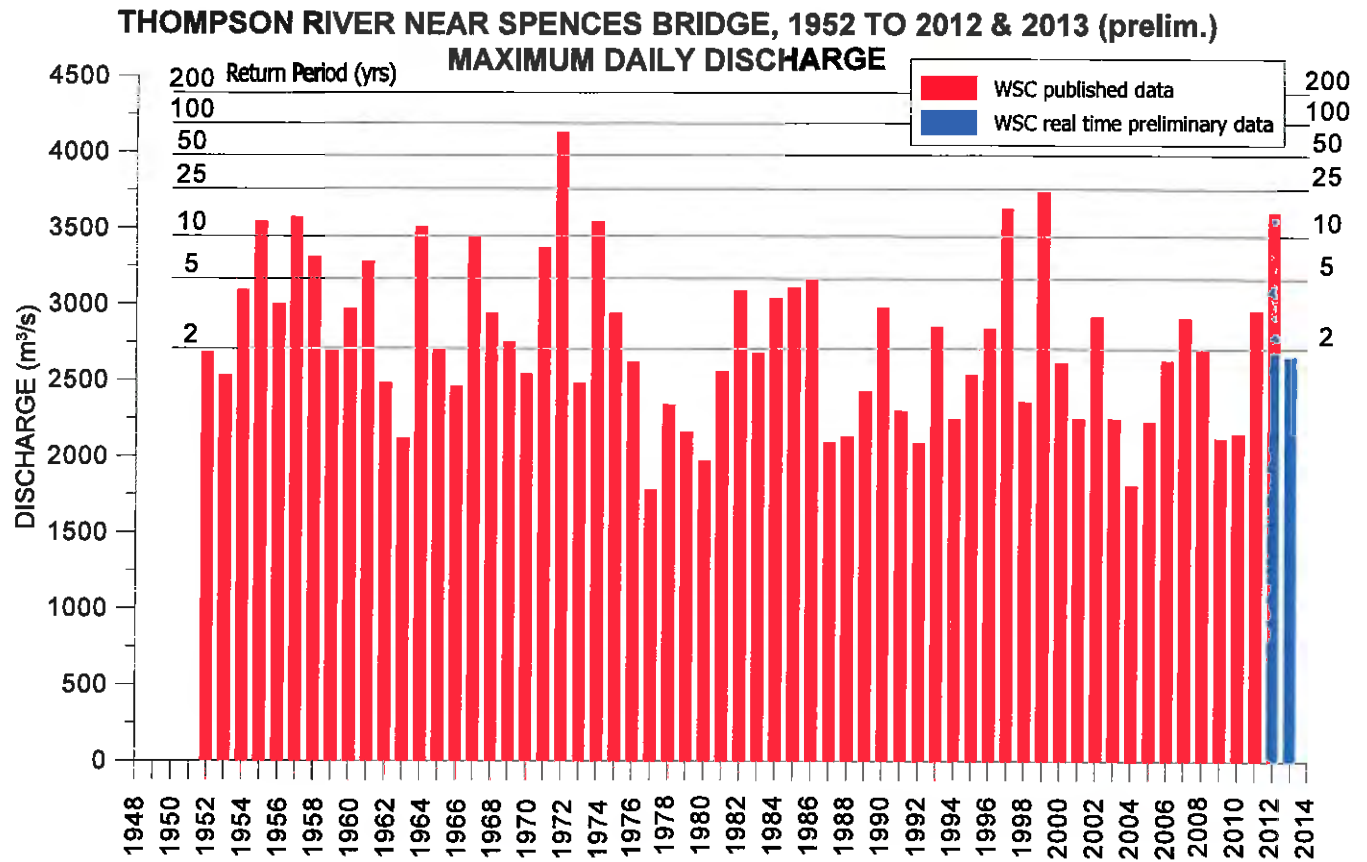
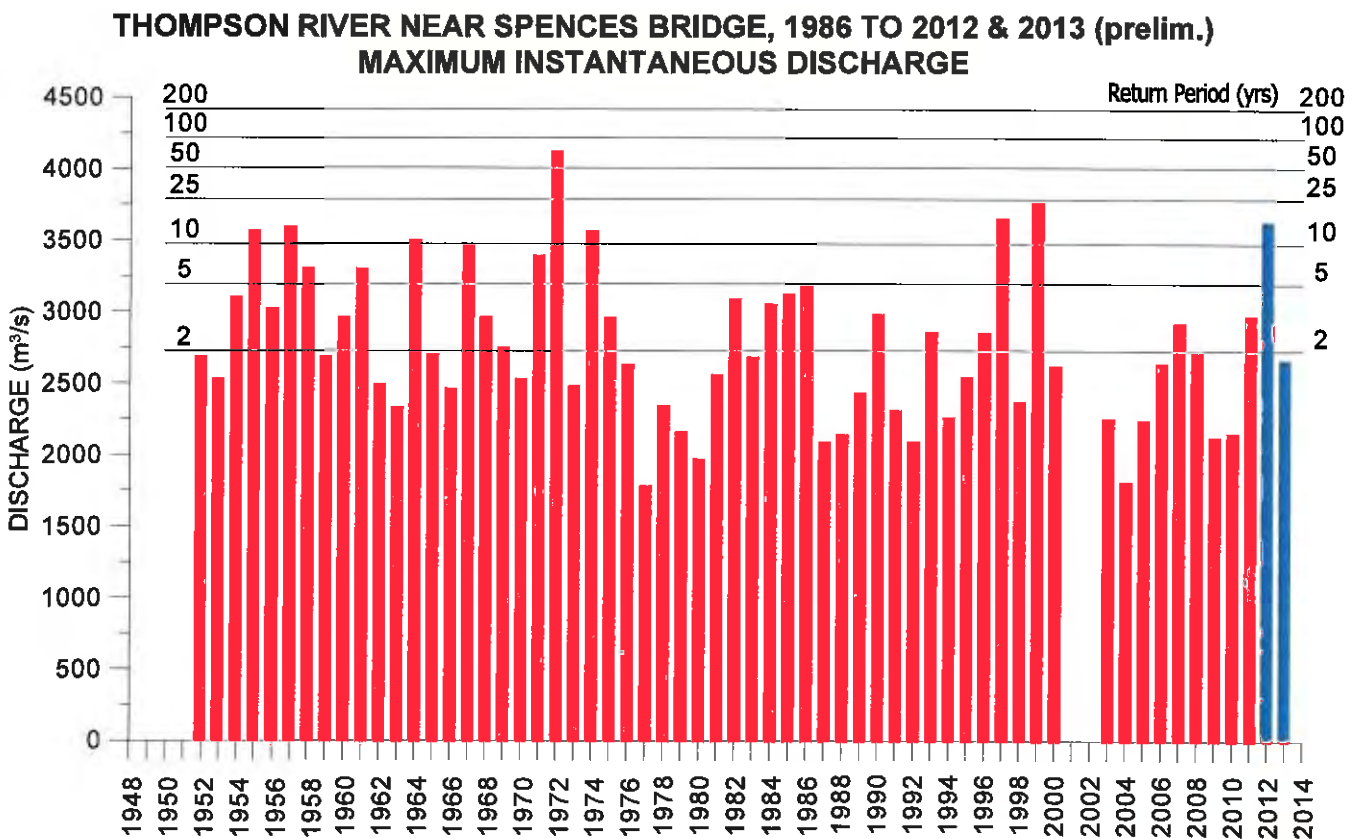
Figure 3.2.2: Historical variation in annual maximum daily and instantaneous discharge, Thompson River near Spences Bridge, 1952 to 2012 & 2013 (prelim.).

The historical variation in annual maximum daily and instantaneous discharges observed on *Thompson River near Spences Bridge* is illustrated on *Figure 3.2.2*. A flood frequency analysis has been undertaken using the BC Government computer program 'FREQUAN' ^{*1} and the results are compiled on *Tables 3.2.1 & 3.2.2*. This analysis indicates that the largest recorded flood was in 1972 and has an average return period of approximately 75 years. More recent sizeable events occurred in 1997, 1999 and 2012 and the average return periods are ~15, 25 and 15 years, respectively. The historical variation in annual minimum flows is illustrated on *Figure 3.2.3* and the results of a low flow frequency analysis are compiled on *Table 3.2.3*. These analyses indicate the average annual minimum flow is ~180 m³/s with predicted extreme values at Spences Bridge being as low as ~120 m³/s. The associated flows at Ashcroft could be marginally lower.

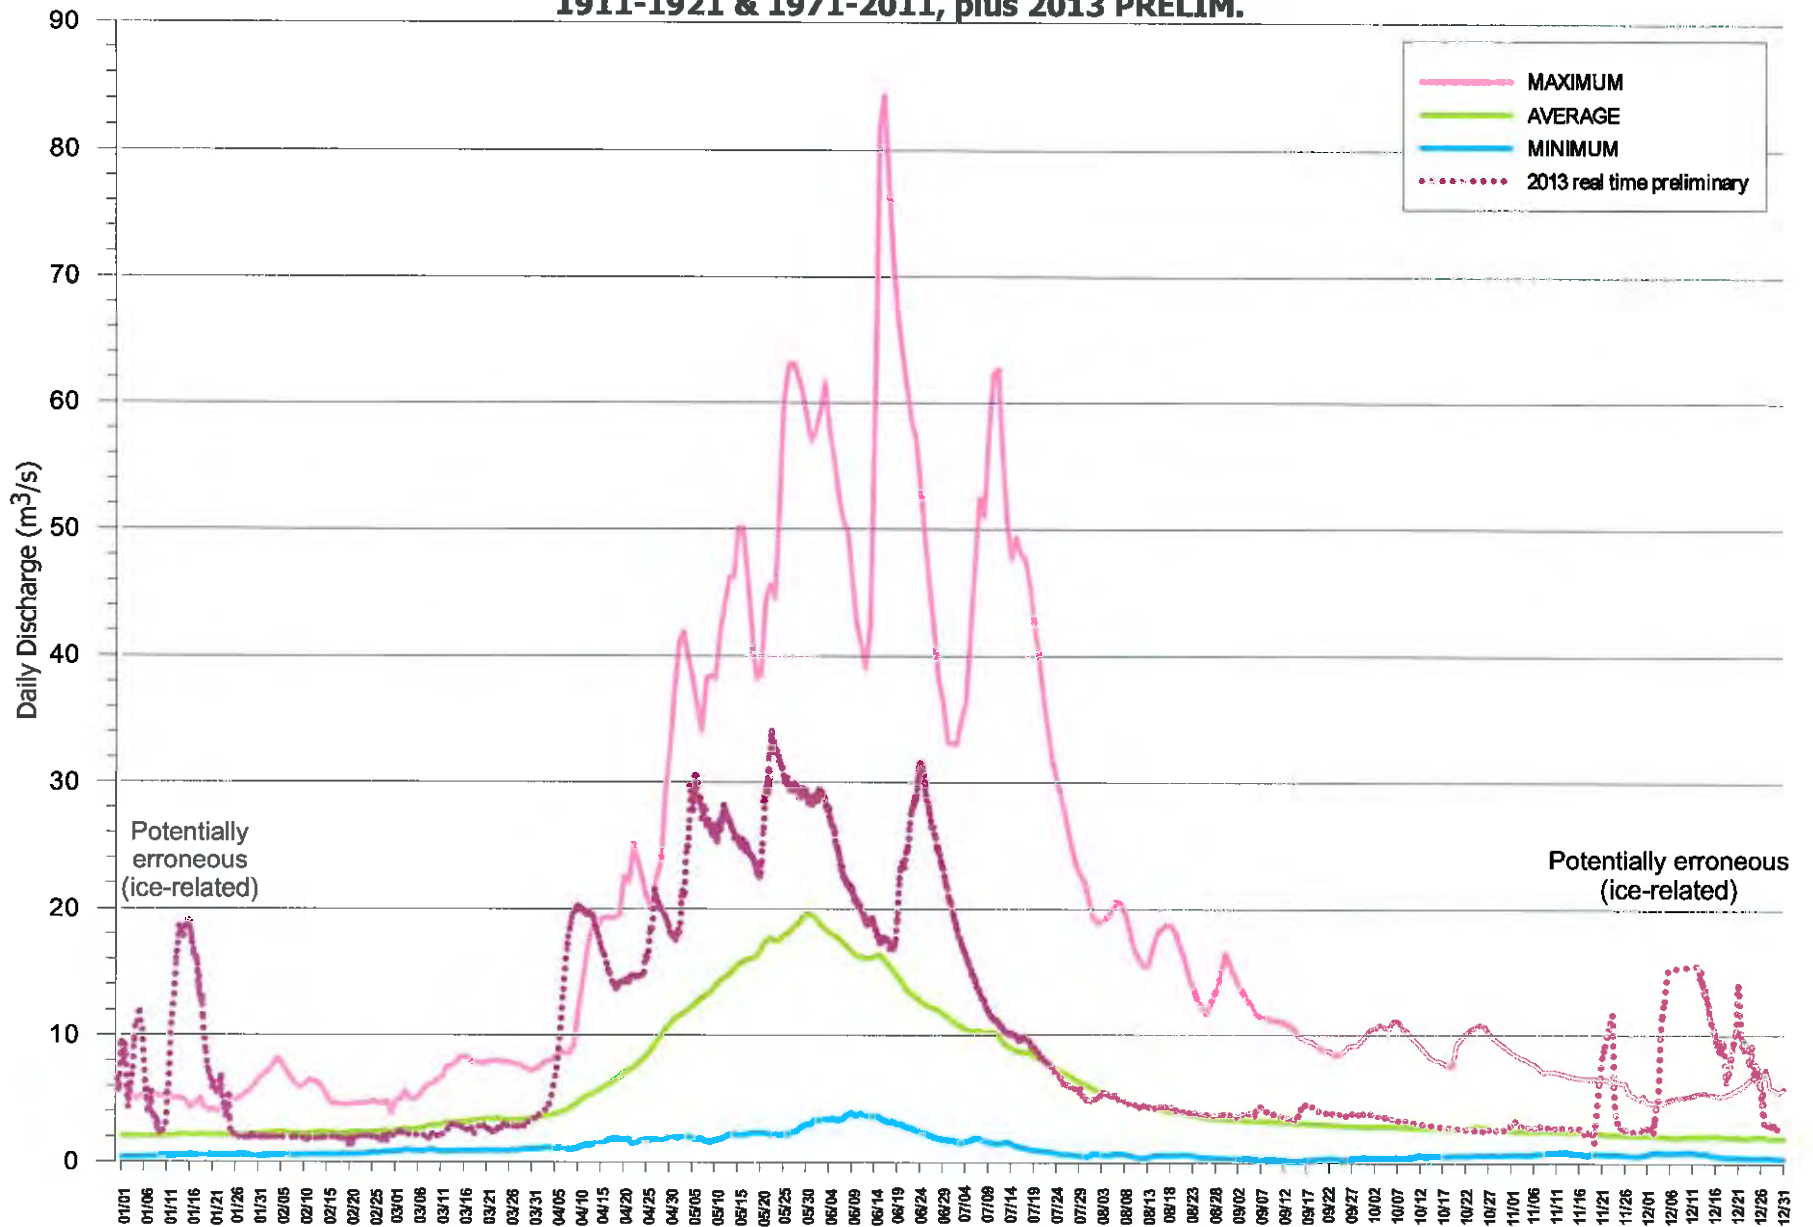
**SEASONAL VARIATION IN FLOW - BONAPARTE RIVER BELOW CACHE CK [05LF002],
1911-1921 & 1971-2011, plus 2013 PRELIM.**

Figure 3.2.4: Seasonal Variation in Flow, Bonaparte River Below Cache Creek, 1911-1921 and 1972 to 2011, plus 2013 preliminary.

Similar analyses have also been undertaken on streamflow data collected at the WSC station "*Bonaparte River below Cache Creek*". The gauge has operated between 1912 and 1921 and post-1972. This site, which has a basin area of 5,020 km², is located 11 km upstream of the Thompson River confluence. The seasonal variation in flow is illustrated on *Figure 3.2.4*. Flows again begin to rise in late-March or April, the snowmelt freshet typically reaches a maximum around early-June, but intense rain-caused runoff can occur into late-July followed by declining discharges through the winter period. Winter ice effects can result in locally increased water levels.

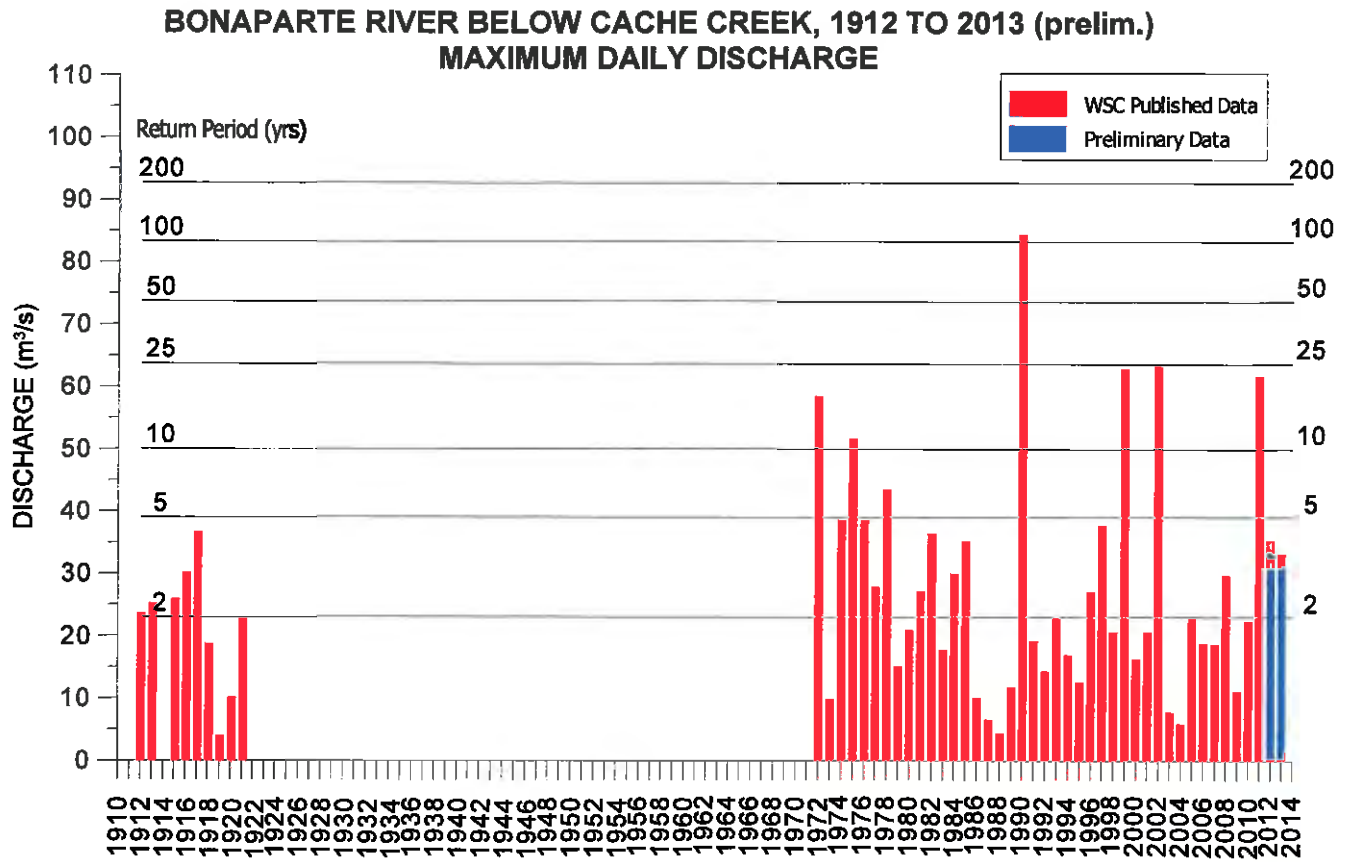
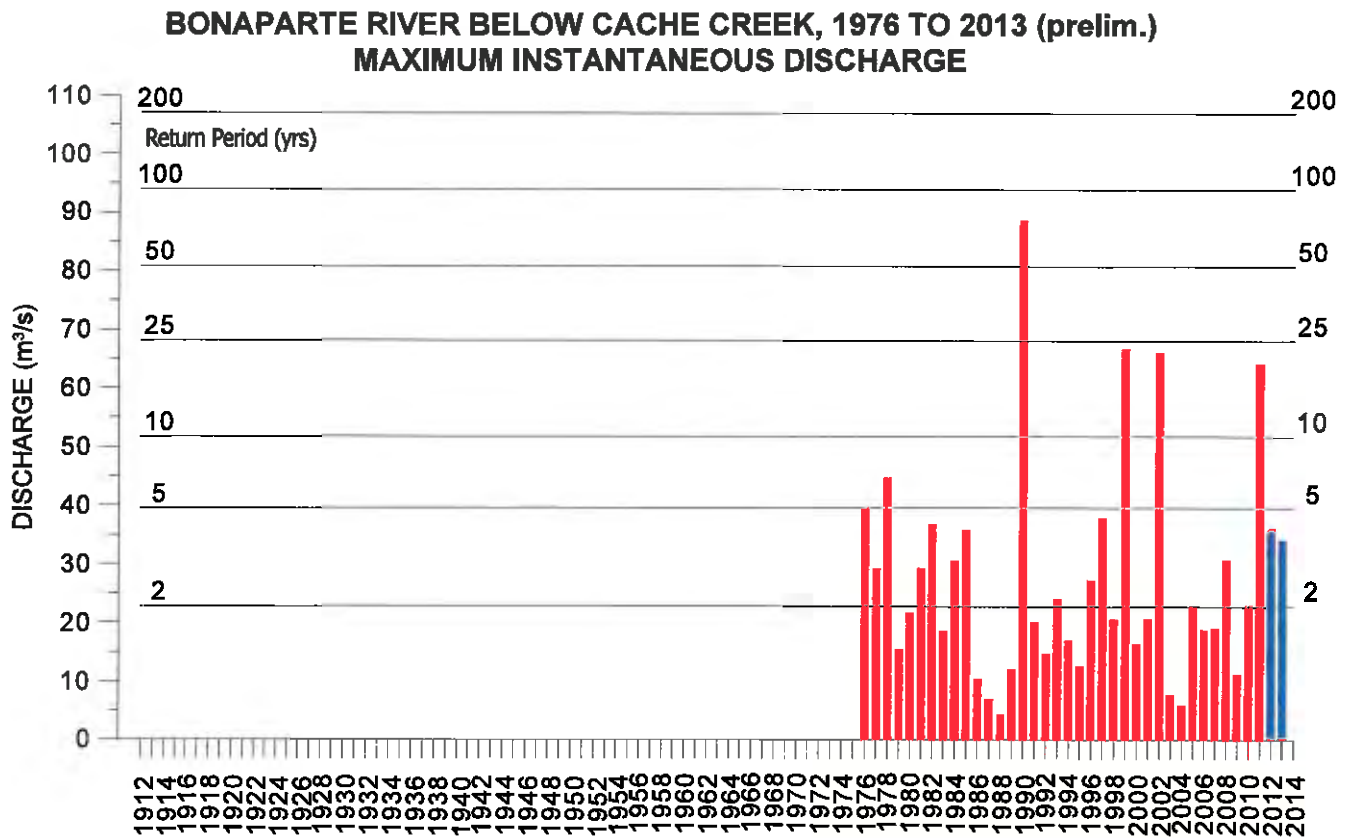
Figure 3.2.5: Historical variation in annual maximum daily and instantaneous discharge, Bonaparte River below Cache Creek, 1912 to 2013 (prelim.).

The historical variation in annual maximum daily and instantaneous discharges on Bonaparte River are illustrated on *Figure 3.2.5*. The results of flood frequency analyses are presented on *Tables 3.2.4 & 3.2.5*. This analysis indicates the largest recorded flood occurred in 1980 and has an average return period of 75 to 100 years. Recent sizeable events also occurred in 1999, 2002 and 2011 with average return periods being ~20 years. The historical variation in annual minimum flows on Bonaparte River is illustrated on *Figure 3.2.6* and the results of a low flow frequency analysis are presented on *Table 3.2.6*. This analysis indicates that the average annual minimum flow is 1.2 m³/s and extreme values can be ~0.1 m³/s.

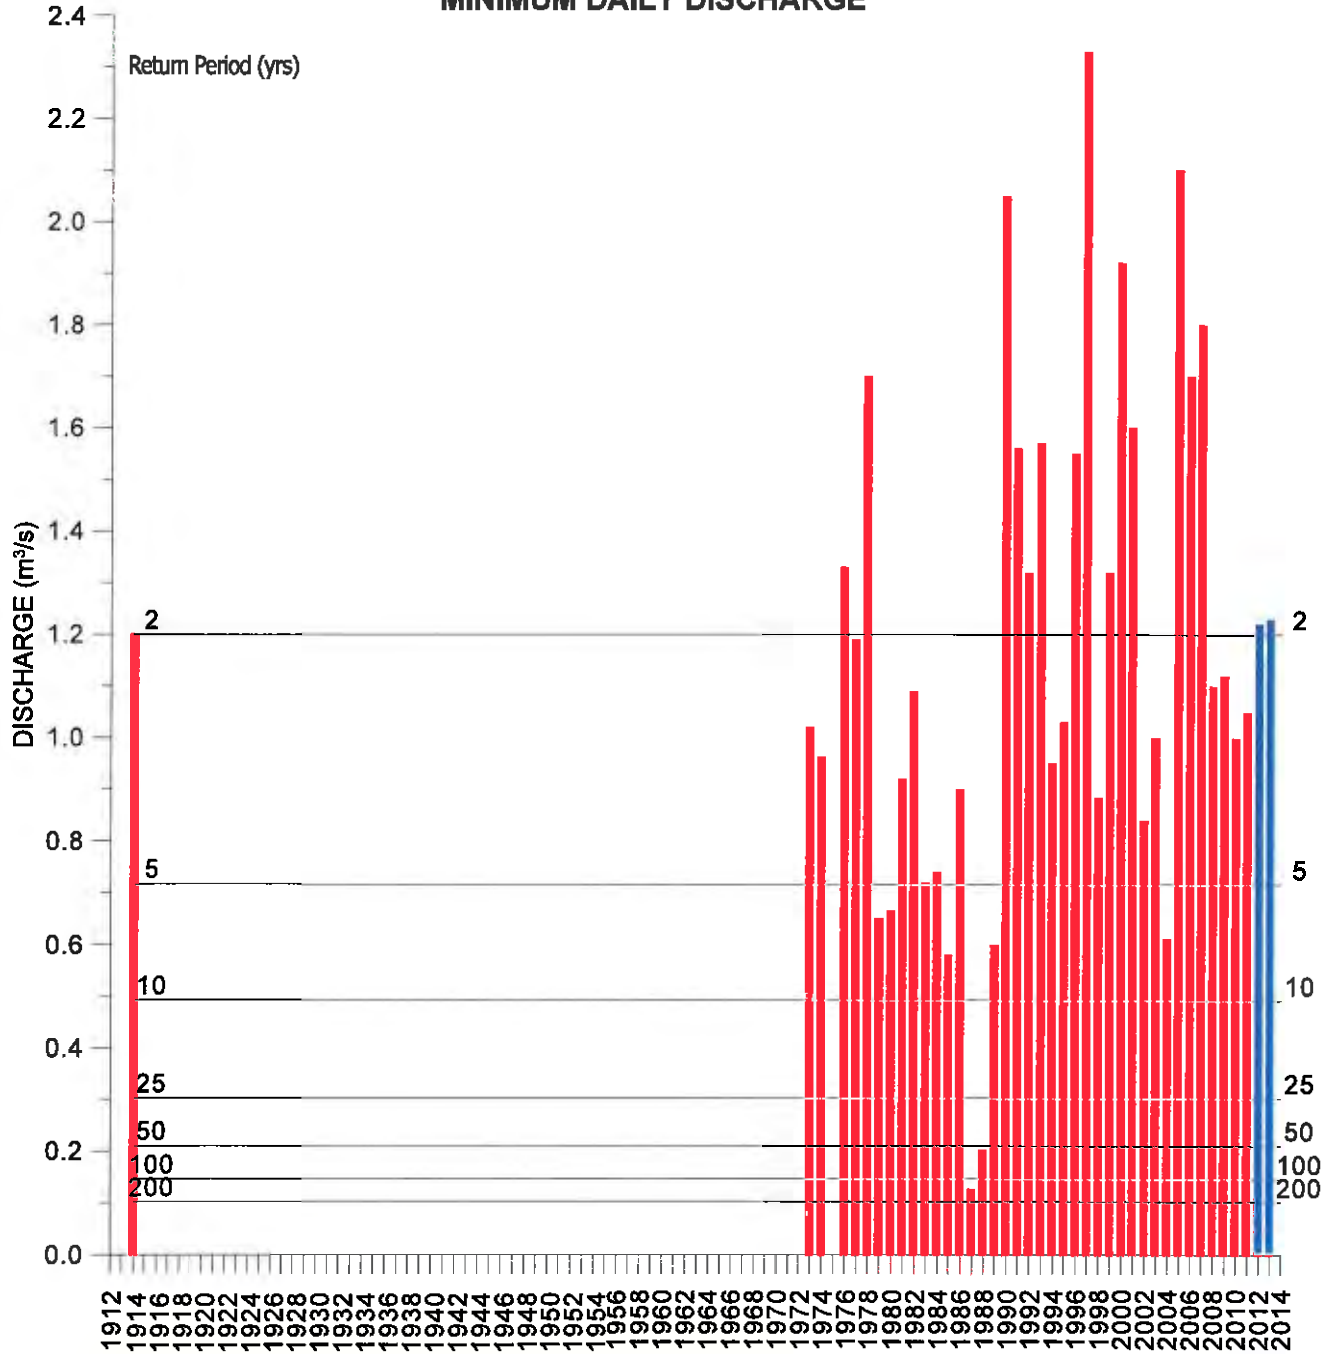
**BONAPARTE RIVER BELOW CACHE CREEK, 1914 TO 2013 (PRELIMINARY)¹
MINIMUM DAILY DISCHARGE**

Figure 3.2.6: Historical variation in annual minimum daily discharge, Bonaparte River below Cache Creek, 1912 to 2013 (preliminary).

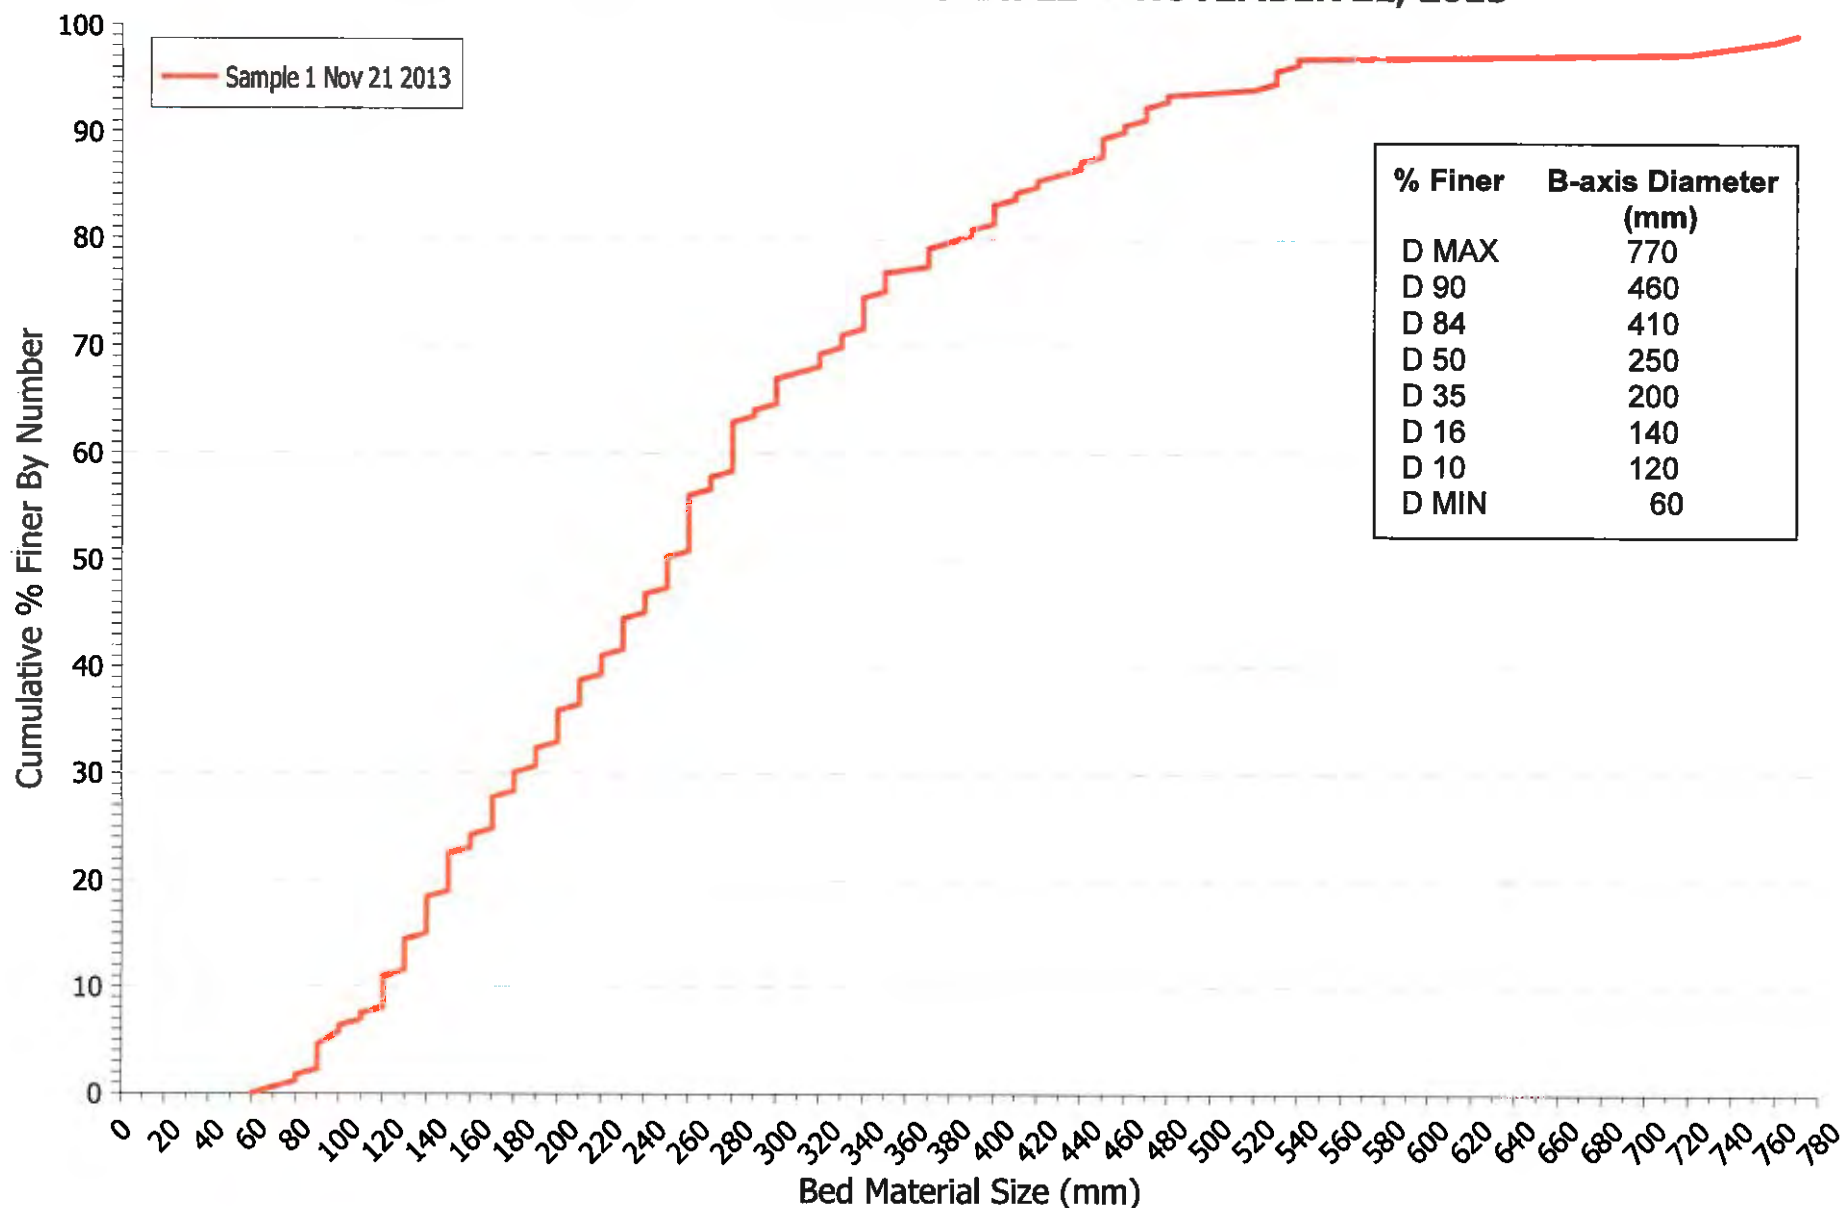
THOMPSON RIVER - TAPE GRID SAMPLE - NOVEMBER 21, 2013

Figure 4.1.1: Bed material size distribution on the left bank downstream of the water supply intake.

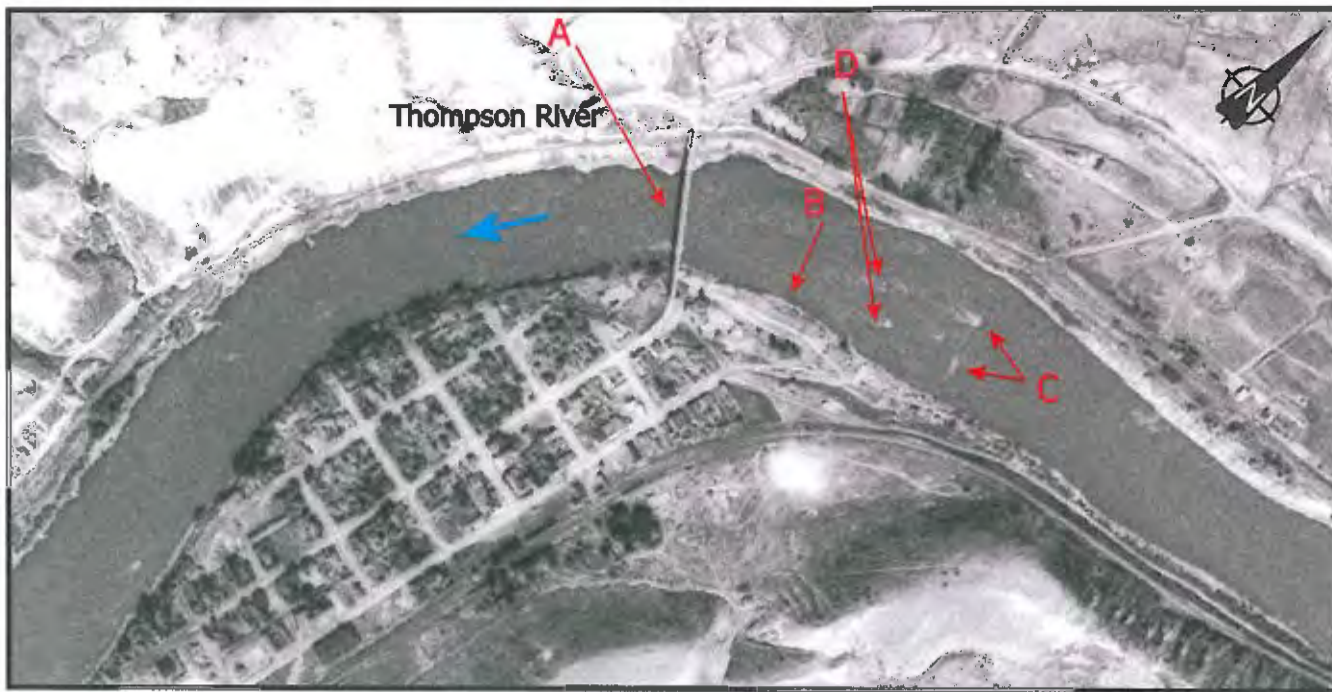
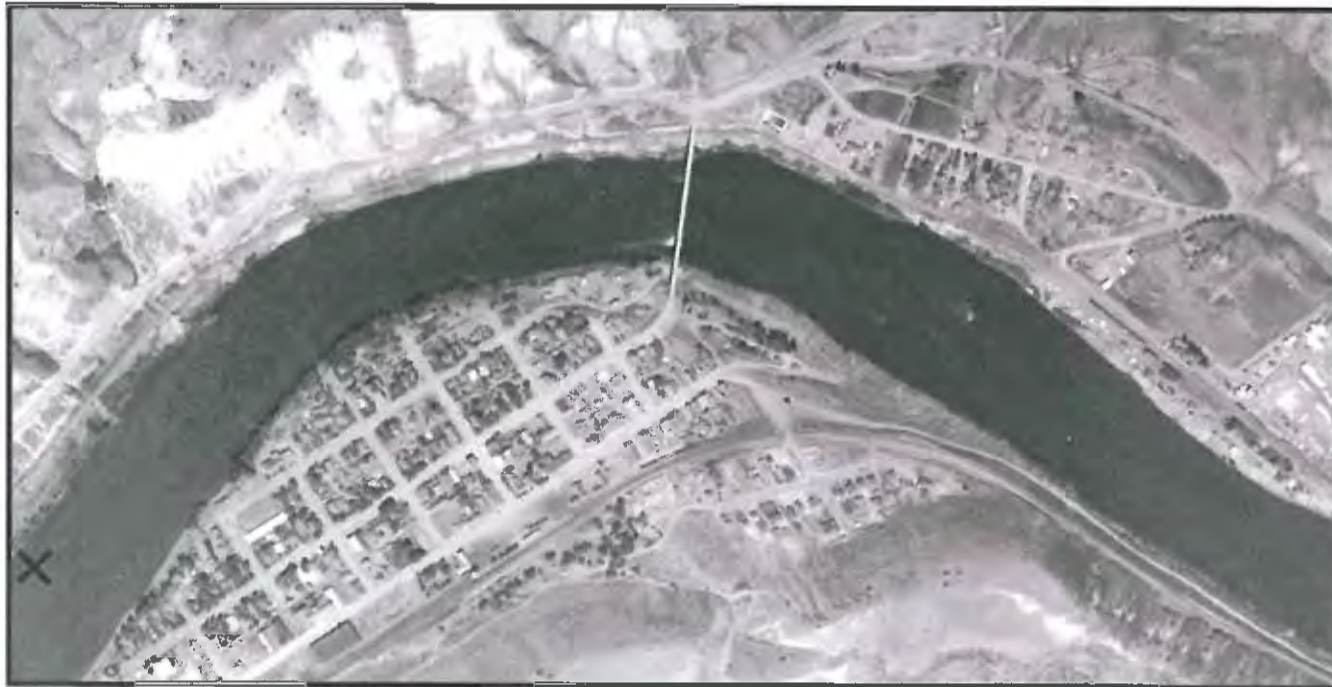
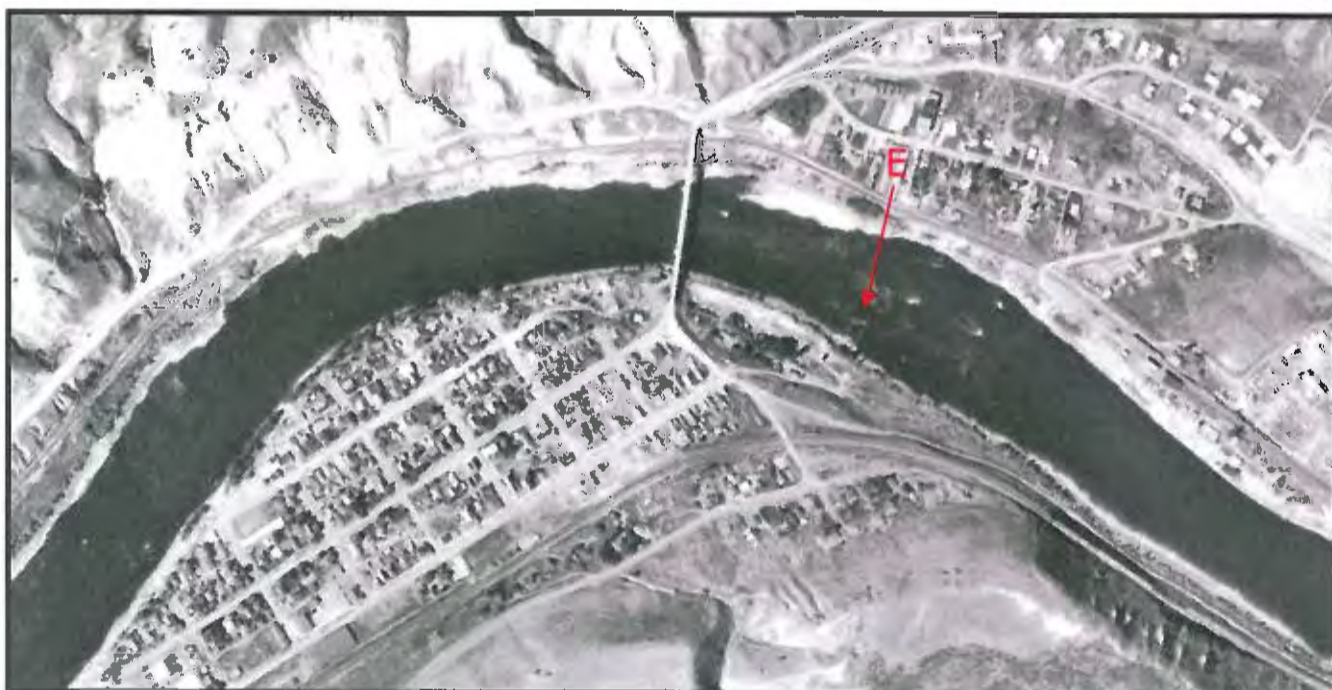
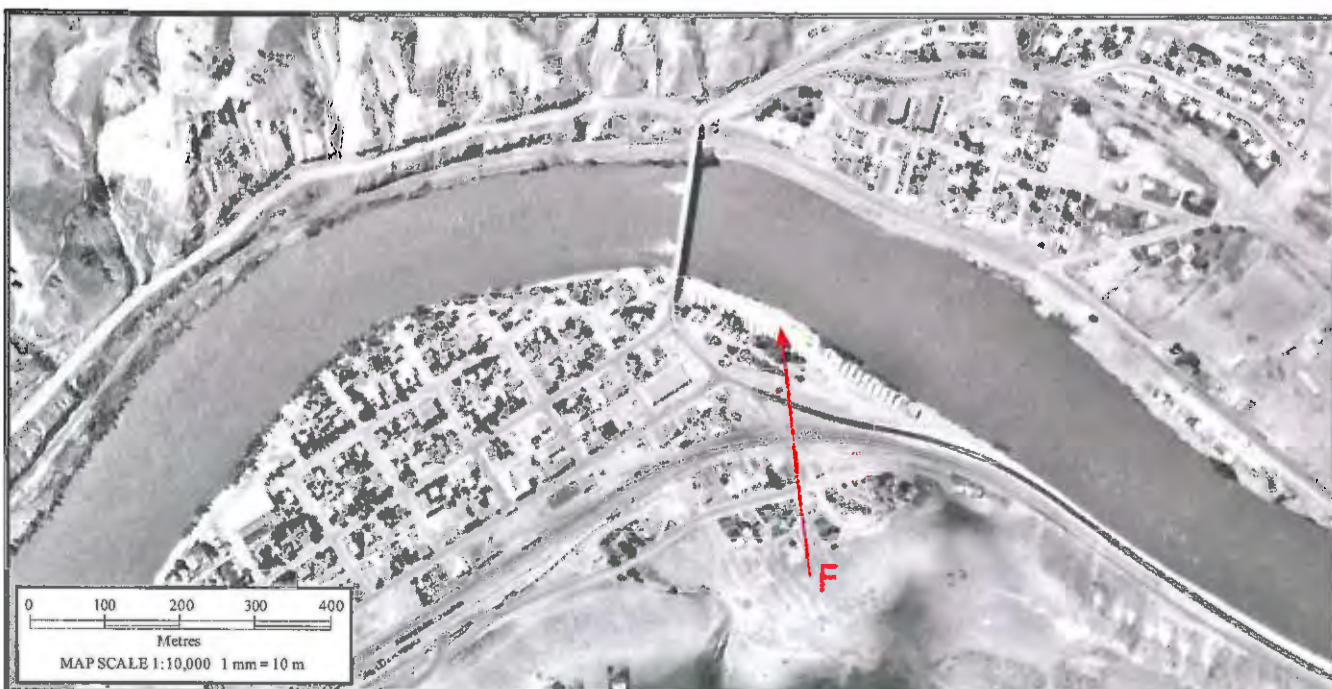
Bonaparte River below Cache Creek na
Thompson River near Spences Bridge 2,070 m³/s

Bonaparte River below Cache Creek na
Thompson River near Spences Bridge 518 m³/s

Bonaparte River below Cache Creek 33.7 m³/s
Thompson River near Spences Bridge 3,030 m³/s

Figure 4.2.1A: Historical changes in channel morphology, Thompson River at Ashcroft.

A series of larger scale historical air photos centred on the water supply intake is presented as *Figures 4.2.1A & B*. These photos further illustrate the stability of this section of channel. The persistence of individual large boulders on the channel bed and remnants of former upstream bridge piers suggest that the bed elevation has remained quite stable over the last sixty years. However, high water levels generally cover the mid-channel bar at the water supply intake site and prevent detailed comparisons of river bed characteristics. The cessation or reduction of gravel removal in the upstream channel has the potential to increase the bed elevation on the mid-channel bar located at the existing infiltration gallery. The stability of this site over the last 60 years suggests that this effect will likely be small as the incoming sediment load appears to be carried through this reach. Improved riparian and upslope land use practices on Deadman River or Battle Creek could also be reducing rates of coarse textured sediment production and might mitigate the effects of any reduction in future volumes of upstream gravel extraction.
