Village of Ashcroft

Water Master Plan

November 2014

URBAN
systems

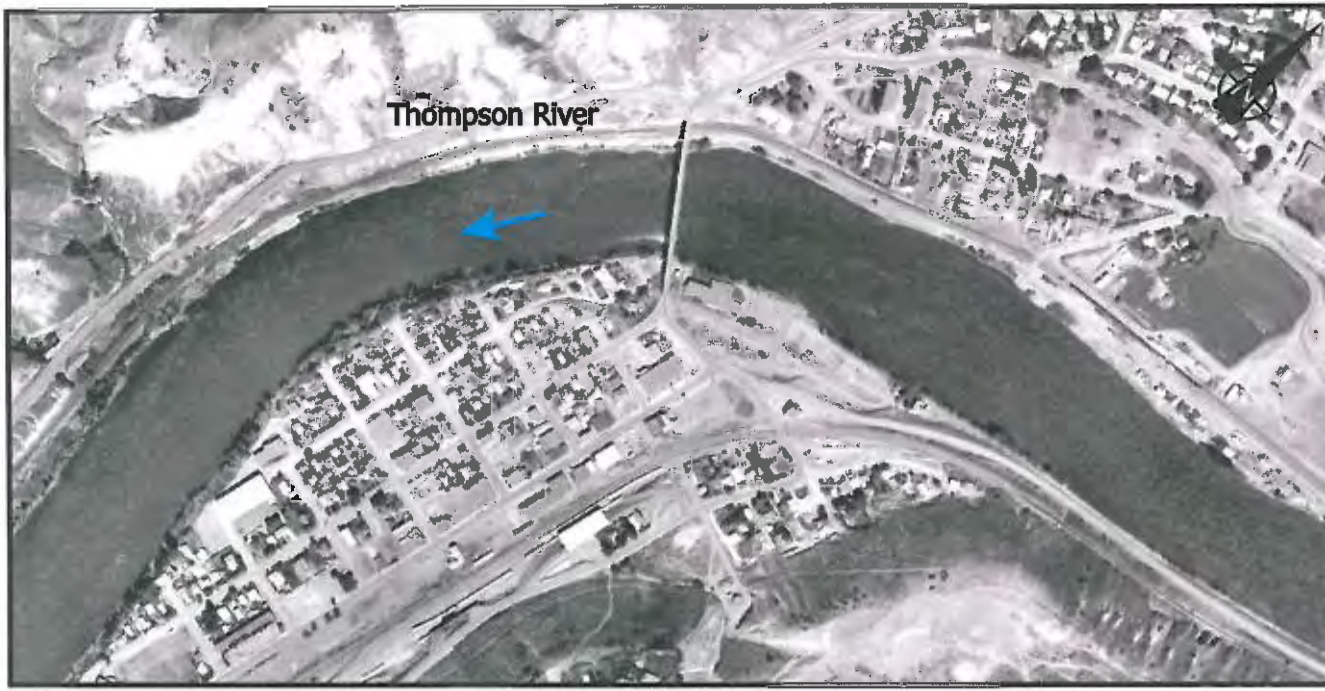
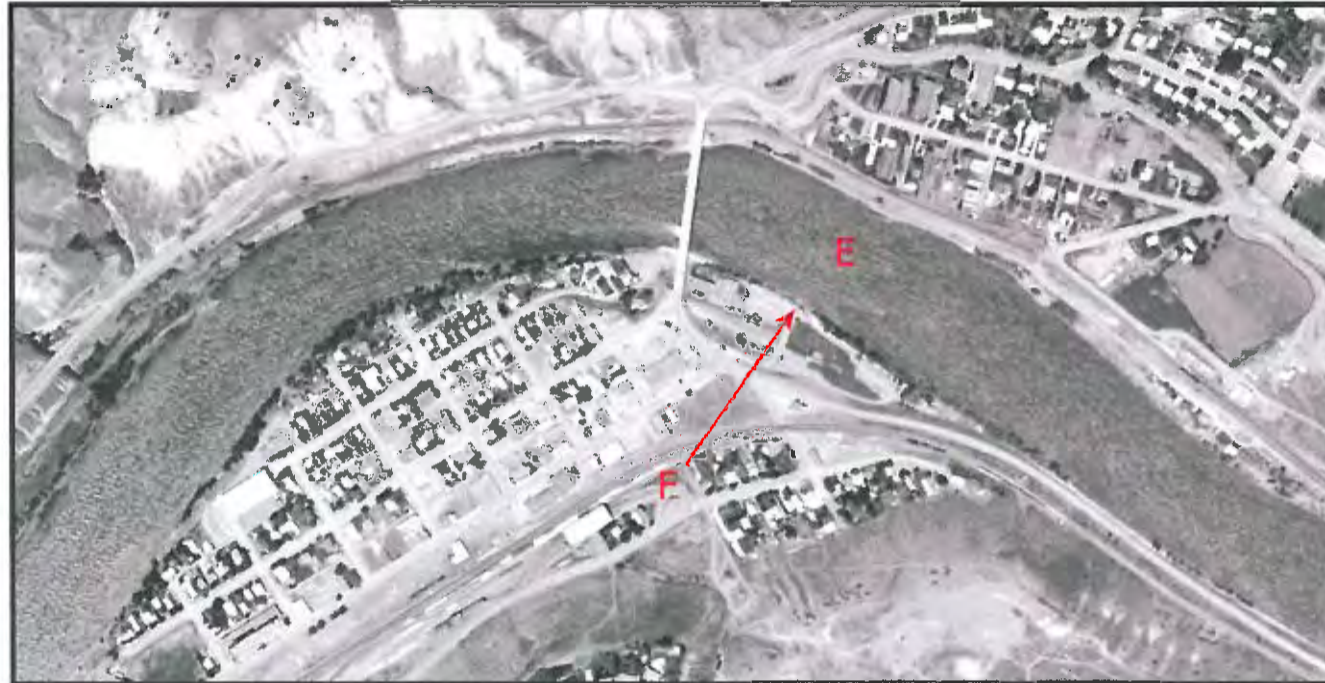
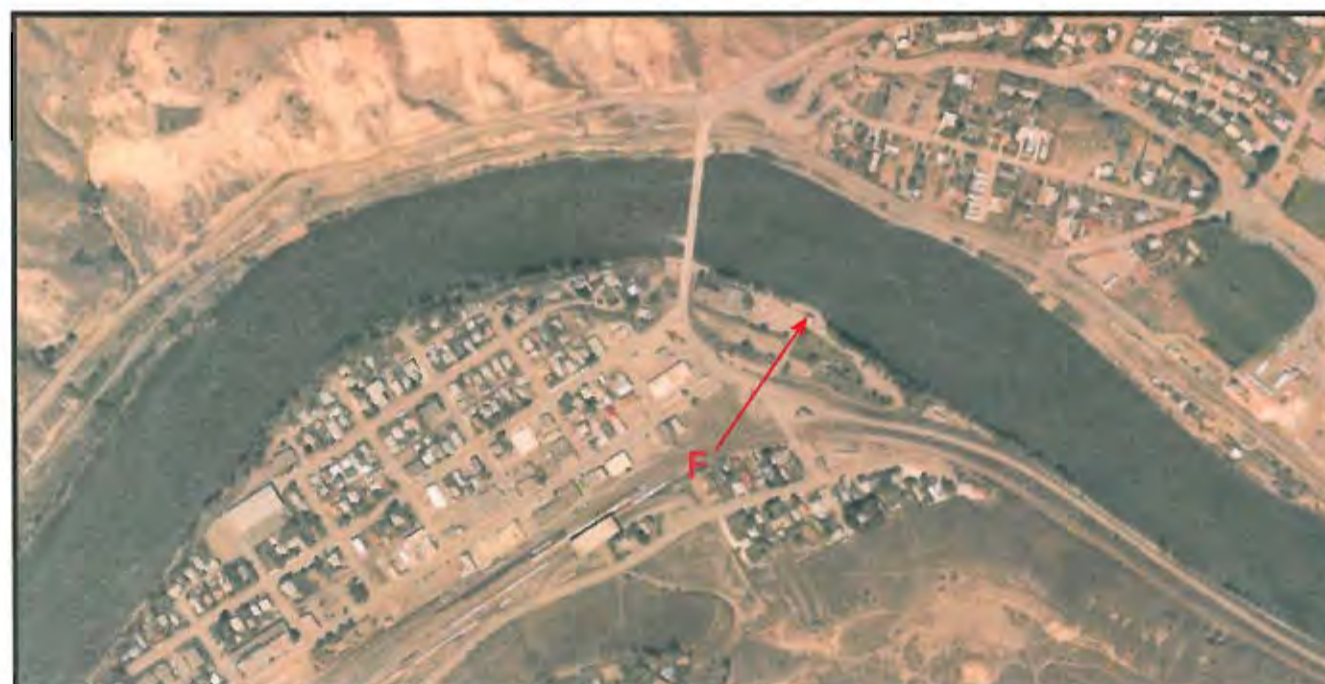
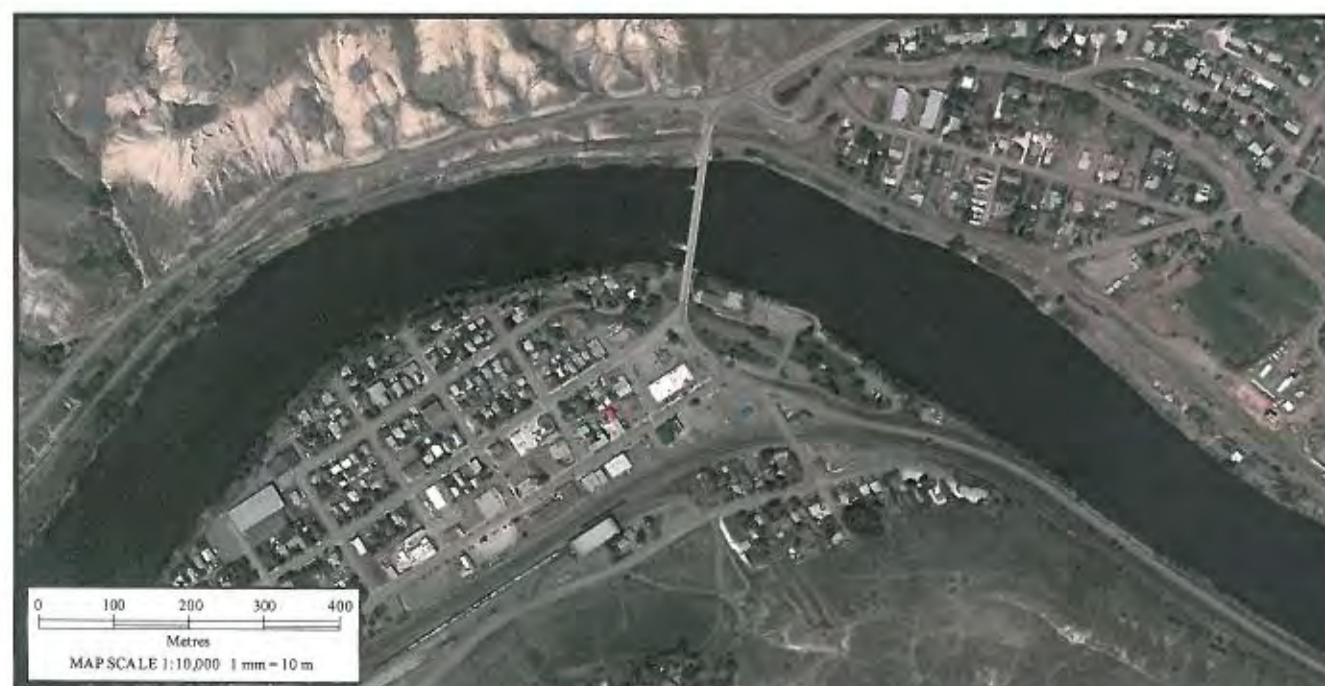
Bonaparte River below Cache Creek 5.01 m³/s
Thompson River near Spences Bridge 2,130 m³/s

Bonaparte River below Cache Creek 7.51 m³/s
Thompson River near Spences Bridge 632 m³/s

Bonaparte River below Cache Creek 7.50 m³/s
Thompson River near Spences Bridge 2,000 m³/s

Bonaparte River below Cache Creek 9.06 m³/s
Thompson River near Spences Bridge 1,680 m³/s

Figure 4.2.1B: Historical changes in channel morphology, Thompson River at Ashcroft.

A series of larger scale historical air photos centred on the water supply intake is presented as *Figures 4.2.1A & B*. These photos further illustrate the stability of this section of channel. The persistence of individual large boulders on the channel bed and remnants of former upstream bridge piers suggest that the bed elevation has remained quite stable over the last sixty years. However, high water levels generally cover the mid-channel bar at the water supply intake site and prevent detailed comparisons of river bed characteristics. The cessation or reduction of gravel removal in the upstream channel has the potential to increase the bed elevation on the mid-channel bar located at the existing infiltration gallery. The stability of this site over the last 60 years suggests that this effect will likely be small as the incoming sediment load appears to be carried through this reach. Improved riparian and upslope land use practices on Deadman River or Battle Creek could also be reducing rates of coarse textured sediment production and might mitigate the effects of any reduction in future volumes of upstream gravel extraction.

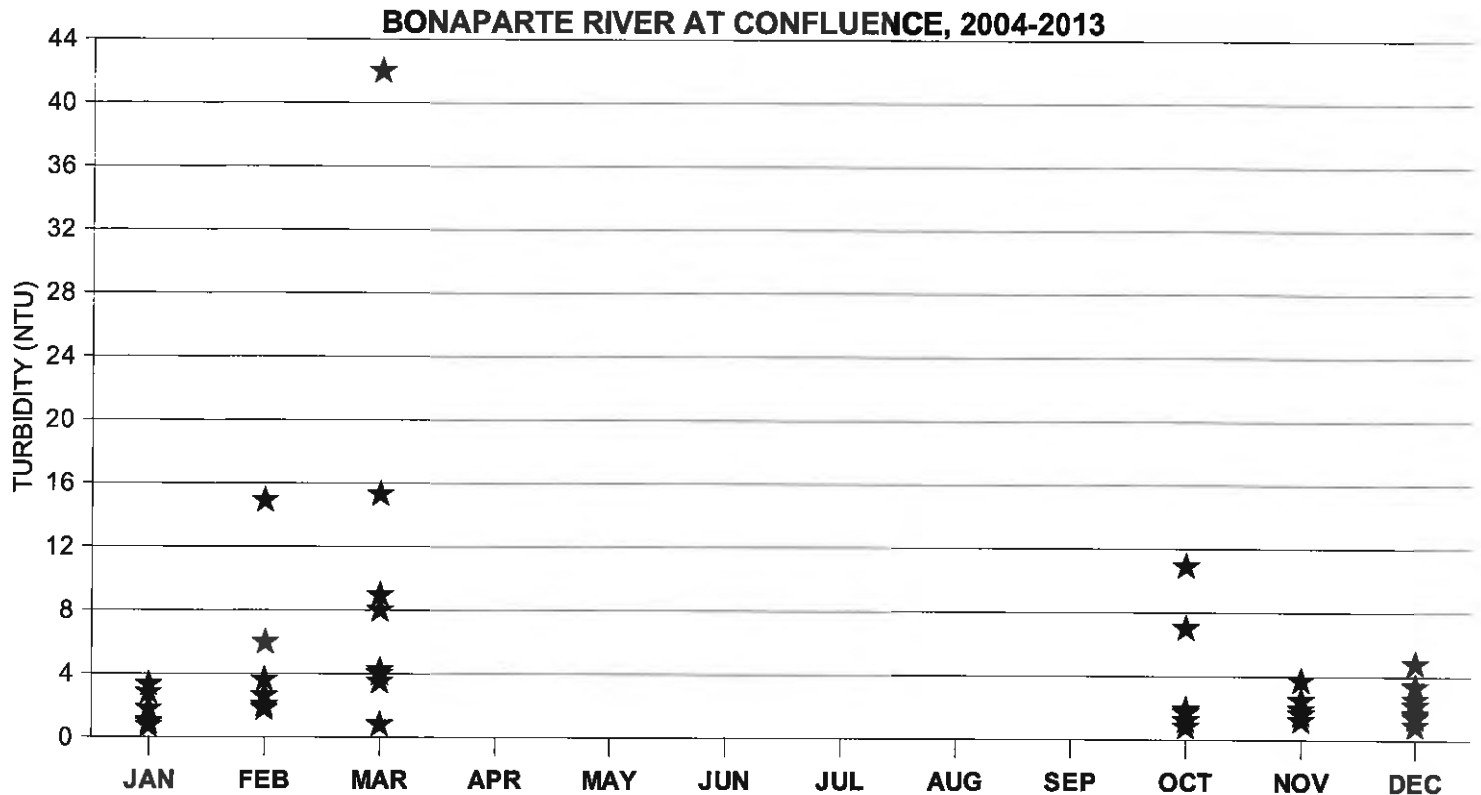
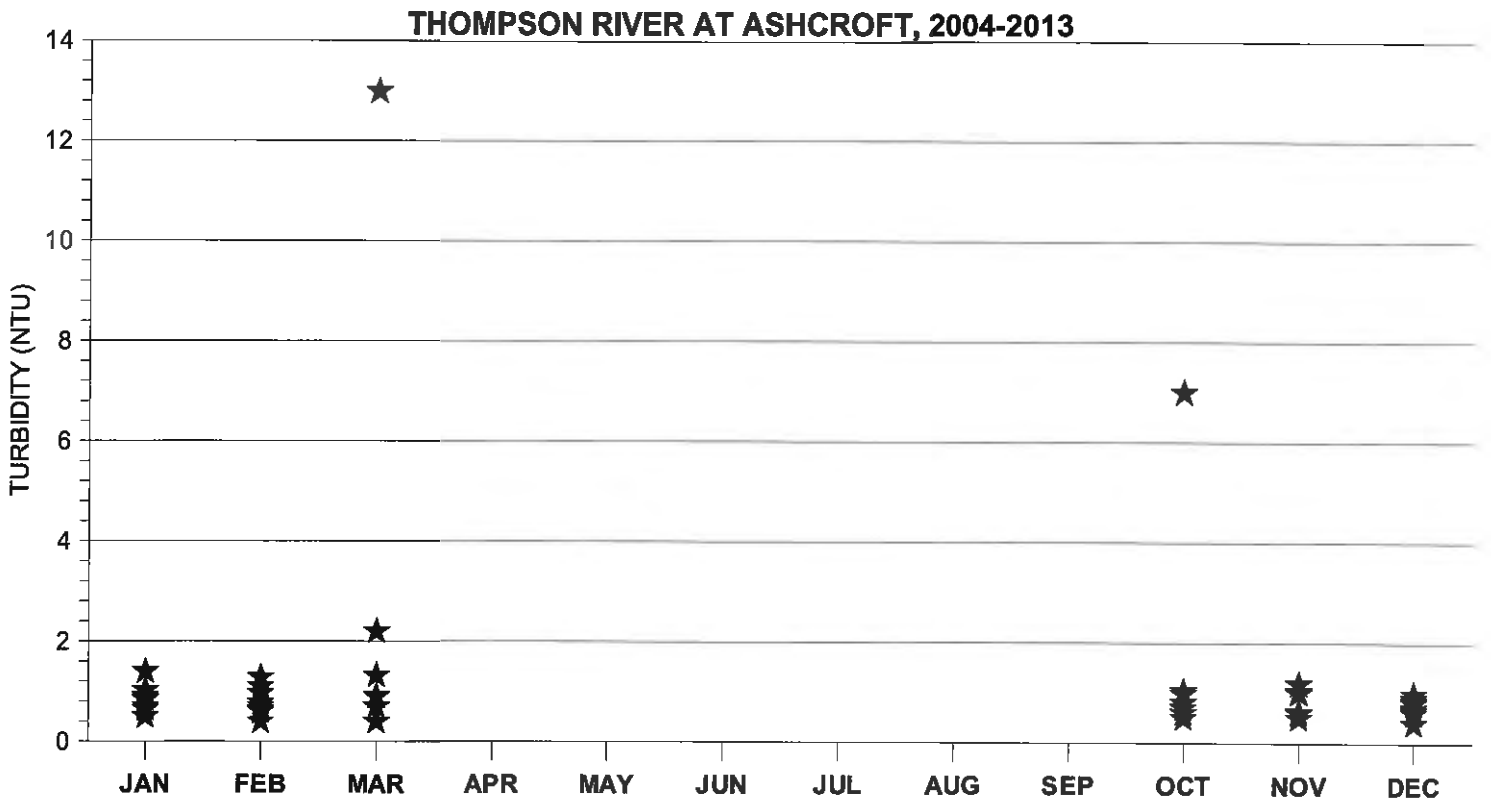
Figure 4.3.1: Seasonal variability in turbidity at Bonaparte River at Confluence and Thompson River at Ashcroft. [Data from BC Ministry of Environment.]

No measurements are available to document rates of bedload transport or to quantify suspended sediment concentrations or loadings. However, the BC Ministry of Environment is conducting a water quality sampling program in cooperation of the Village of Ashcroft [Jennifer Puhallo, R.P.Bio, pers. comm.] Seasonal data has been collected on Thompson River at Ashcroft and on lower Bonaparte River. All data available in March 2014 have been compiled on *Tables 4.3.1 & 4.3.2*, and this information includes 'turbidity' measurements. Information is only available for the winter low flow months when turbidity values will be at their seasonal minimum values. The collected data, which are plotted on *Figure 4.3.1*, suggest that fall and winter turbidity values on Bonaparte River are roughly twice as high as those observed on Thompson River. Measured values on Thompson River are typically less than 2 NTU and reached a maximum of 13 NTU. In contrast, turbidity observations on Bonaparte River are generally less than 4 NTU, occasionally reach values of 16 NTU and the maximum observed winter value is 42 NTU. Previous experience in the Bonaparte watershed suggest that these comparatively elevated values reflect the lack of upstream lake regulation, the occurrence of fine-textured surficial materials and land use related impacts. Turbidity values in the spring and summer (*see Figures 3.2.1 & 3.2.4*) are expected to be much higher than those observed in the winter low flow period.

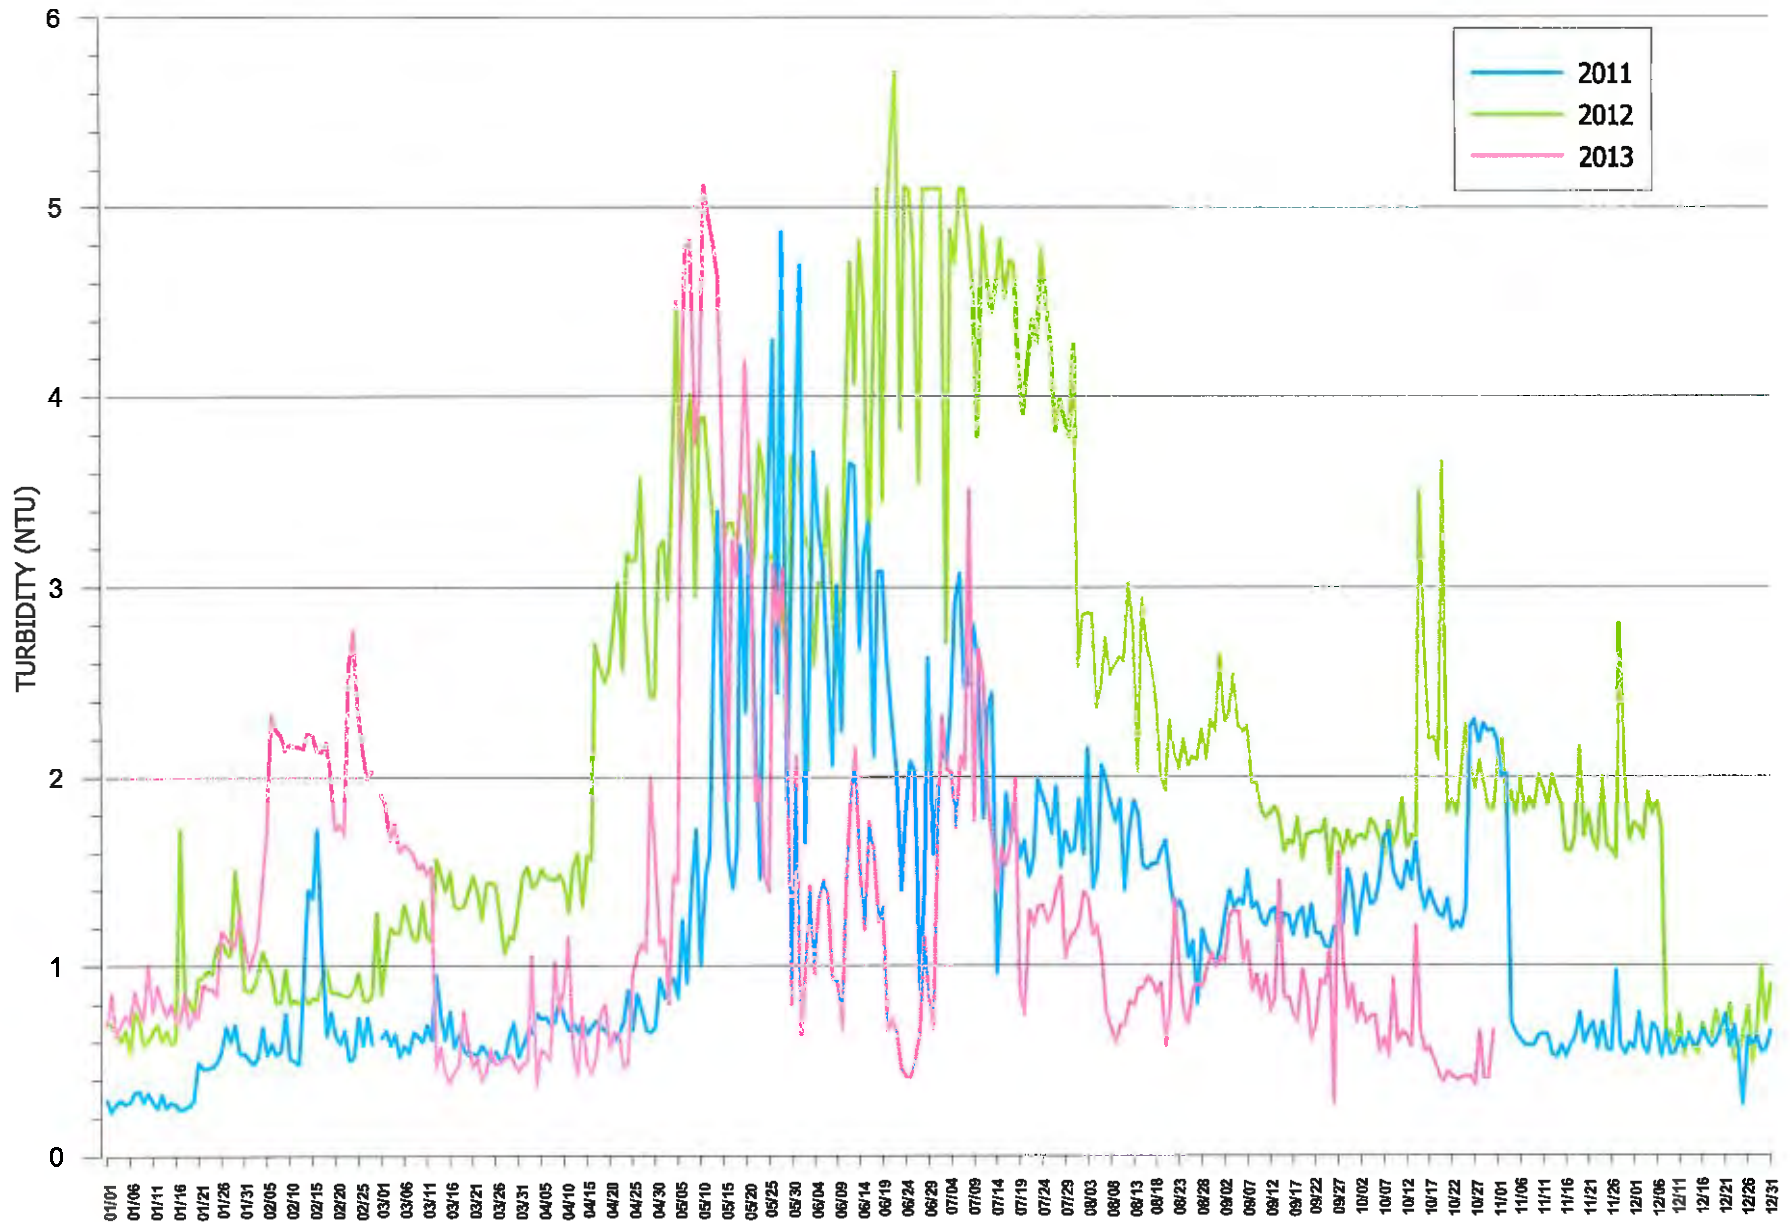
WATER TURBIDITY VALUES - VILLAGE OF ASHCROFT #1 PUMPHOUSE, JANUARY 2011 TO OCTOBER 2013

Figure 4.3.2: Water Turbidity Values - Village of Ashcroft #1 Pumphouse, January 1, 2011 to October 31, 2013.

4.3.2	Water turbidity values - Village of Ashcroft #1 Pumphouse, January 1, 2011 to October 31, 2013 F-16
5.3.1	Design cross-section of the intake pipe installed to augment or replace the infiltration gallery F-17

The VOA routinely measures turbidity values along with other parameters in the raw water supplied to the #1 Pumphouse. These data have been extracted for the period between January, 2011 and October 2013 and the results are summarized on *Figure 4.3.2*. The seasonal variation in turbidity values generally follows the previously discussed seasonal variations in flow. Maximum observed values of ~5 NTU have occurred in May, June and July. To put these values in perspective, the maximum recommended drinking water turbidity values for treated water are summarized below, based on guidelines prepared by *Health Canada (2012)*.

The 'raw water' data shown on *Figure 4.3.2* periodically exceed the recommended 1.0 NTU treated water value.

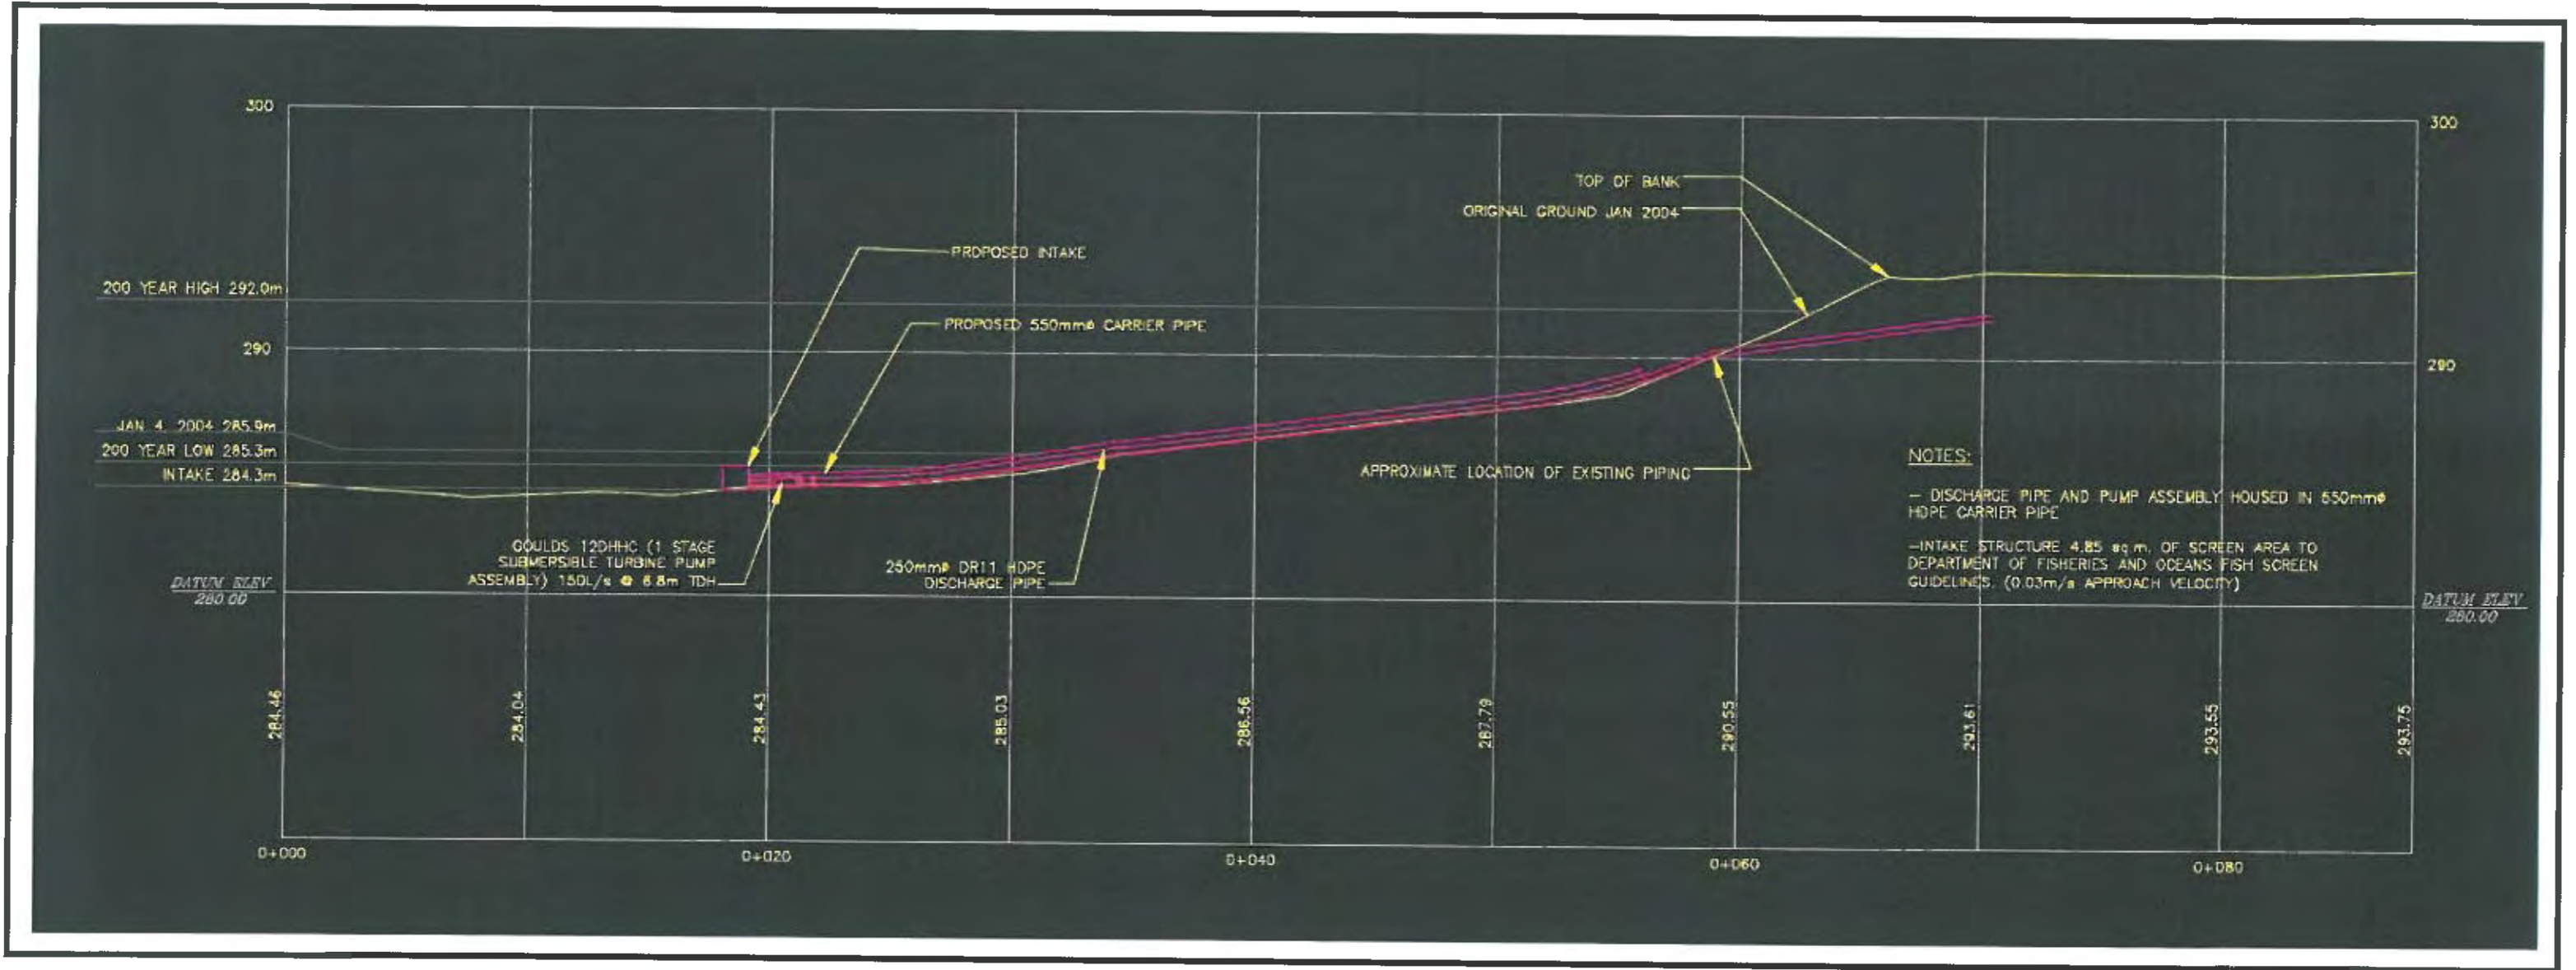
Figure 5.3.1: Design cross-section of the intake pipe installed to augment or replace the infiltration gallery (from Urban Systems Ltd.).

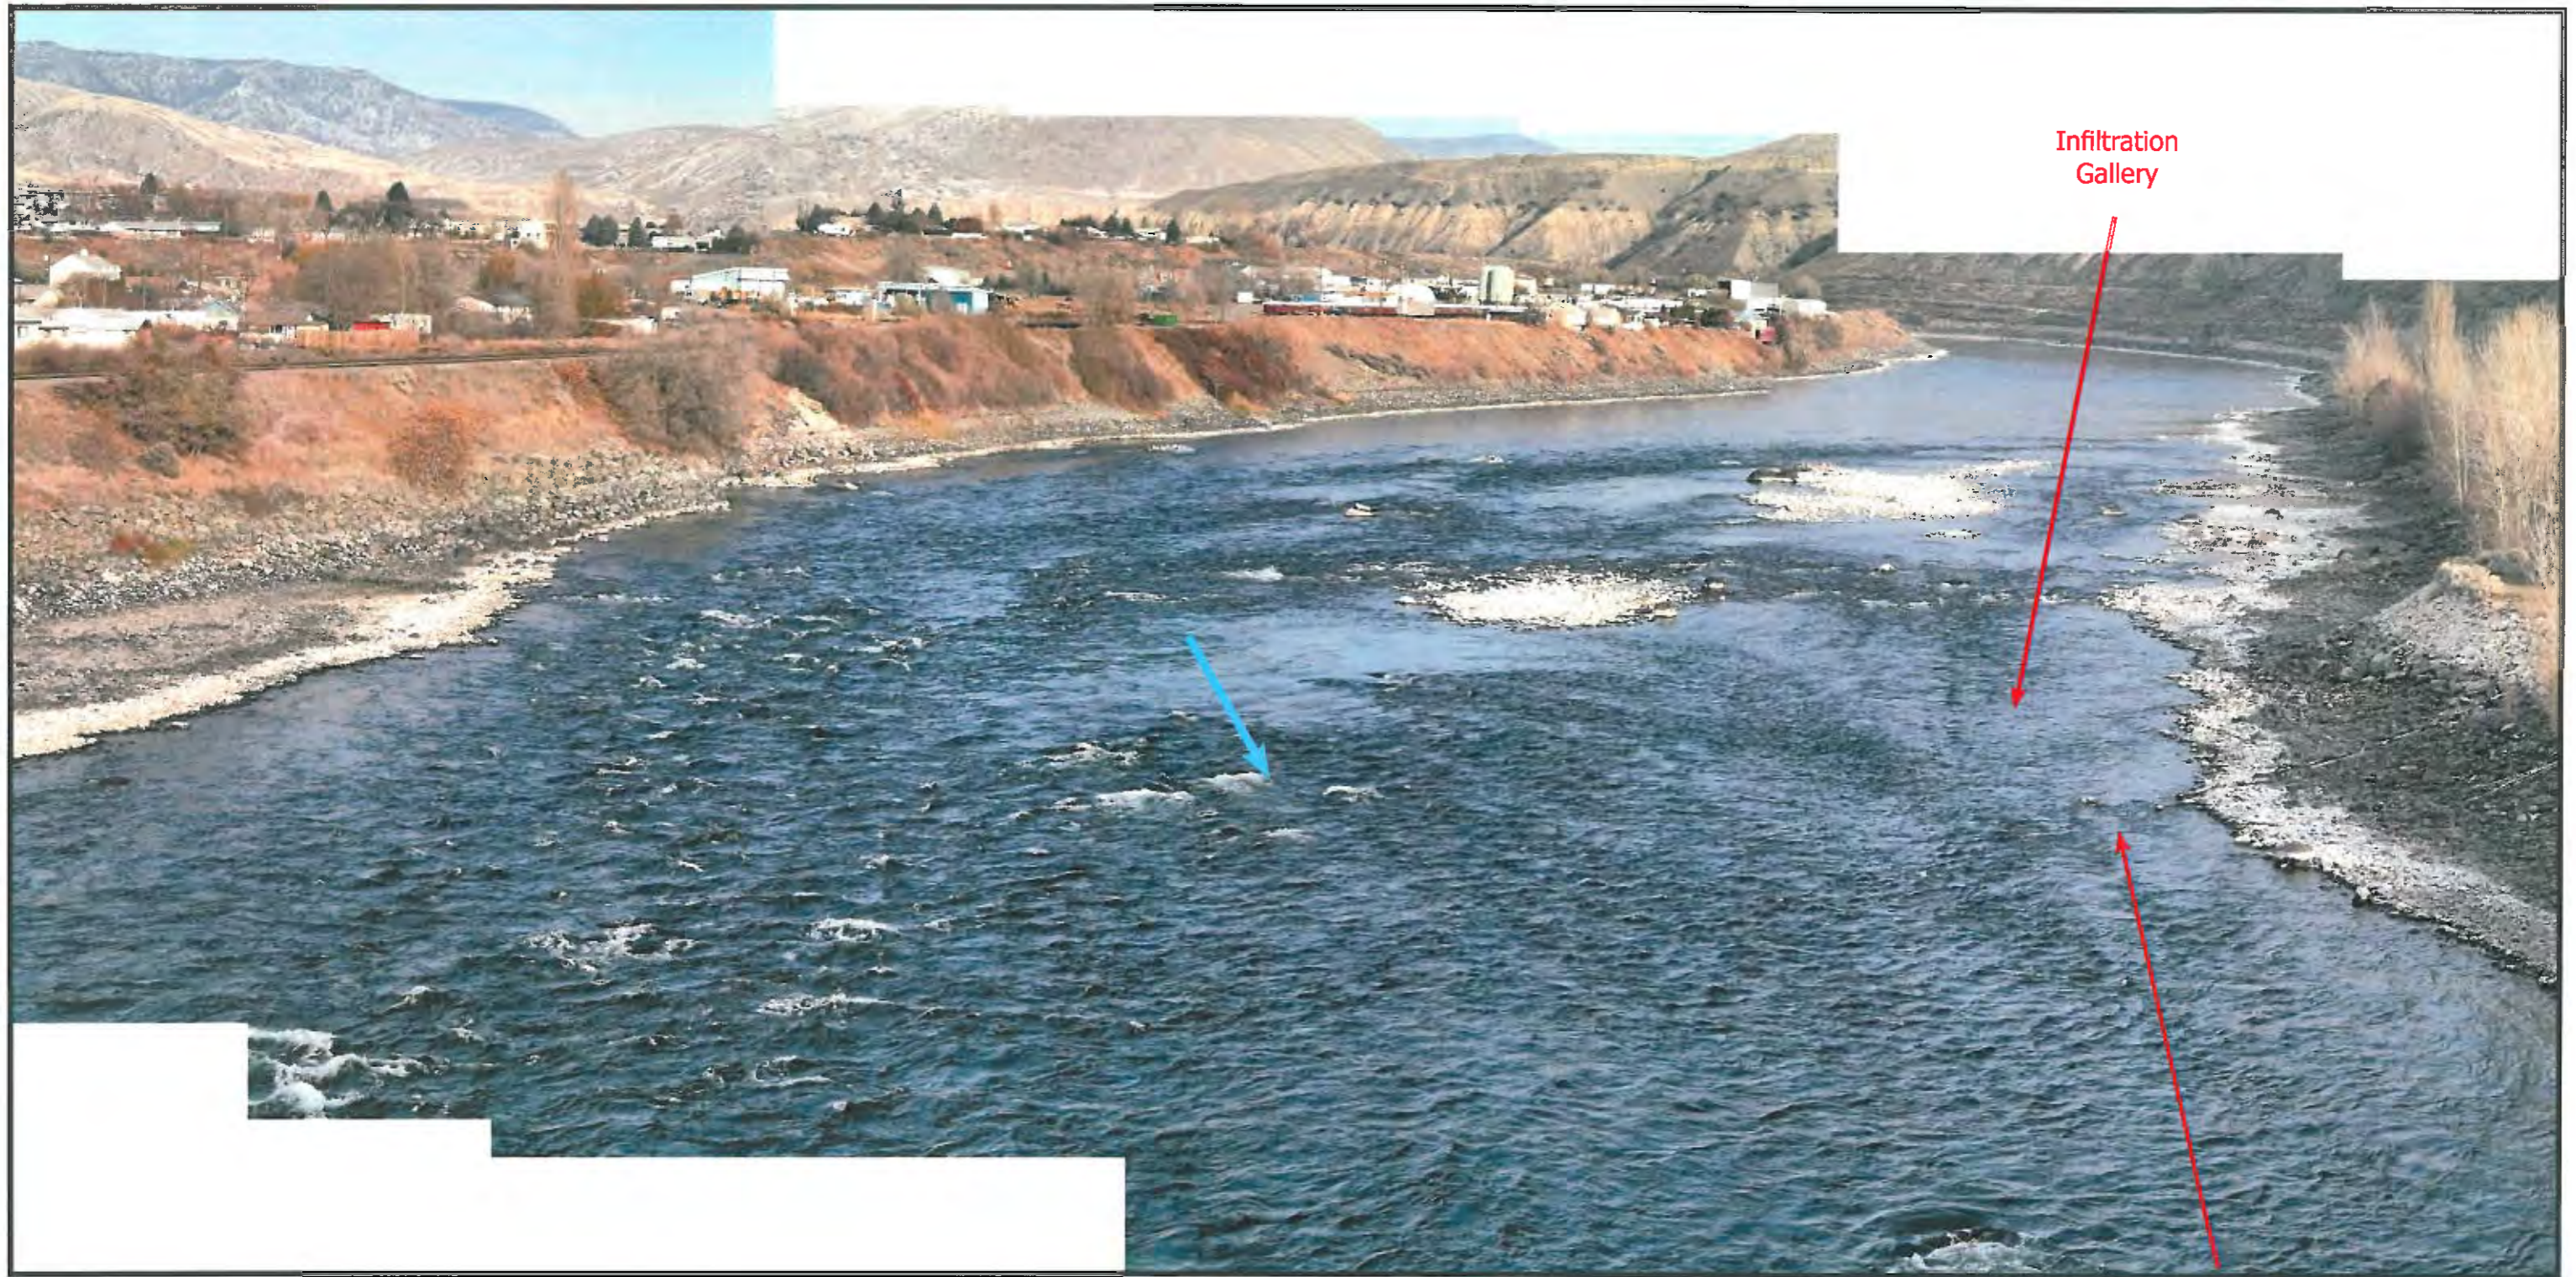
Infiltration
Gallery

Emergency Water
Supply Intake

Plate 4.1.1: Looking upstream from the Highway 97C Bridge on November 21, 2013, illustrating the extent of the mid-channel bar at a discharge of 283 m³/s (measured near Spences Bridge).

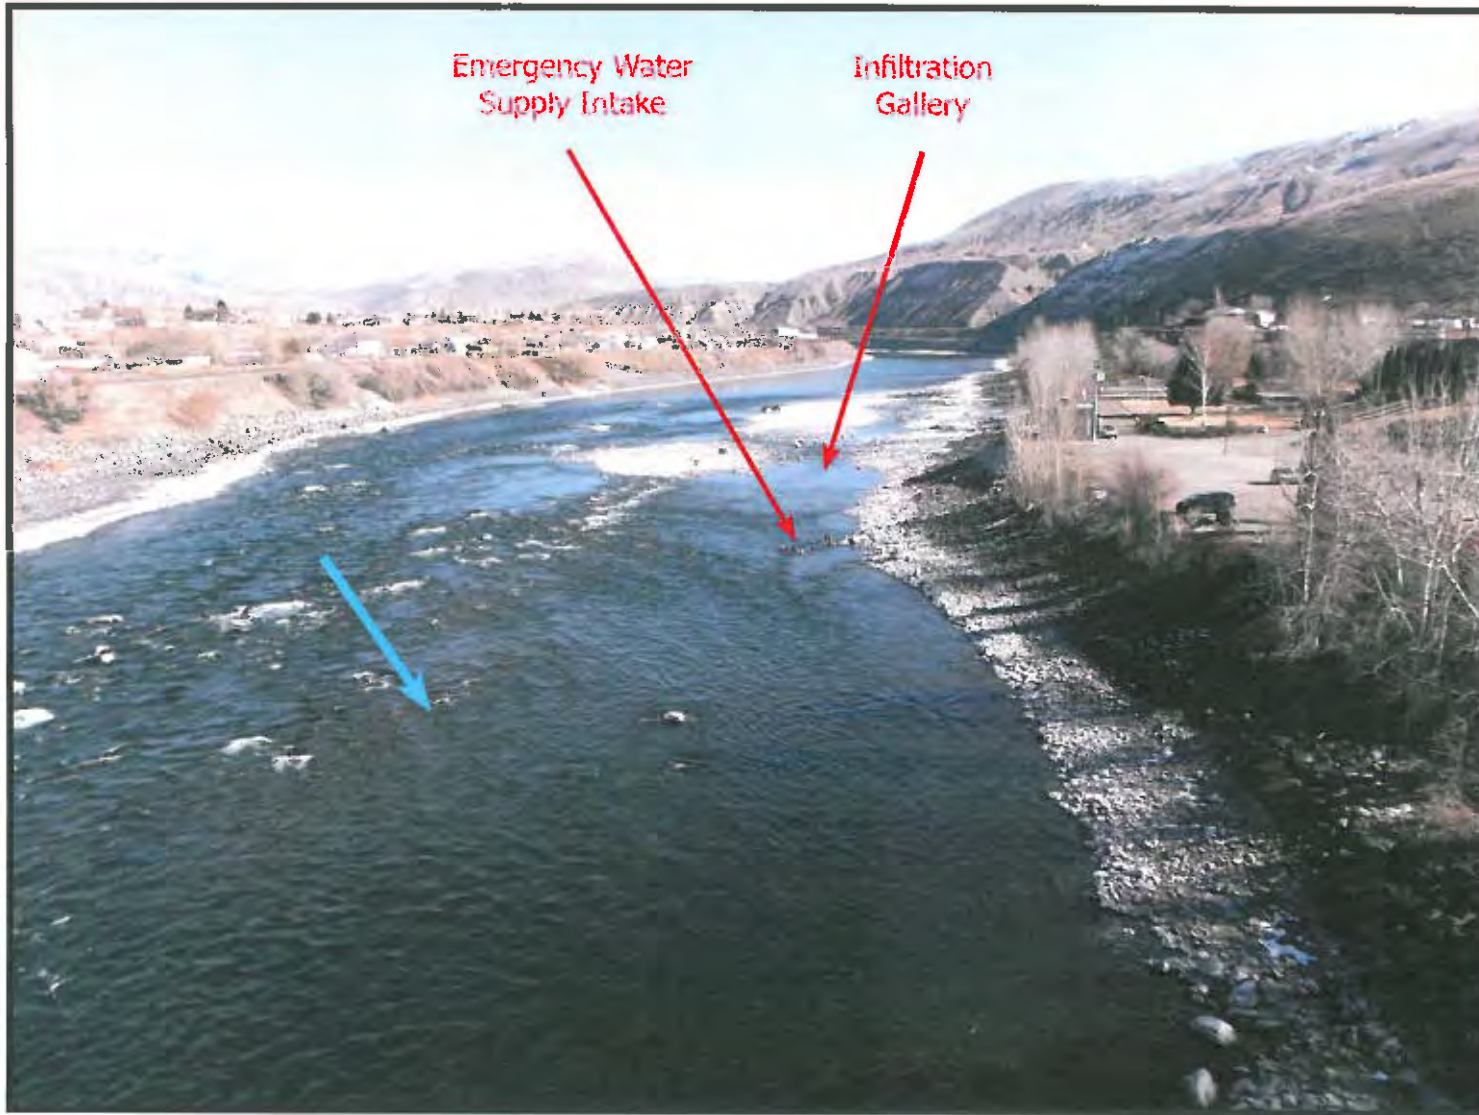
Plate 4.1.2: Looking upstream from the Highway 97C Bridge on February 25, 2014, illustrating the extent of the mid-channel bar at a discharge of $164.5 \text{ m}^3/\text{s}$ (measured near Spences Bridge).

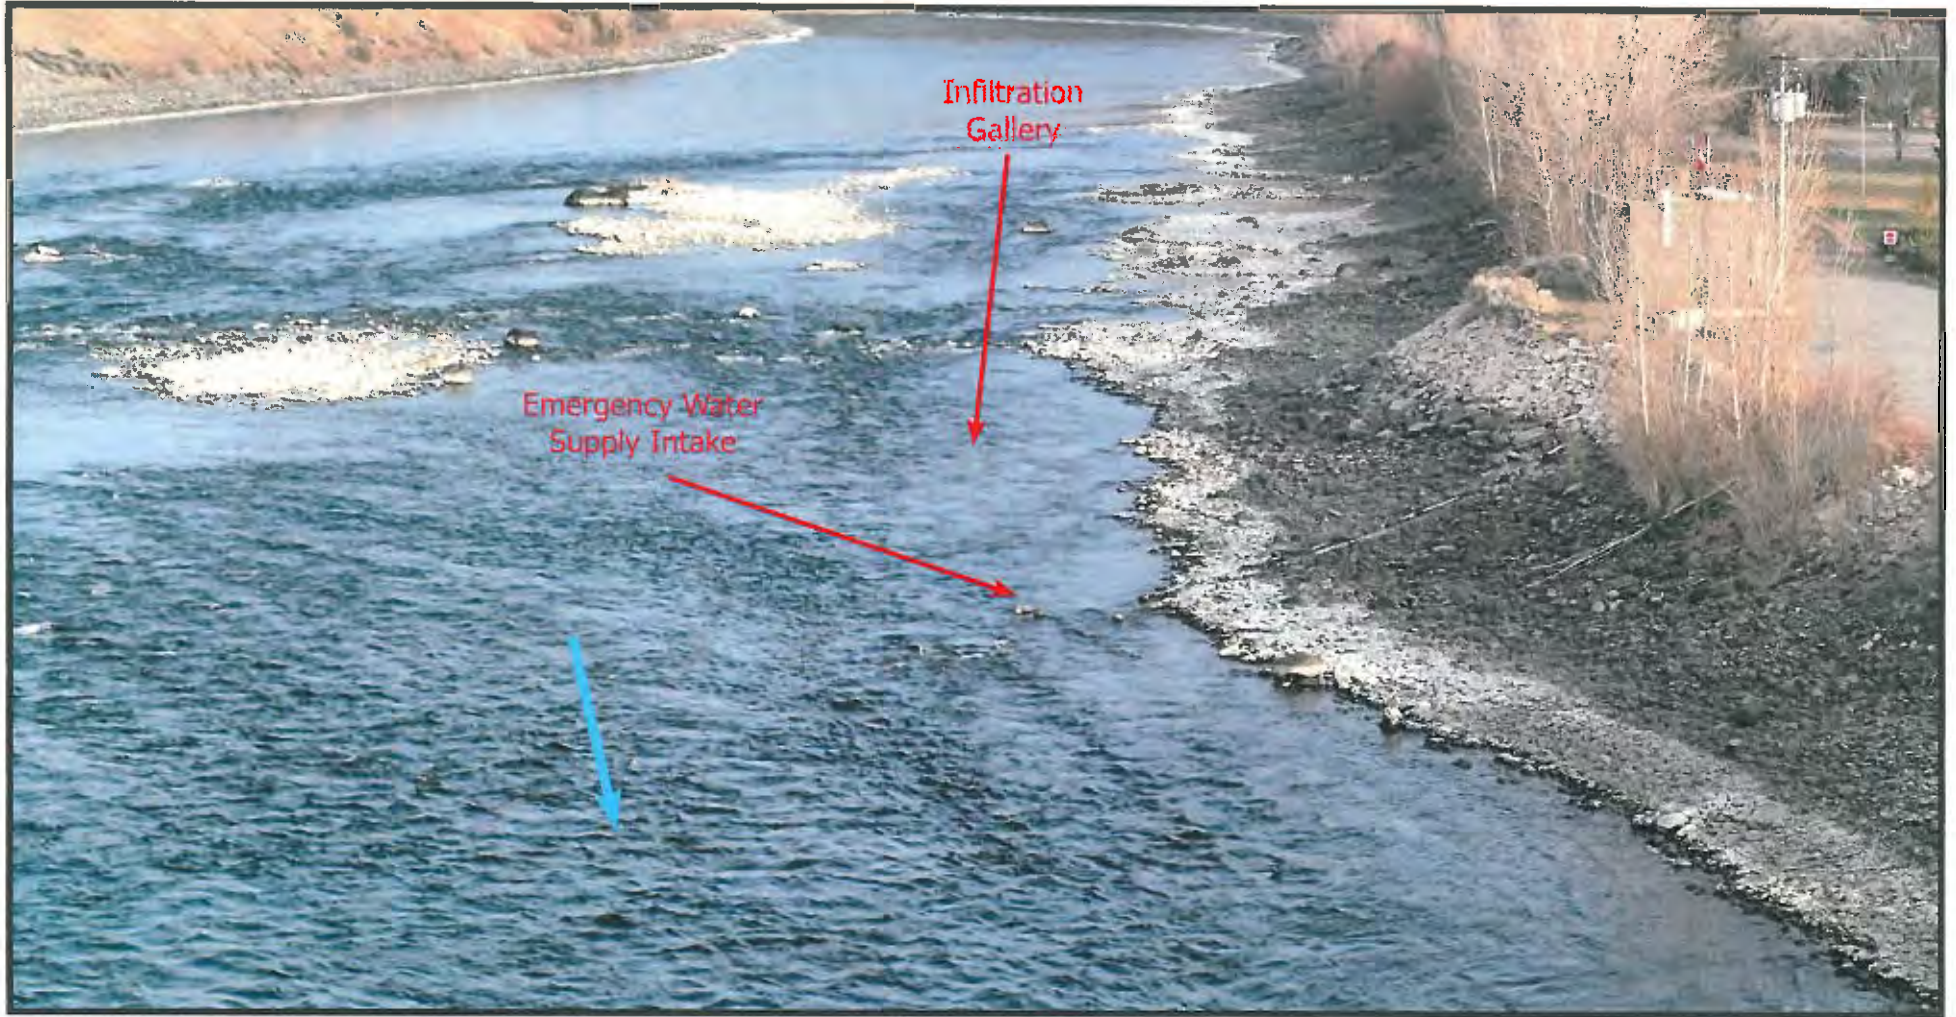
Plate 4.1.3: Looking upstream from the Highway 97C Bridge on November 21, 2013, illustrating flow conditions at the emergency intake pipe and the upstream infiltration gallery during a discharge of $283 \text{ m}^3/\text{s}$ (measured near Spences Bridge).

4.1.3	Looking upstream from the Highway 97C bridge on November 21, 2013, illustrating flow conditions at the emergency intake pipe and the upstream infiltration gallery during a discharge of 283 m ³ /s	P-3

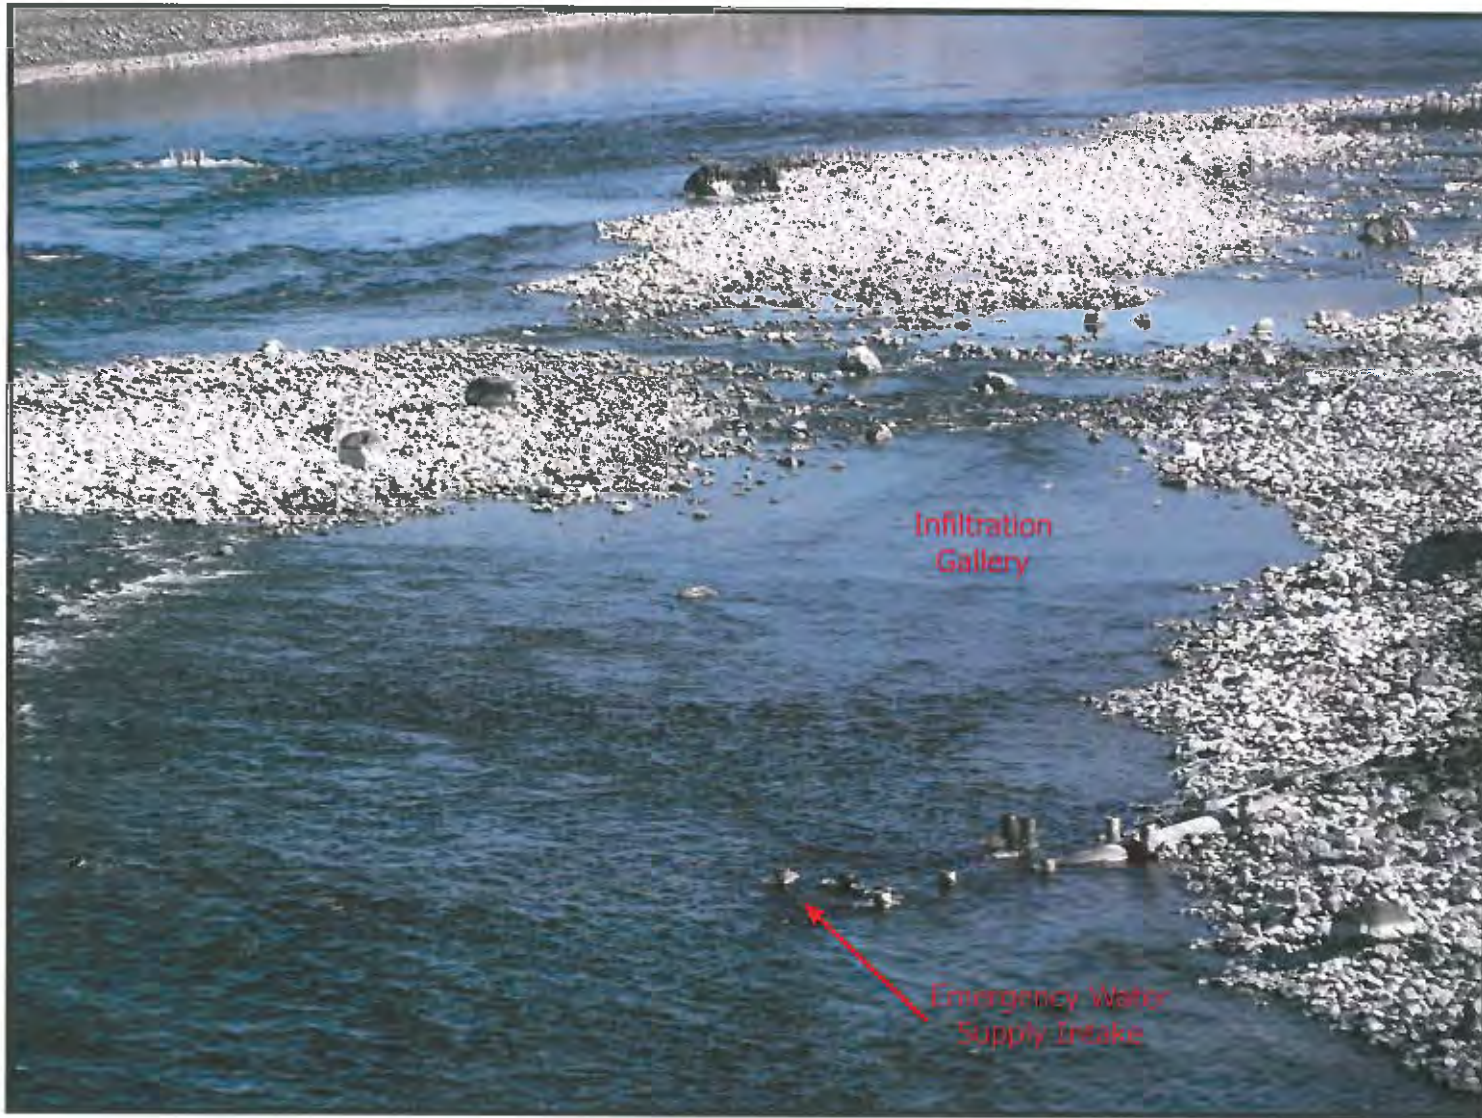
Plate 4.1.4: Looking upstream from the Highway 97C Bridge on February 25, 2014, illustrating flow conditions at the emergency intake pipe and the upstream infiltration gallery during a discharge of $164.5 \text{ m}^3/\text{s}$ (measured near Spences Bridge).

4.1.4	Looking upstream from the Highway 97C bridge on February 25, 2014, illustrating flow conditions at the emergency intake pipe and the upstream infiltration gallery during a discharge of 164.5 m ³ /s	P-4

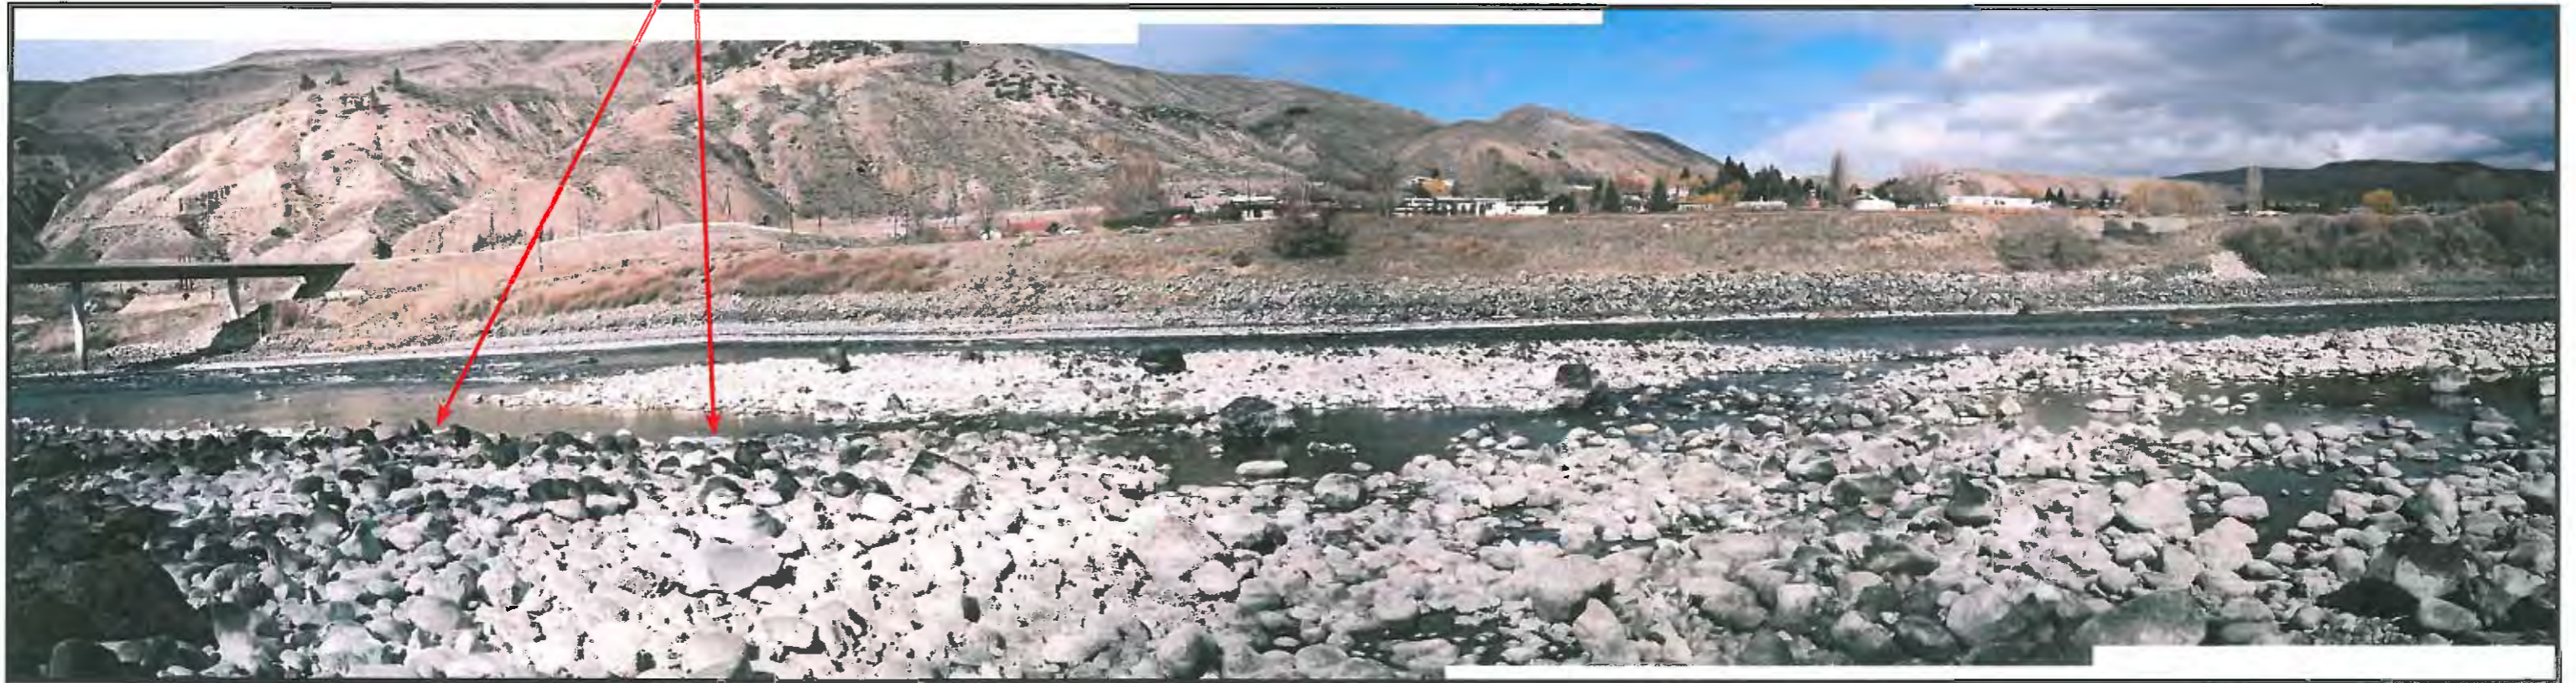
Plate 4.1.5: Photograph of the infiltration gallery in 2003 illustrating the limited extent of upstream open water during a discharge of $\geq 183 \text{ m}^3/\text{s}$ (measured near Spences Bridge)

4.1.5	Photograph of the infiltration gallery in 2003 illustrating the limited extent of upstream open water during a discharge of ≥183 m ³ /s at Spences Bridge			P-5
