Village of Ashcroft

Water Master Plan

November 2014

URBAN
systems

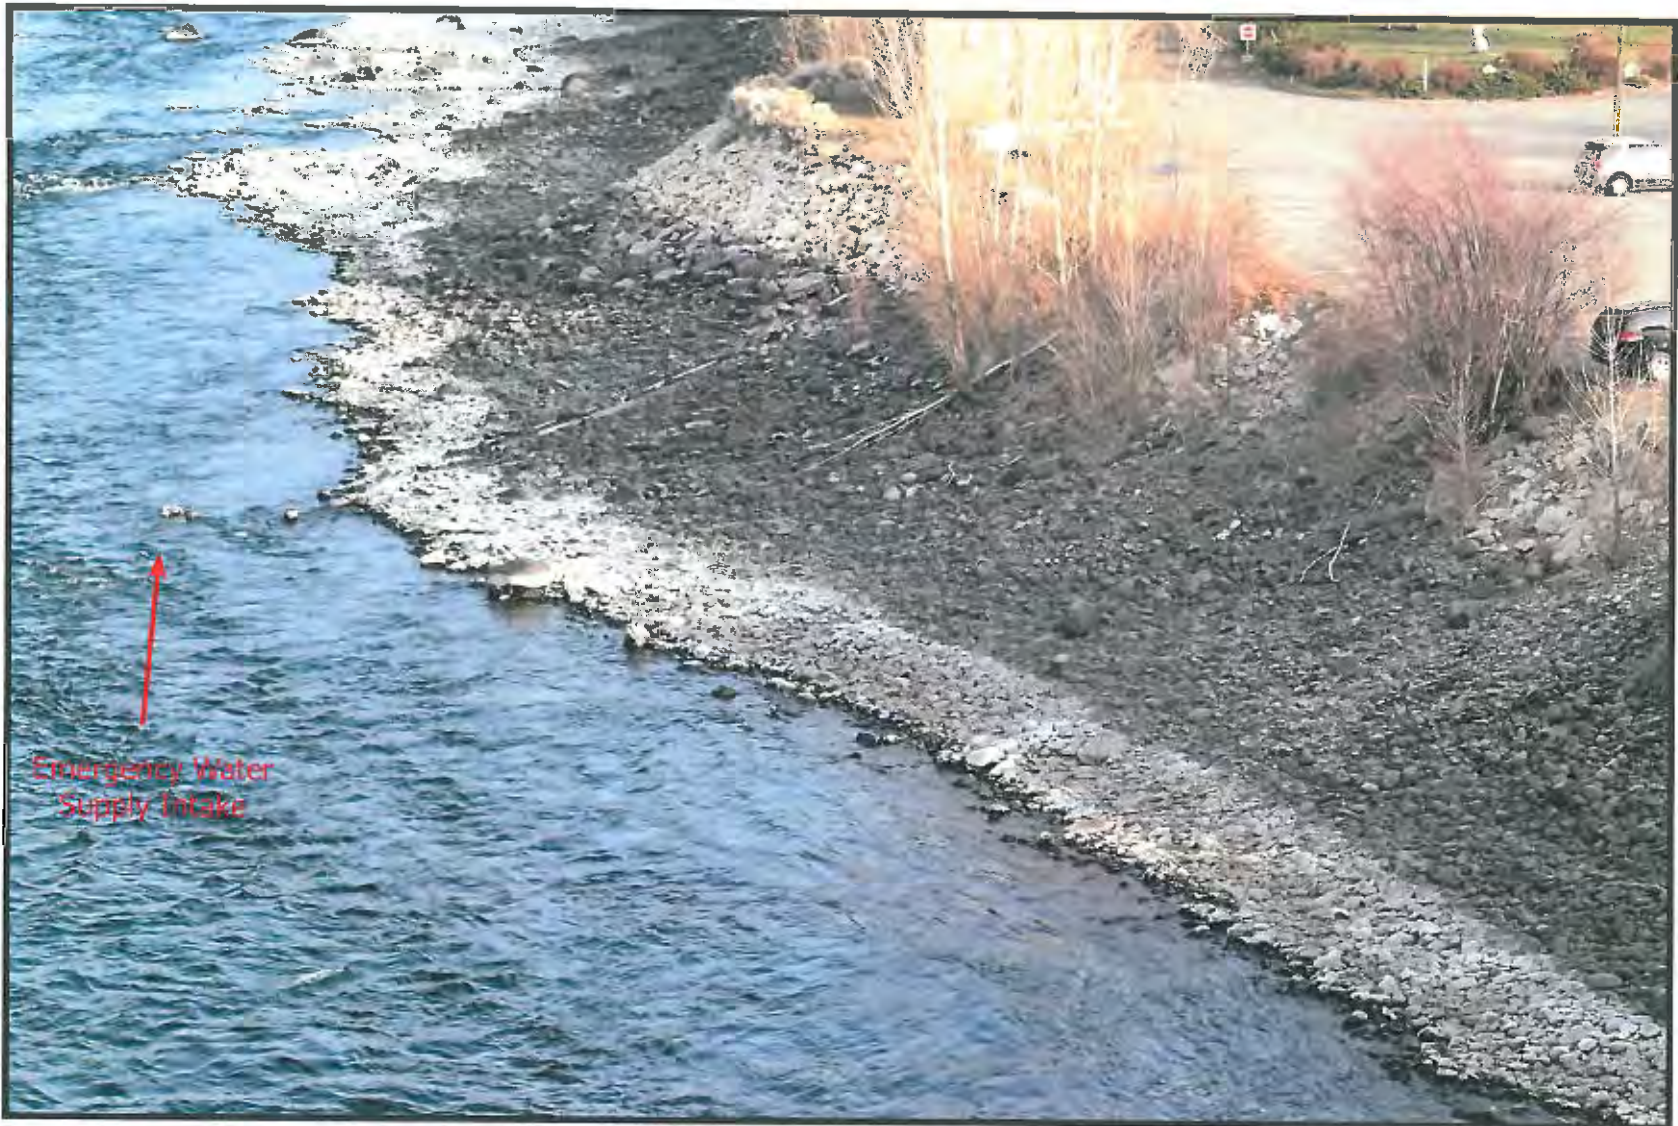
Plate 4.1.7: Looking upstream from the Highway 97C bridge to the bed material sampling area on the left bank in the vicinity of the emergency water supply intake.

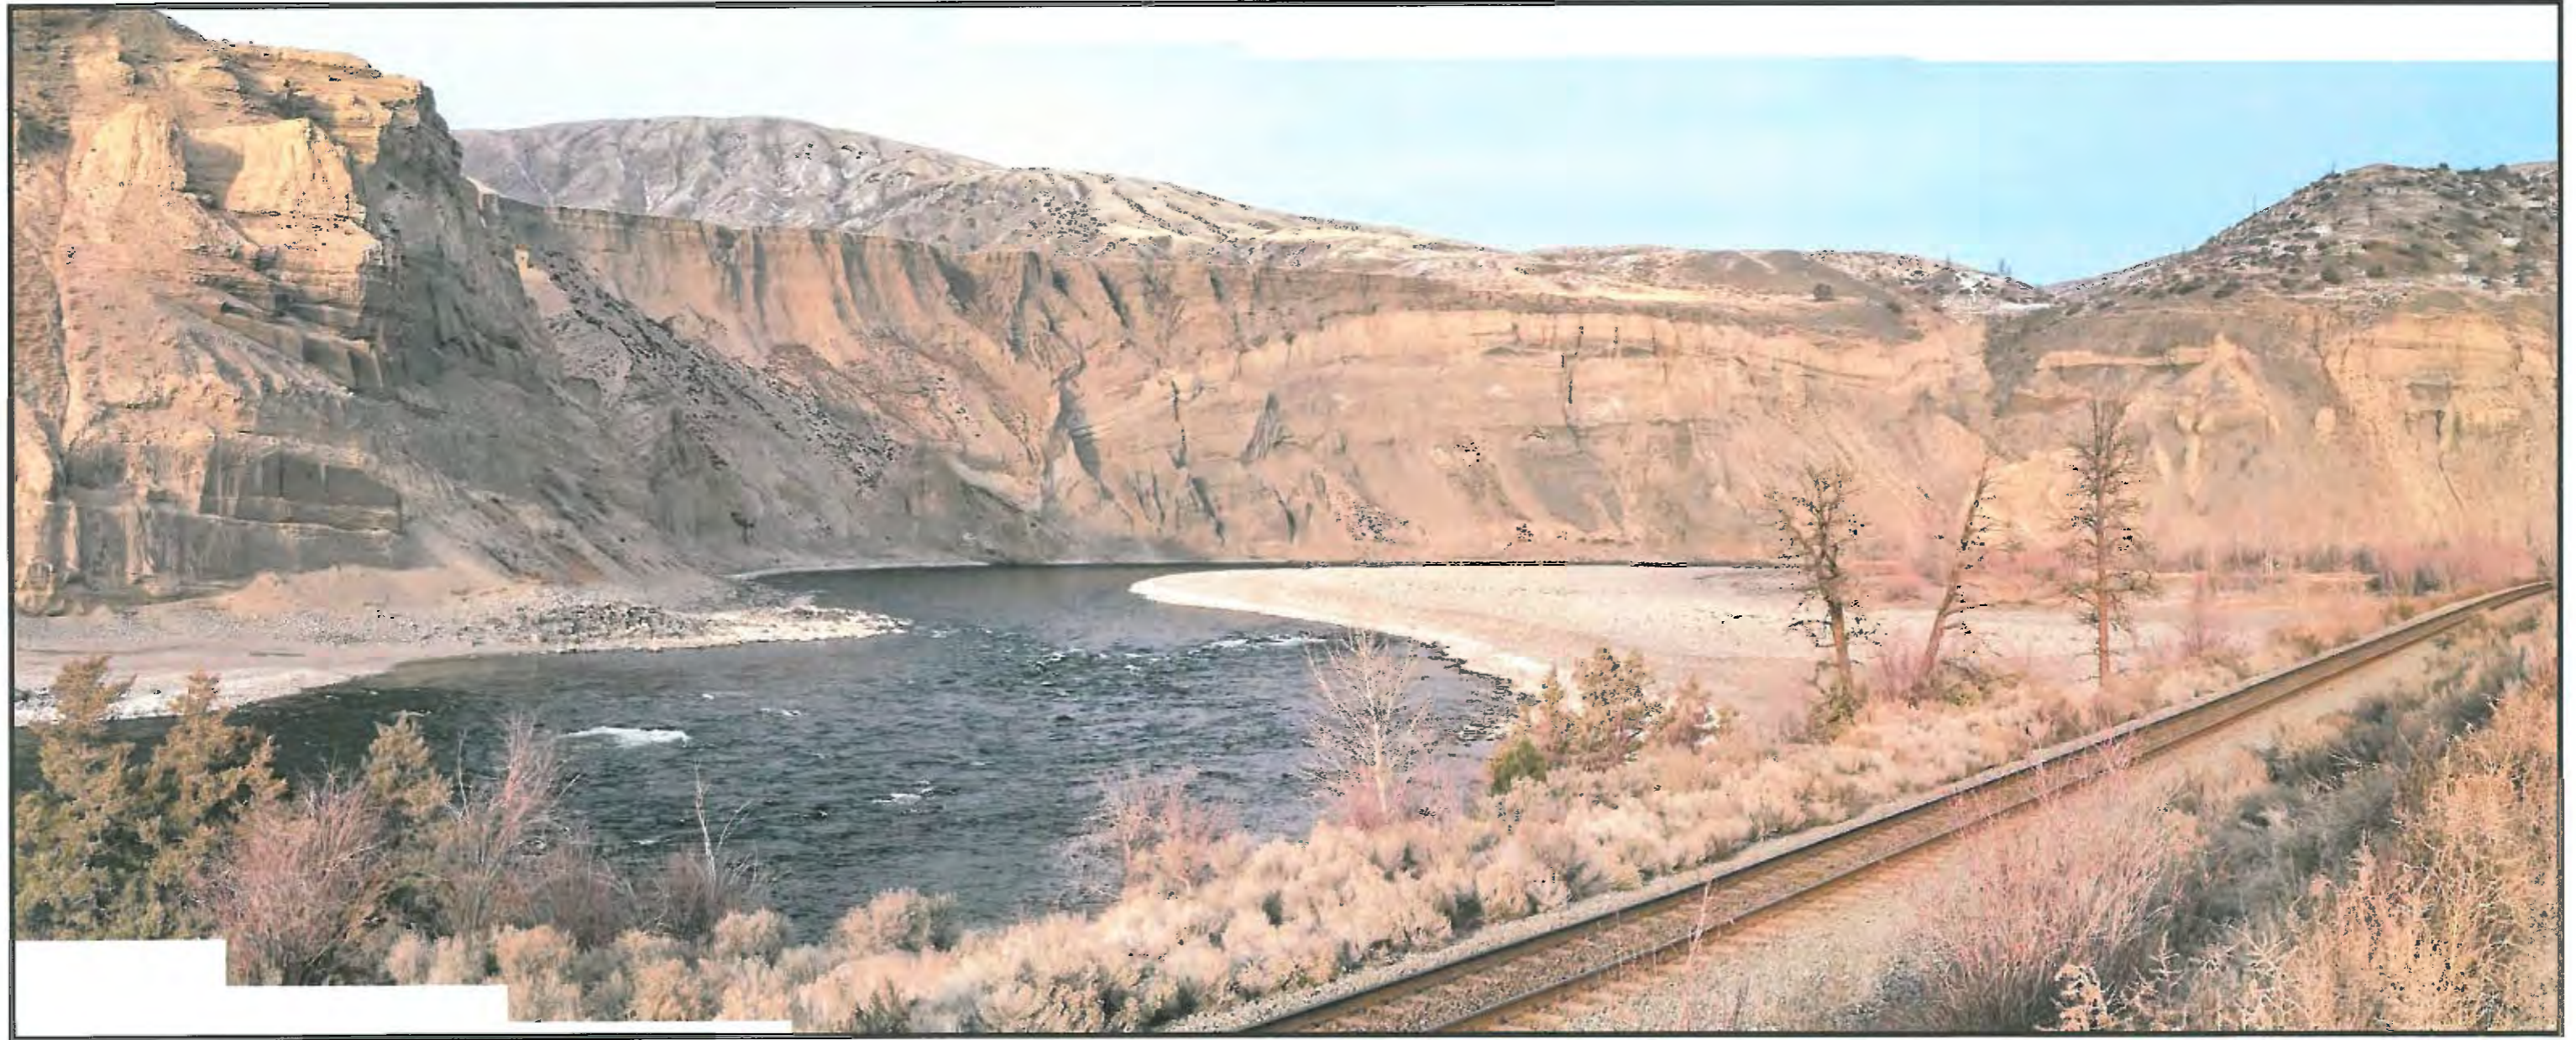
Plate 4.3.1: Looking upstream to the eroding right bank terrace and active left bank point bar located 4 km upstream of the Ashcroft water supply intake.

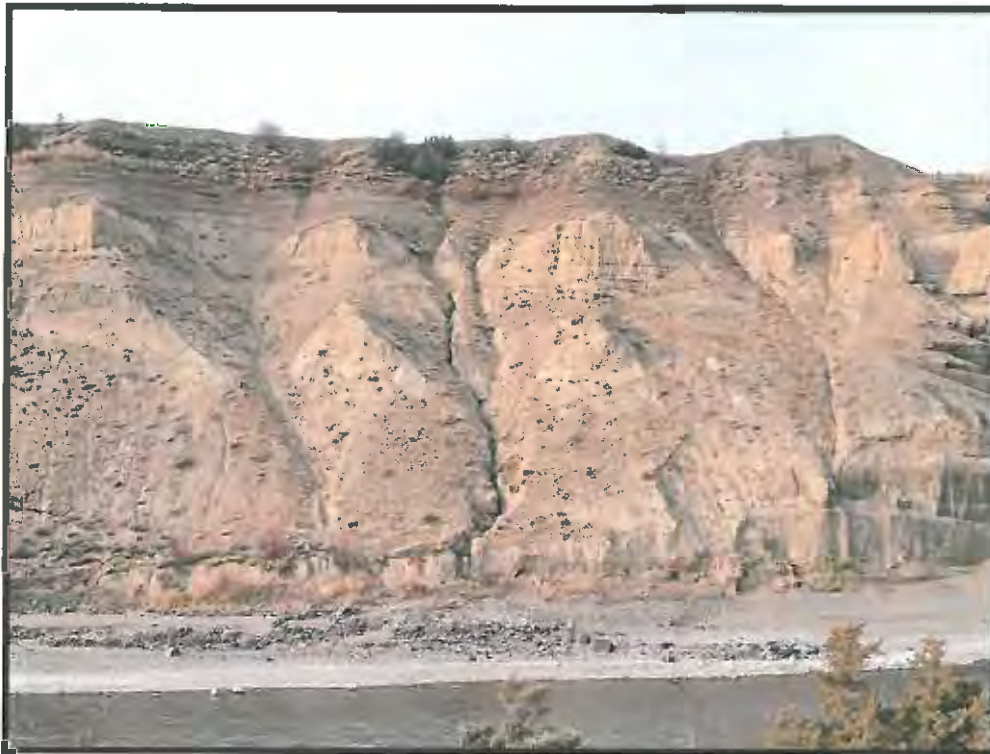
Plate 4.3.2: Illustration of gully formation and sediment production from eroding areas on the terraces bordering Thompson River.

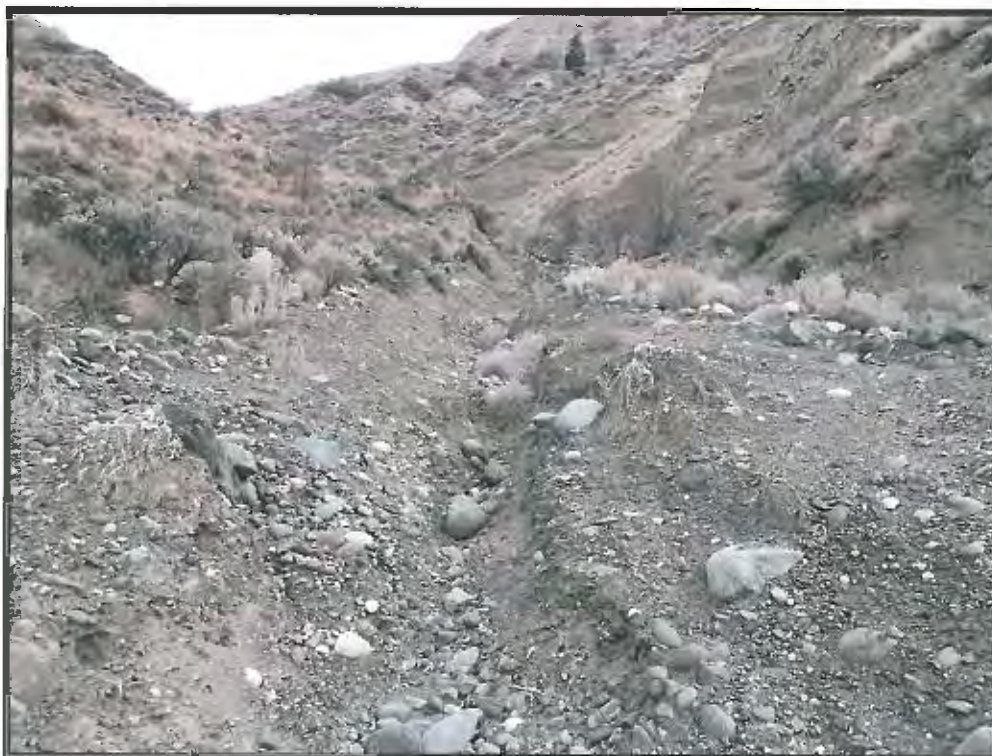
Plate 4.3.3: Looking upstream illustrating sediment production from one of the two small left bank streams located 2 km upstream of the Ashcroft water supply intake.

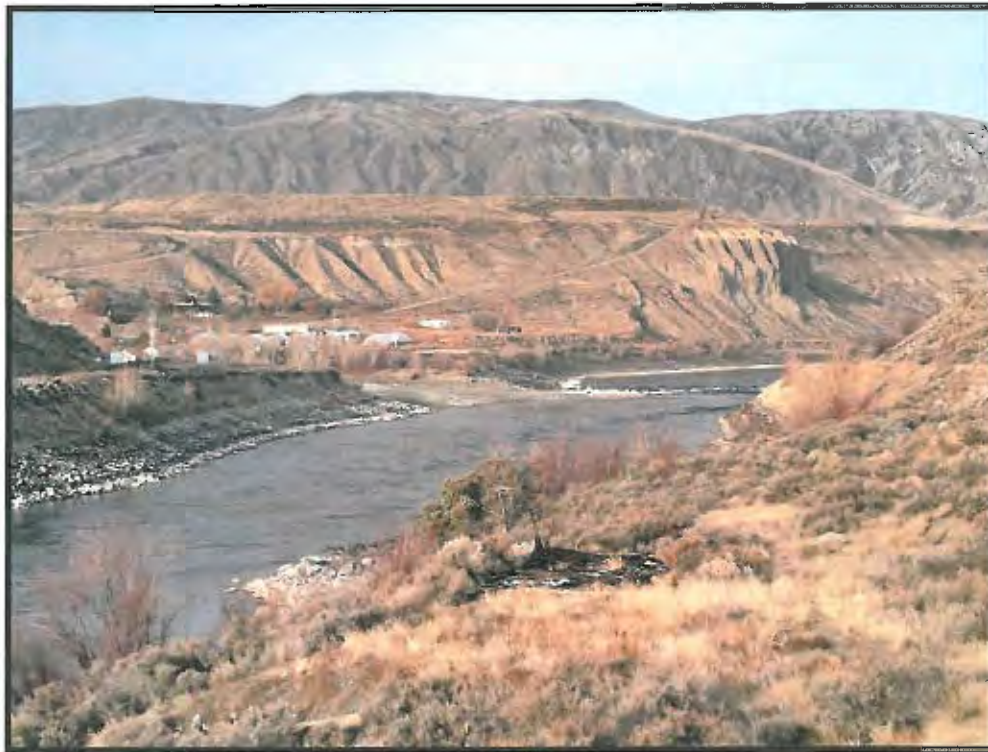
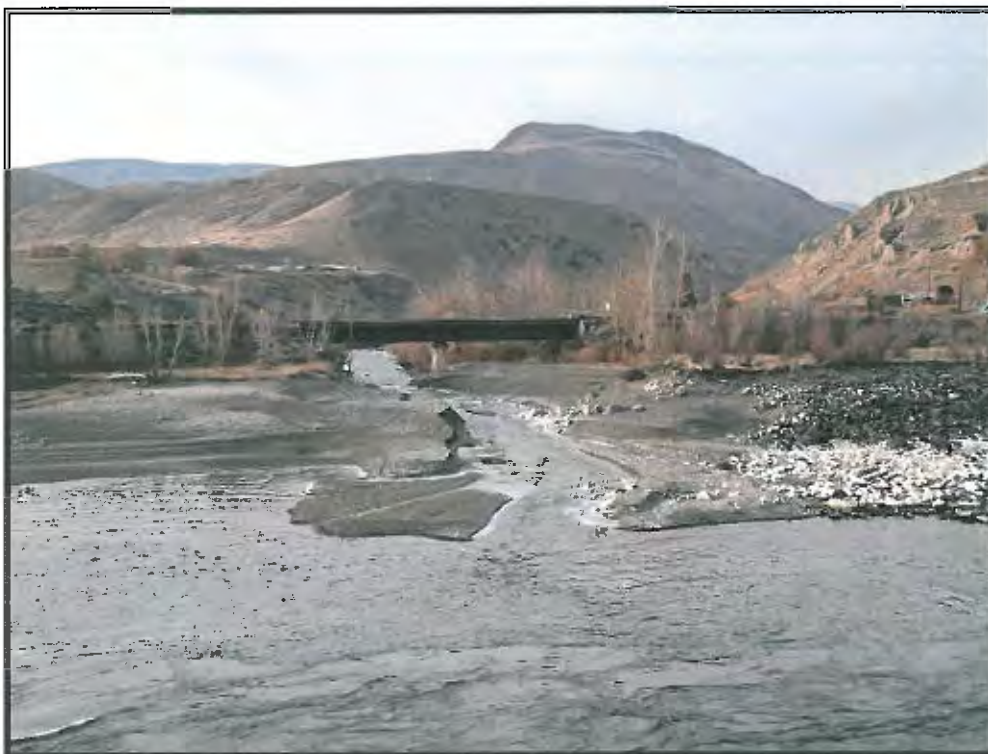
a) Looking upstream to the confluence

b) Looking west illustrating the sediment deposited along the channel banks.

Plate 4.3.4: Photographs of Bonaparte River at the confluence with Thompson River.

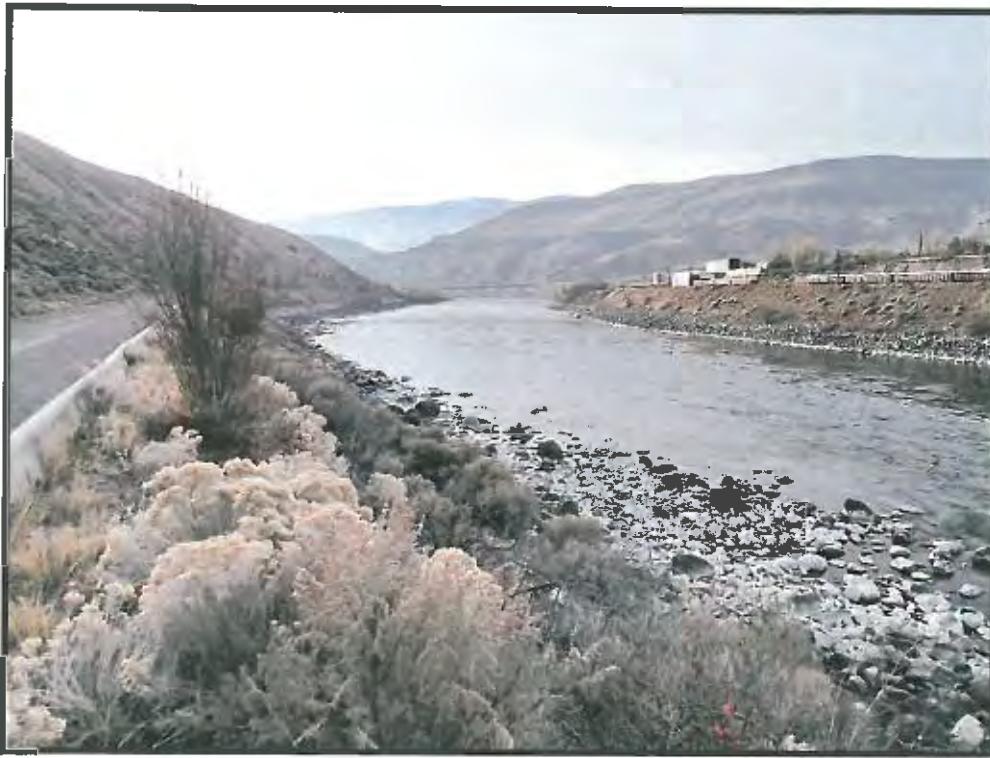
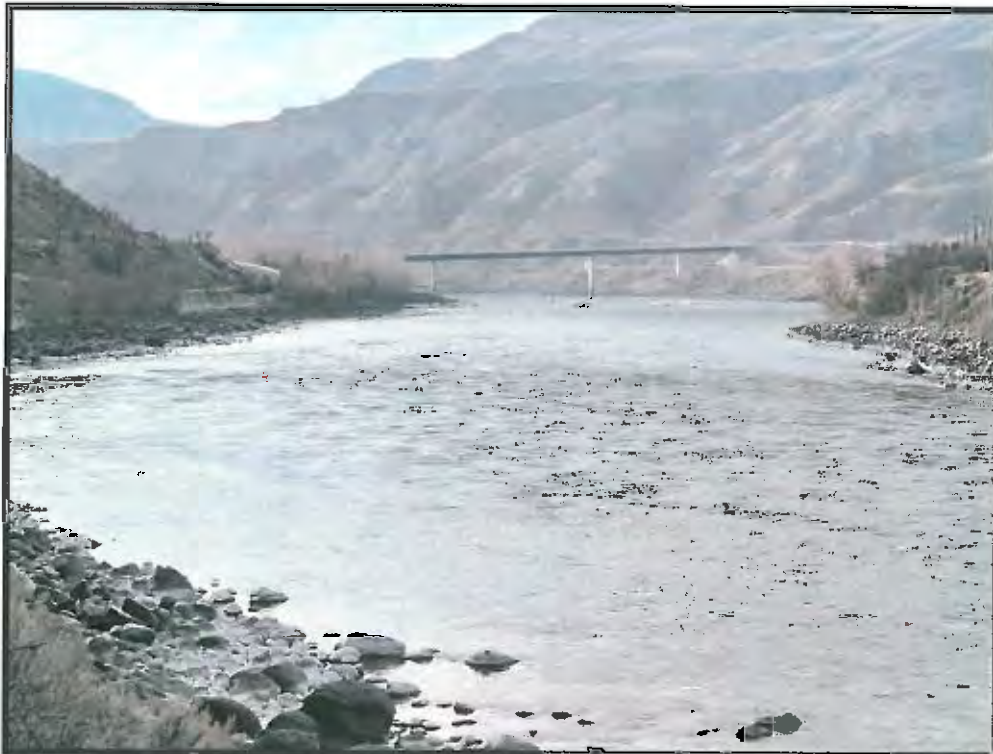
Plate 4.3.5: Looking downstream to the Highway 97C bridge illustrating the coarse textured material on the channel banks and the limited extent of areas which are susceptible to erosion.

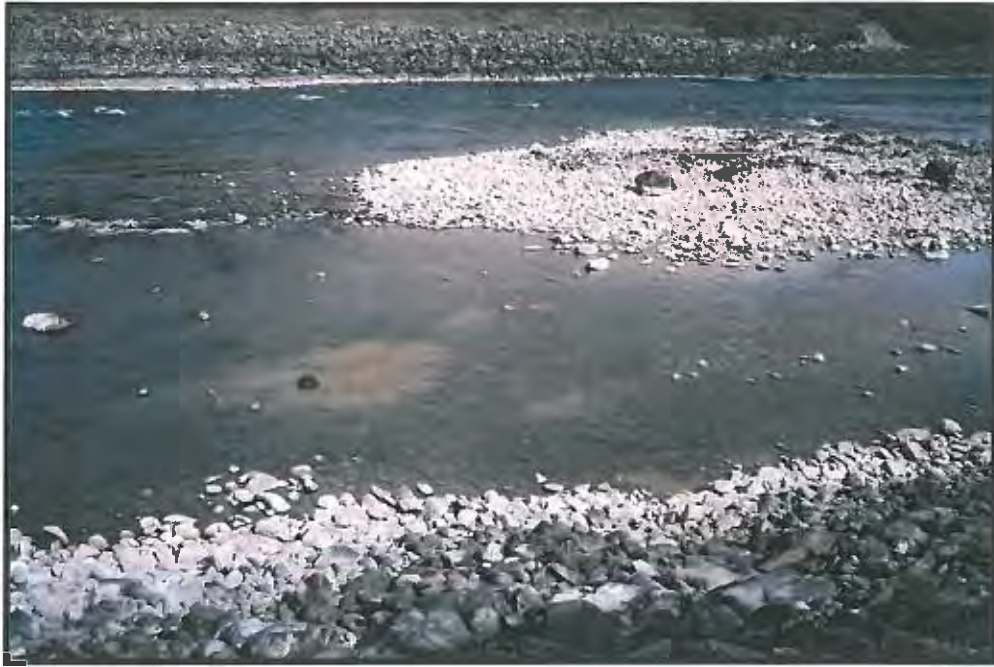
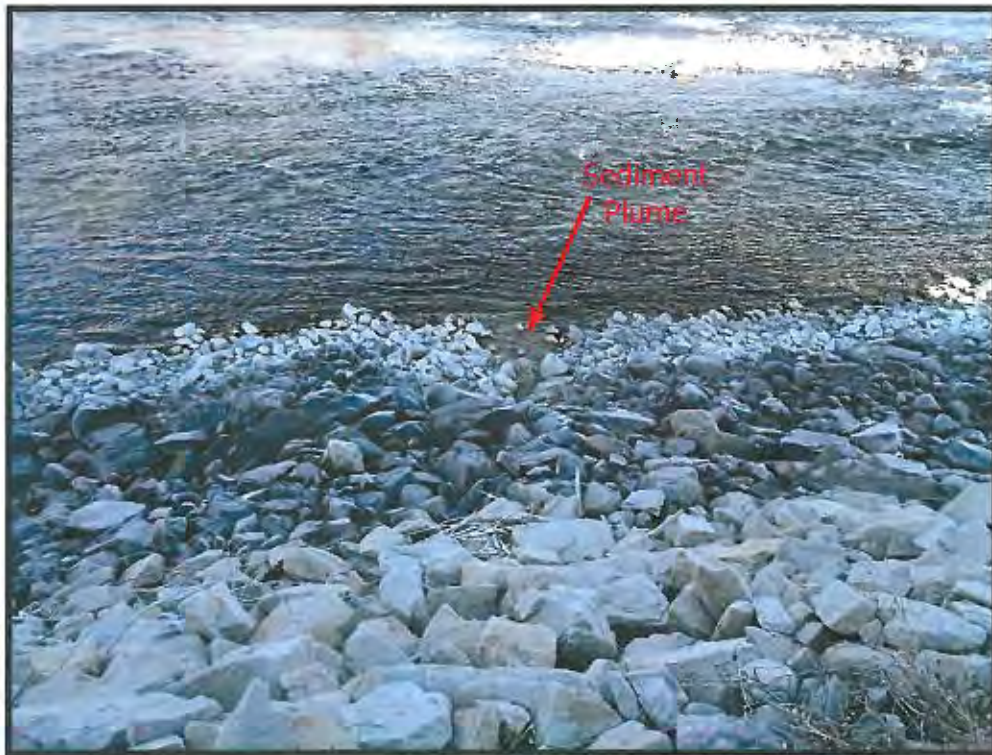
a) Discharge Thompson River near Spences Bridge $\geq 183 \text{ m}^3/\text{s}$.

Plate 5.1.1: Photographs of the infiltration gallery illustrating the fine sediment plumes resulting from back-flushing in March 2003 and November 2013.

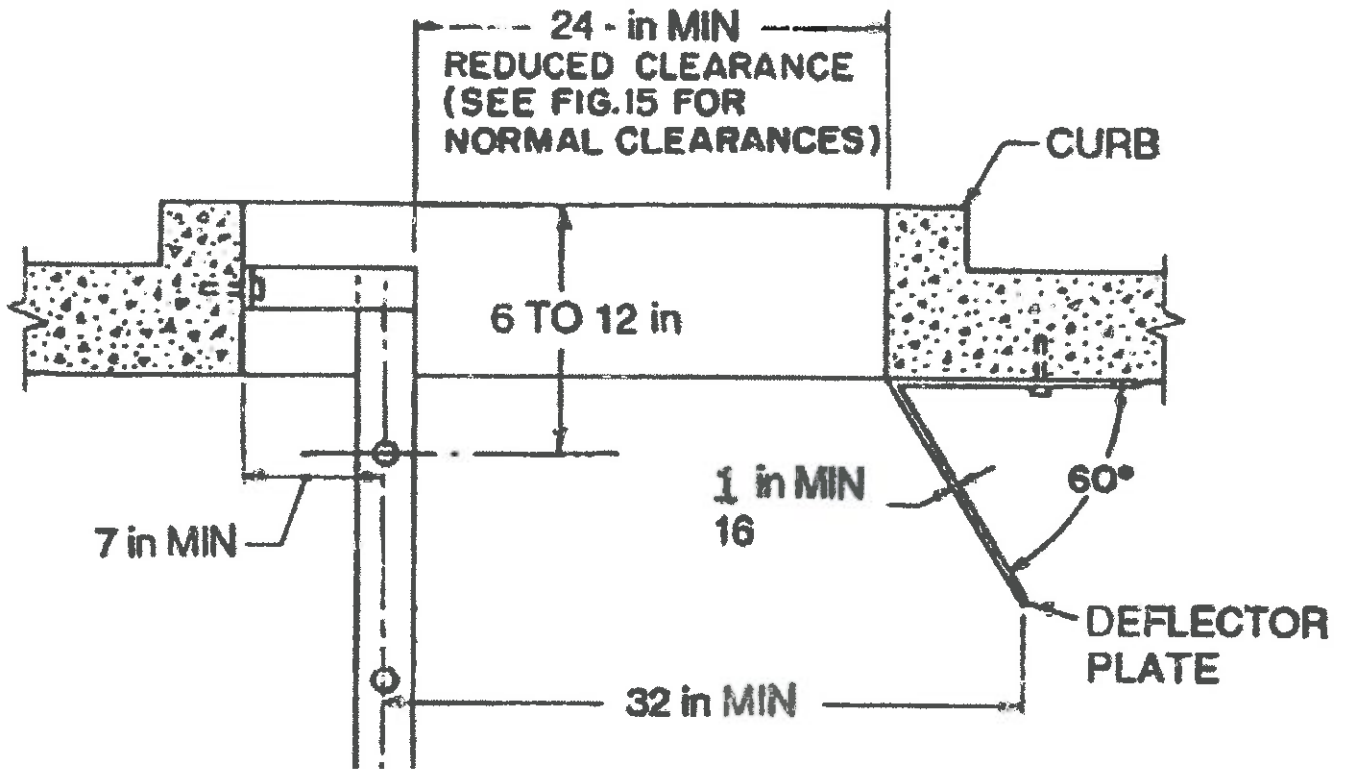
Figure 13: Deflector Plate for Hatch Opening with Reduced Clearance

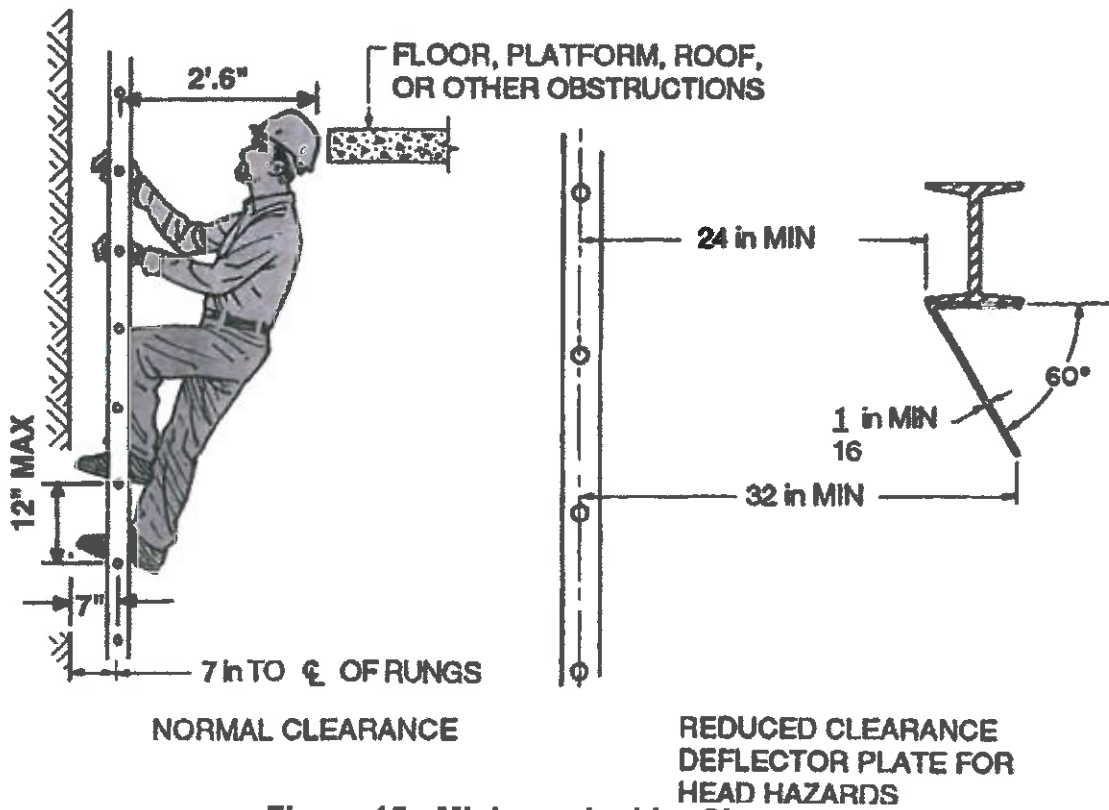
Figure 15 : Minimum Ladder Clearance
