Village of Ashcroft

Water Master Plan

November 2014

URBAN
systems

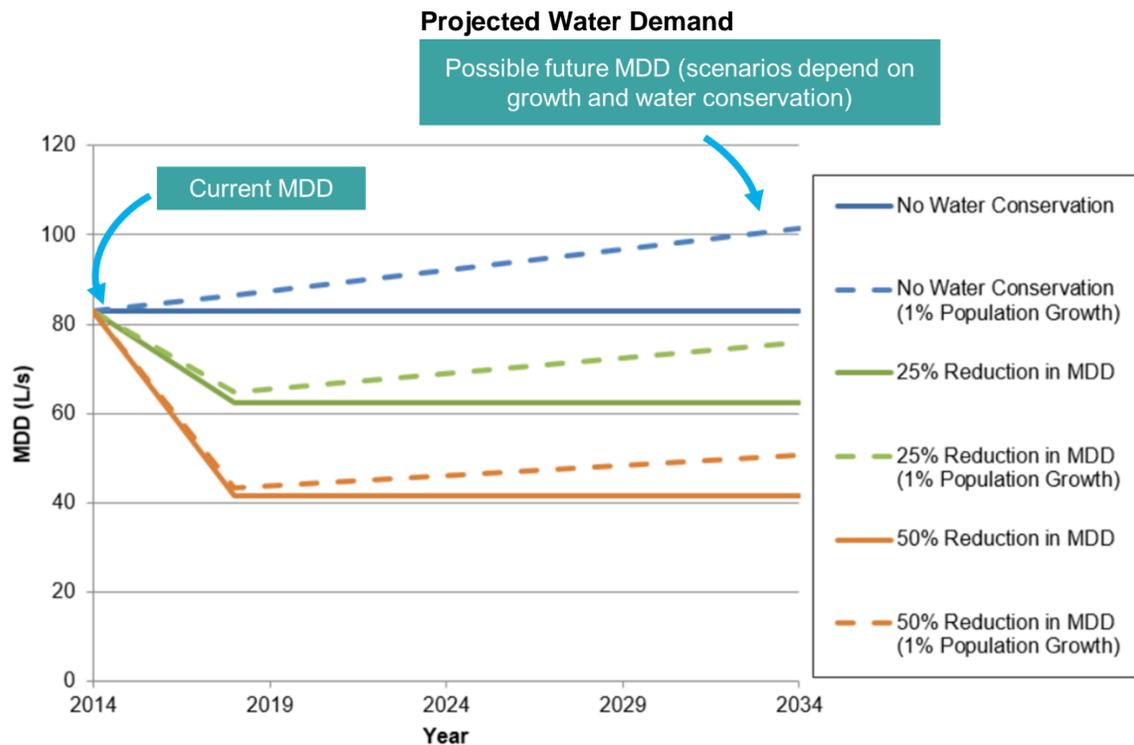
Population and Related Water Demands

There is some uncertainty associated with future population growth and water use. Based on the per capita demands, projected population growth, and water conservation considerations outlined above, the below figure displays the range of projected future maximum day demands for the Village.

The magnitude of the Village’s existing water use indicates that there are a number of opportunities to reduce water use. Since a reduction in MDD will have an impact on capital costs for future treatment infrastructure upgrades, as well as pump station upgrades, it is recommended that the Village select a suitable long-term water conservation factor to account for population growth and water use uncertainties.

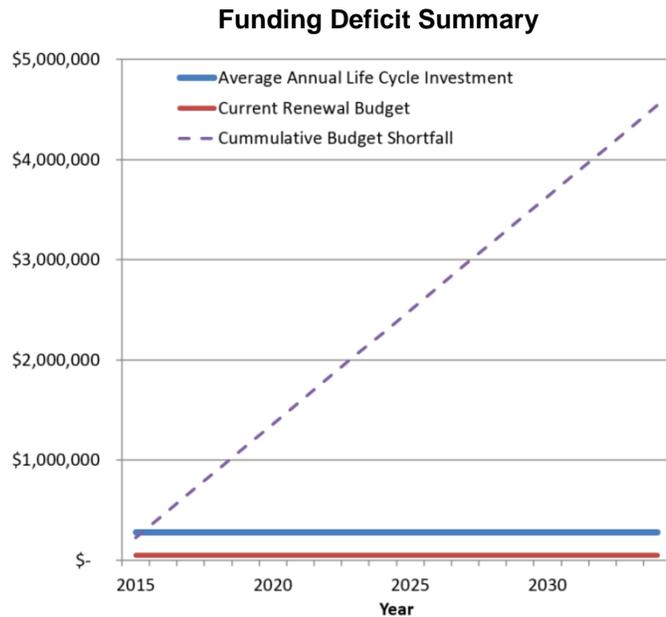
In order to maintain levels of service of the existing water infrastructure in perpetuity the Village would theoretically need to annually invest approximately \$280,000 in capital works.

If it is assumed that the Village would otherwise invest \$50,000 in capital replacement, over the next 20 years the budget shortfall will be in the order of \$4,500,000.

The funding deficit is significant and will grow substantially if not addressed. The 20 Year Capital Plan and related cash flow model includes investments in replacing infrastructure. A theoretical annual investment was not included in the Capital Plan but rather specific investments have been identified.

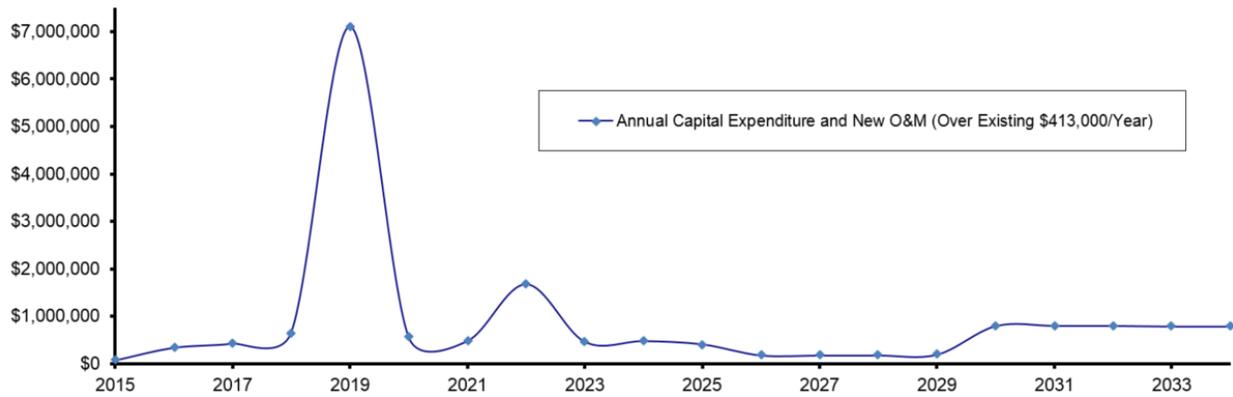
20 Year Investments

The following graph presents a summary of the 20 year investments, with more detail supplied in the Water Master Plan report and supporting appendices. The proposed water treatment plant, with the majority of that capital investment occurring in 2019, represents a significant expenditure in the near term. It is important to note that the timing of the treatment plant could adjust depending on timing of a possible senior government grant.

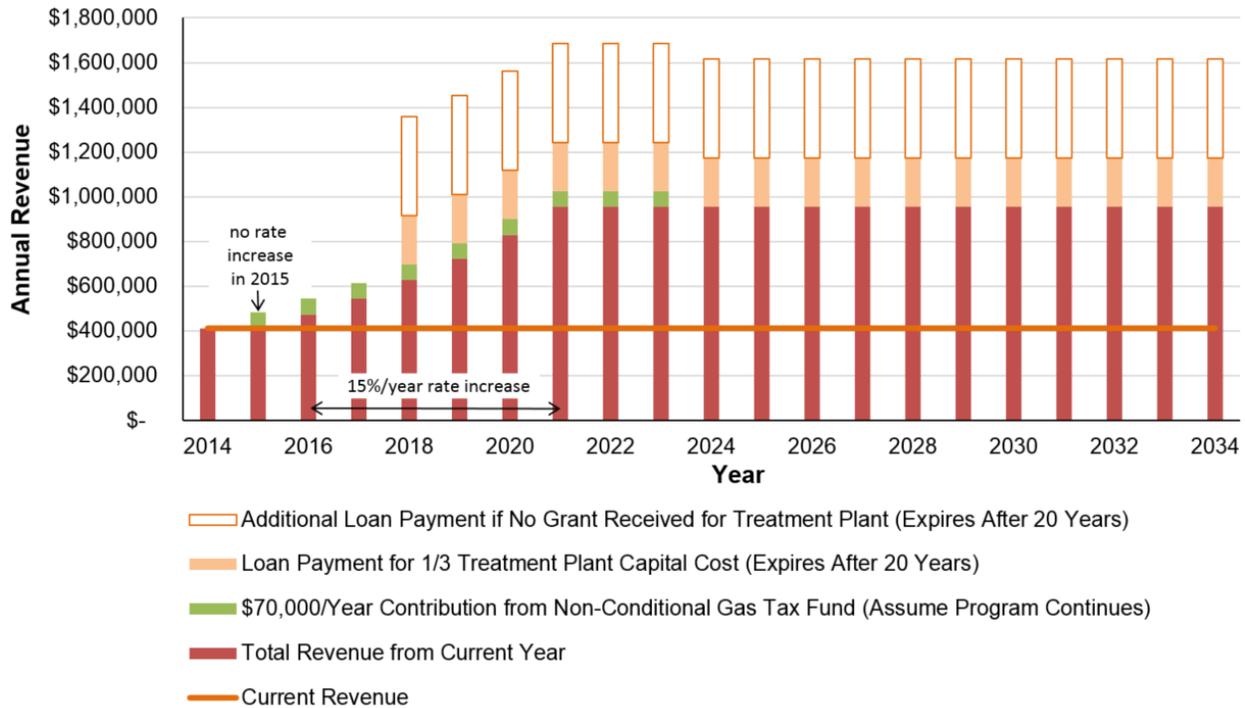
Summary of Annual Revenue Needs to Fund Proposed Capital Plan and Additional Operations Costs

The following figure outlines the revenue needed to fund the proposed 20 Year Capital Plan. The Total Revenue from Current Year category in the below graph includes capital replacement, distribution and storage upgrades as well as operations and maintenance costs for the treatment plant and other proposed activities, thus providing a holistic assessment of the Village’s long-term Water Utility financial needs.

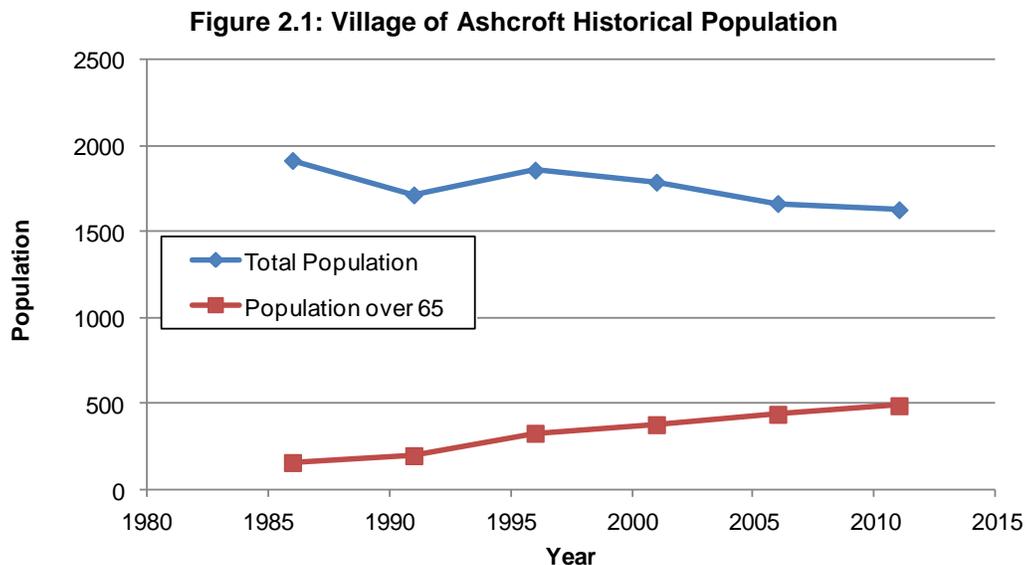
Based on a review of Statistics Canada census data, the Village's current population is 1,628. The historical population data from census data (1981 to 2011) is displayed in Figure 2.1.

Between 1981 and 2011 (30 years), the average annual growth rate is calculated to be -1.1%. Furthermore, the Village's population that is over 65 is increasing. Given the population trend over the past 30 years, it is recommended that a population growth factor of 1% be applied for population growth over the next 20 years.¹ With an ageing population affordability is an important consideration.

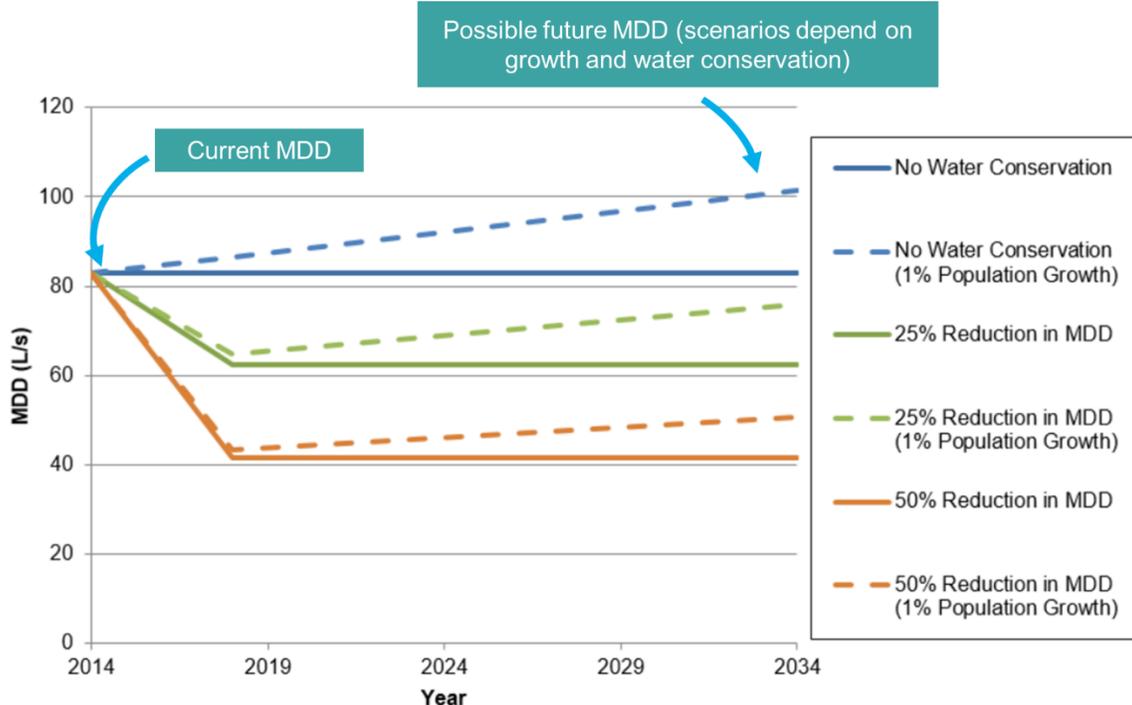
Figure 2.2: Projected Water Demand

There is some uncertainty associated with future population growth and water use. Based on the per capita demands, projected population growth, and water conservation considerations outlined above, Figure 2.2 displays the range of projected future maximum day demands for the Village.

The magnitude of the Village’s existing water use indicates that there are a number of opportunities to reduce water use. Since a reduction in MDD will have an impact on capital costs for future treatment infrastructure upgrades, as well as pump station upgrades, it is recommended that the Village select a suitable long-term water conservation factor to account for population growth and water use uncertainties.

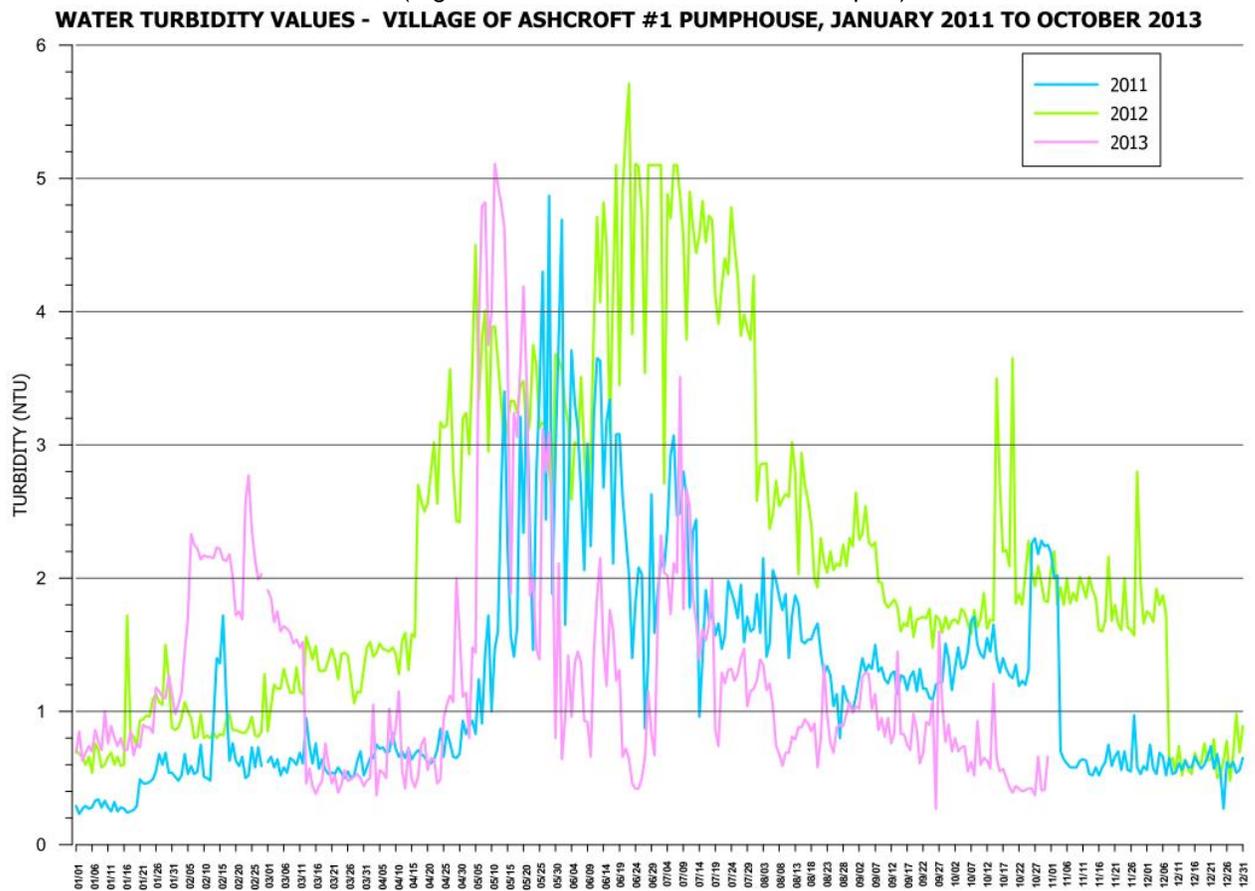
Figure 4.1: Historical Thompson River Turbidity
(Figure from M. Miles & Associates Report)

Section 4.3 (Two Methods of Treatment) of the MOH document provides a summary of the requirements for deferring filtration, and meeting the above treatment objectives using two forms of disinfection (for example, UV disinfection and chlorination). Figure 4.1 presents the results of turbidity sampling of the Village’s water supply at the Main Pump Station over the period January 1, 2011 to October 31, 2013. Turbidity is shown to be greater than 1 NTU every year for multiple months. The Thompson River water quality does not meet the turbidity requirements stated in the MOH document. Also, it would be extremely difficult to maintain a watershed control program to minimize fecal contamination in this source.

Figure 4.3.2: Water Turbidity Values - Village of Ashcroft #1 Pumphouse, January 1, 2011 to October 31, 2013.

The VOA routinely measures turbidity values along with other parameters in the raw water supplied to the #1 Pumphouse. These data have been extracted for the period between January, 2011 and October 2013 and the results are summarized on *Figure 4.3.2*. The seasonal variation in turbidity values generally follows the previously discussed seasonal variations in flow. Maximum observed values of ~5 NTU have occurred in May, June and July. To put these values in perspective, the maximum recommended drinking water turbidity values for treated water are summarized below, based on guidelines prepared by *Health Canada (2012)*.

The 'raw water' data shown on *Figure 4.3.2* periodically exceed the recommended 1.0 NTU treated water value.

Figure 4.3.2: Water Turbidity Values - Village of Ashcroft #1 Pumphouse, January 1, 2011 to October 31, 2013.

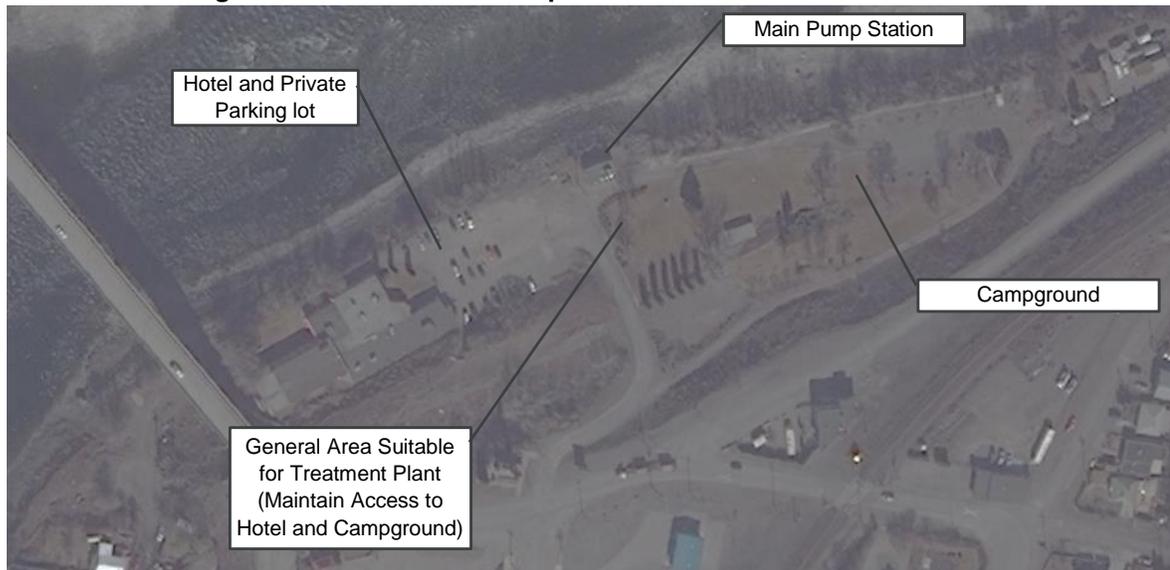
Figure 4.2: Overview of Pump Station and Treatment Plant Area

Figure 4.2 depicts the site and a potential allocation for a filtration facility. This location is above the 200 year flood level, and the river morphology review by M. Miles & Associates identified that the pump station area is situated along a stable river channel area.

The water system includes a dedicated water main between the Main Pump Station and the Zone 1 Reservoir. Therefore, the filtration plant could theoretically be installed along that trunk main route. While an in-depth analysis of topography, property acquisition or potential layout options were not undertaken at this master planning stage, it is reasonable to assume that properly organizing the site beside the Main Pump Station to accommodate the treatment plant and surrounding activities is a more practical solution than developing a new site along the trunk main route. However, further review of technical issues and public consultation should be undertaken during predesign to confirm this approach and the final layout.

Review of regulatory requirements and Thompson River raw water quality also results in these treatment stages being employed for the Village’s proposed water treatment plant. It is recommended that the plant be located adjacent to the existing pump station and intake system.

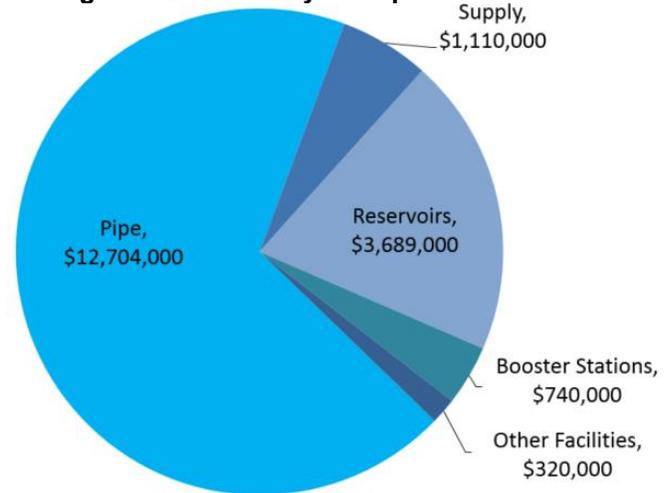
Figure 6.2: Summary of Replacement Values

An overall replacement value in 2015 dollars was developed, as summarized in Figure 6.2, for the Village’s Water Utility infrastructure. Additional detail is provided in Appendix C.

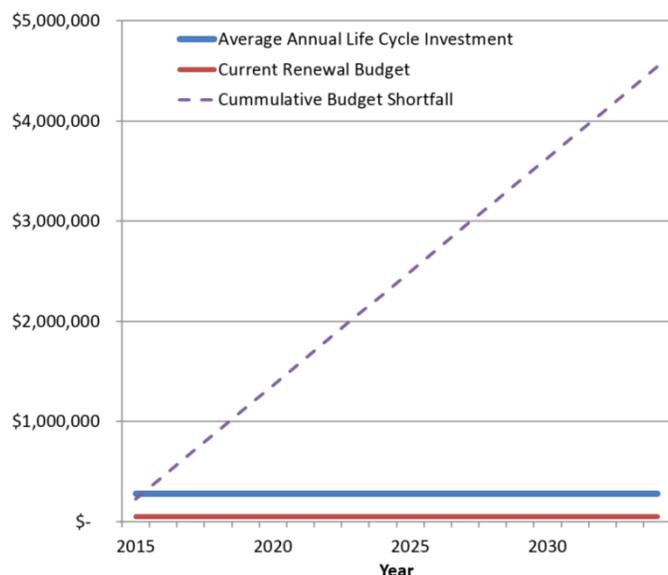
Figure 6.3: Funding Summary

Figure 6.3, identifies the funding shortfall impact associated with a \$280,000/year reinvestment in infrastructure. If it is assumed that the Village would otherwise invest \$50,000 in capital replacement, over the next 20 years the budget shortfall will be in the order of \$4,500,000.

The funding deficit is significant and will grow substantially if not addressed. The 20 Year Capital Plan and related cash flow model therefore includes investments in replacing infrastructure. A theoretical annual investment was not included in the Capital Plan but rather specific investments have been included.

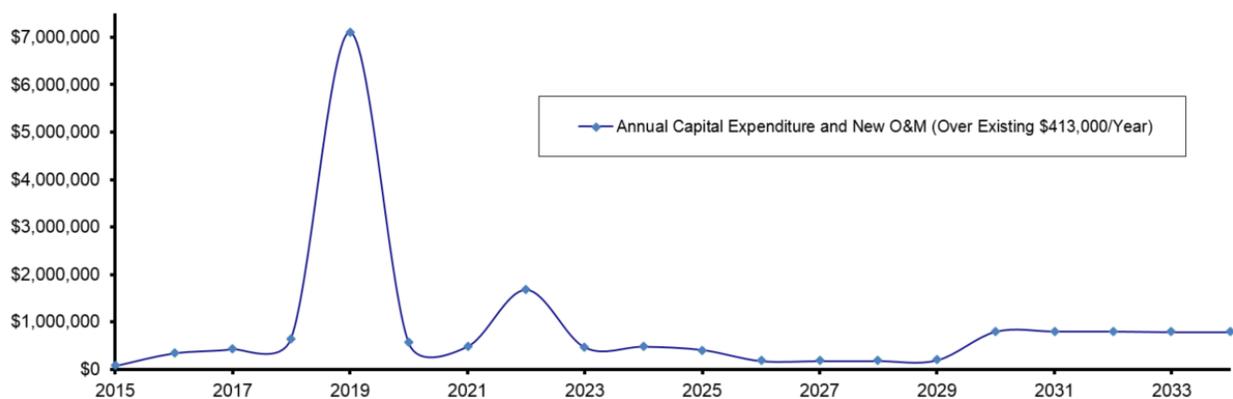
Figure 7.1: 20 Year Investments

Figure 7.1 presents a summary of the 20 year investments. The proposed water treatment plant represents a significant expenditure in the near term.

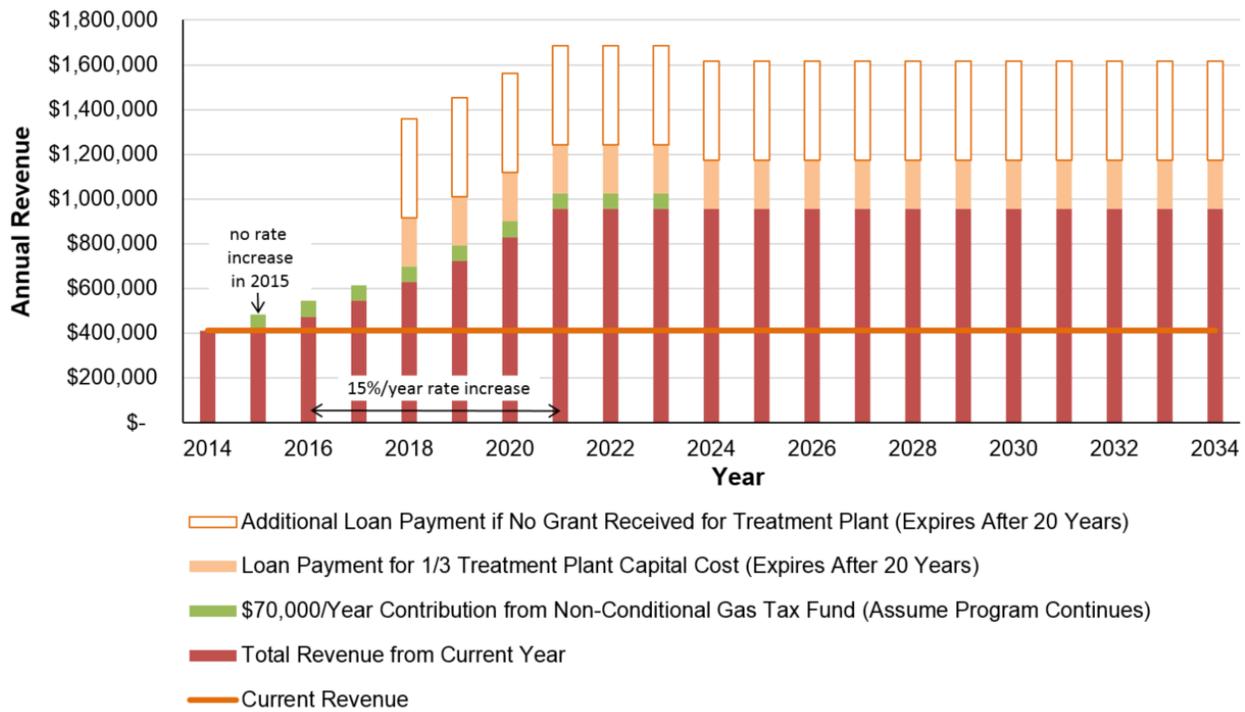
Figure 7.3: Summary of Annual Revenue Needs to Fund Proposed Capital Plan and Additional Operations Costs

The following figure outlines the revenue needed to fund the proposed 20 Year Capital Plan, based on the assumption that pipe replacement will occur as per the base scenario. The Total Revenue from Current Year category in that graph includes capital replacement, distribution and storage upgrades as well as operations and maintenance costs for the treatment plant and other proposed activities.

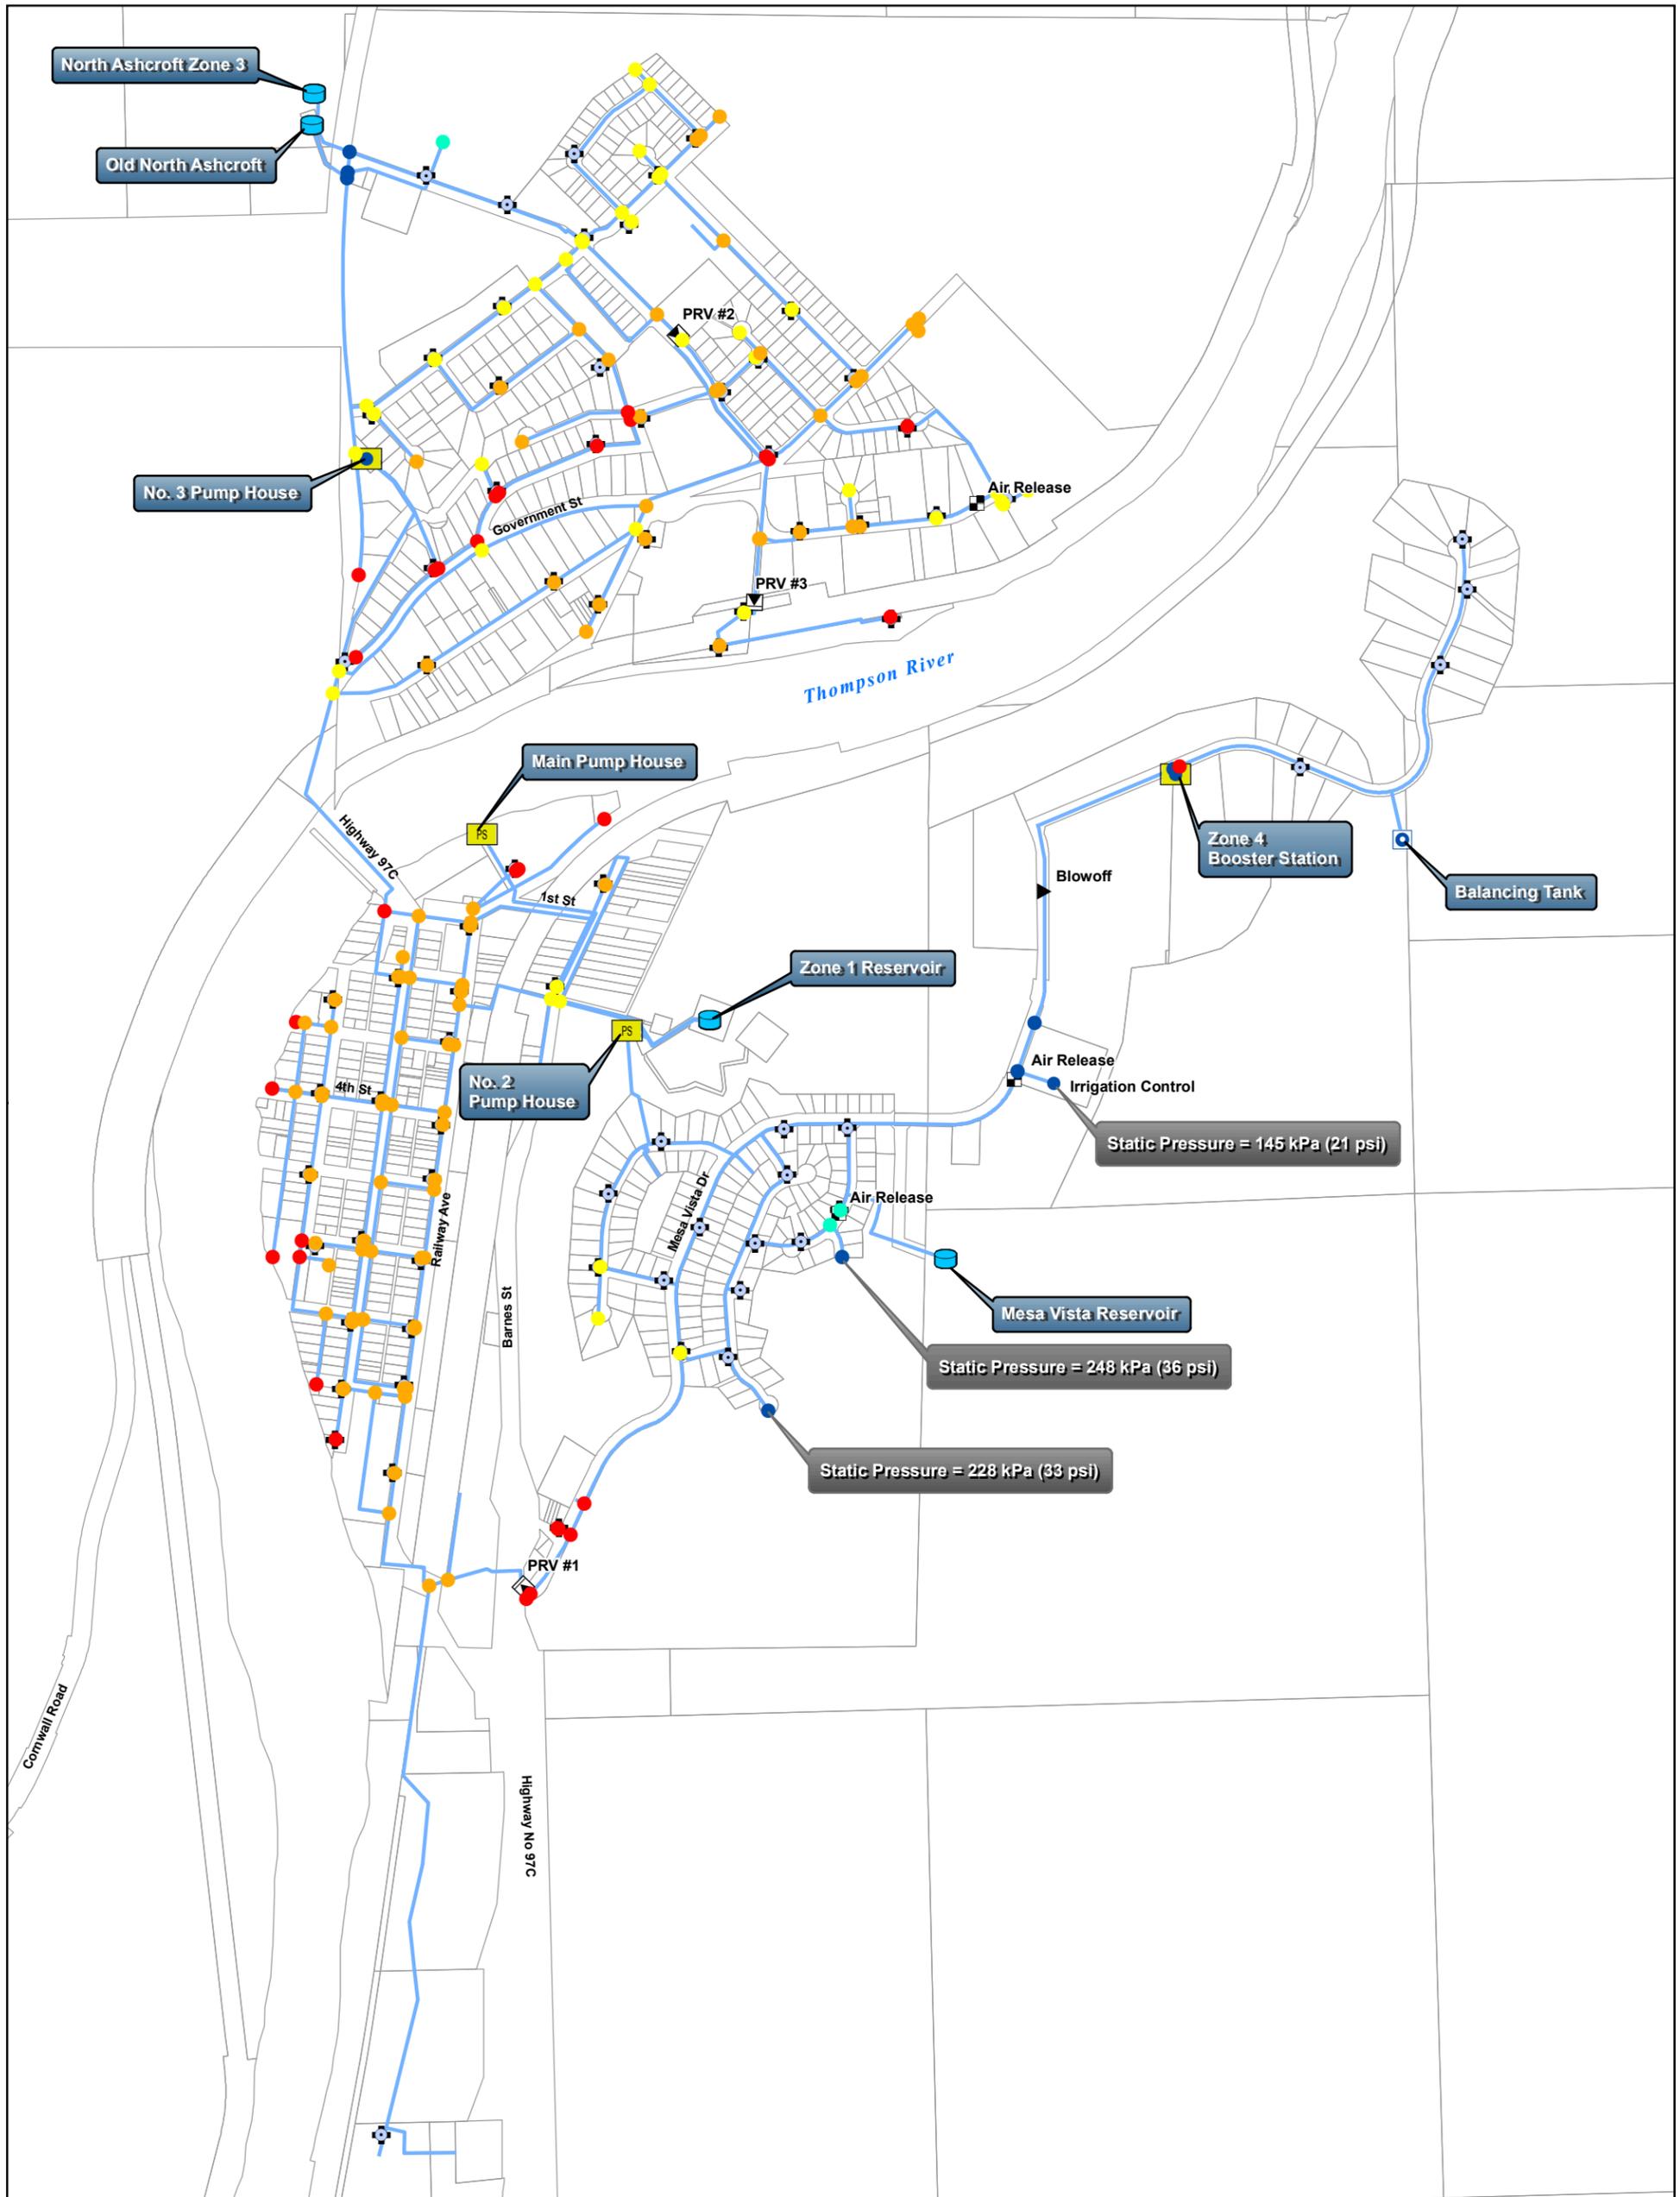
FIGURE 5.1

Water Master Plan
System Pressure Analysis - Existing Conditions

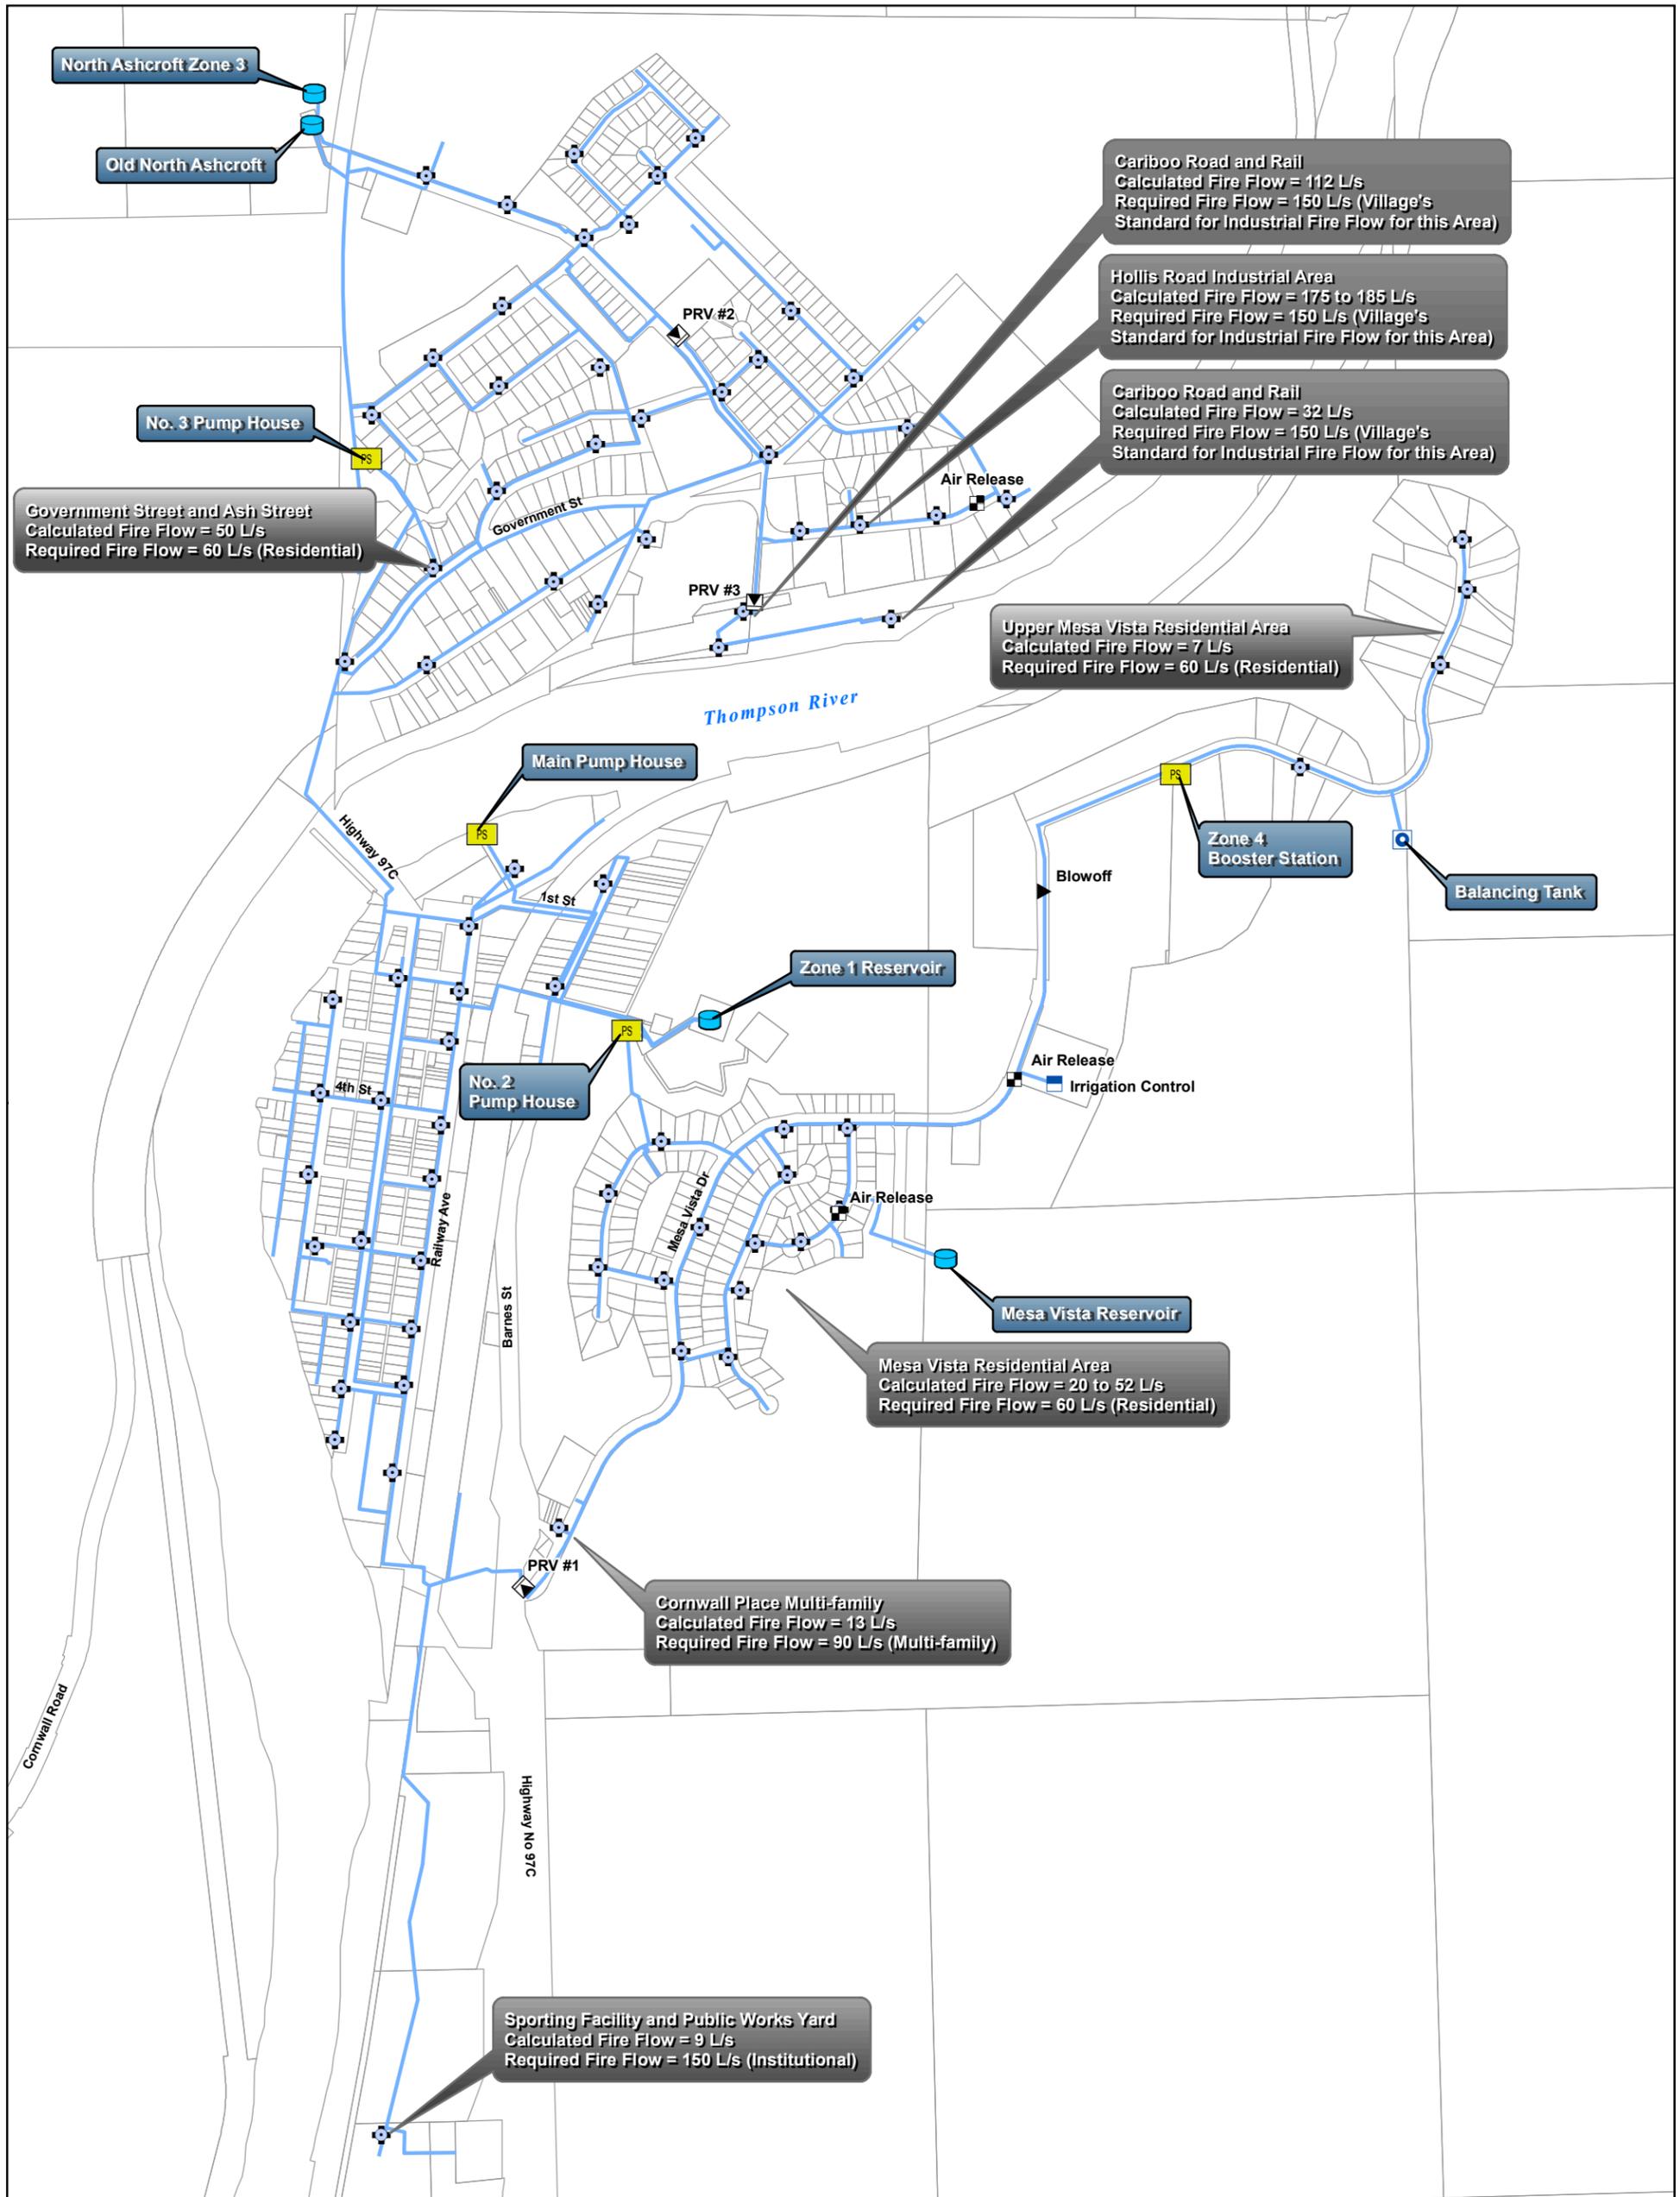
Water Master Plan
Fire Flow Analysis
Existing Conditions

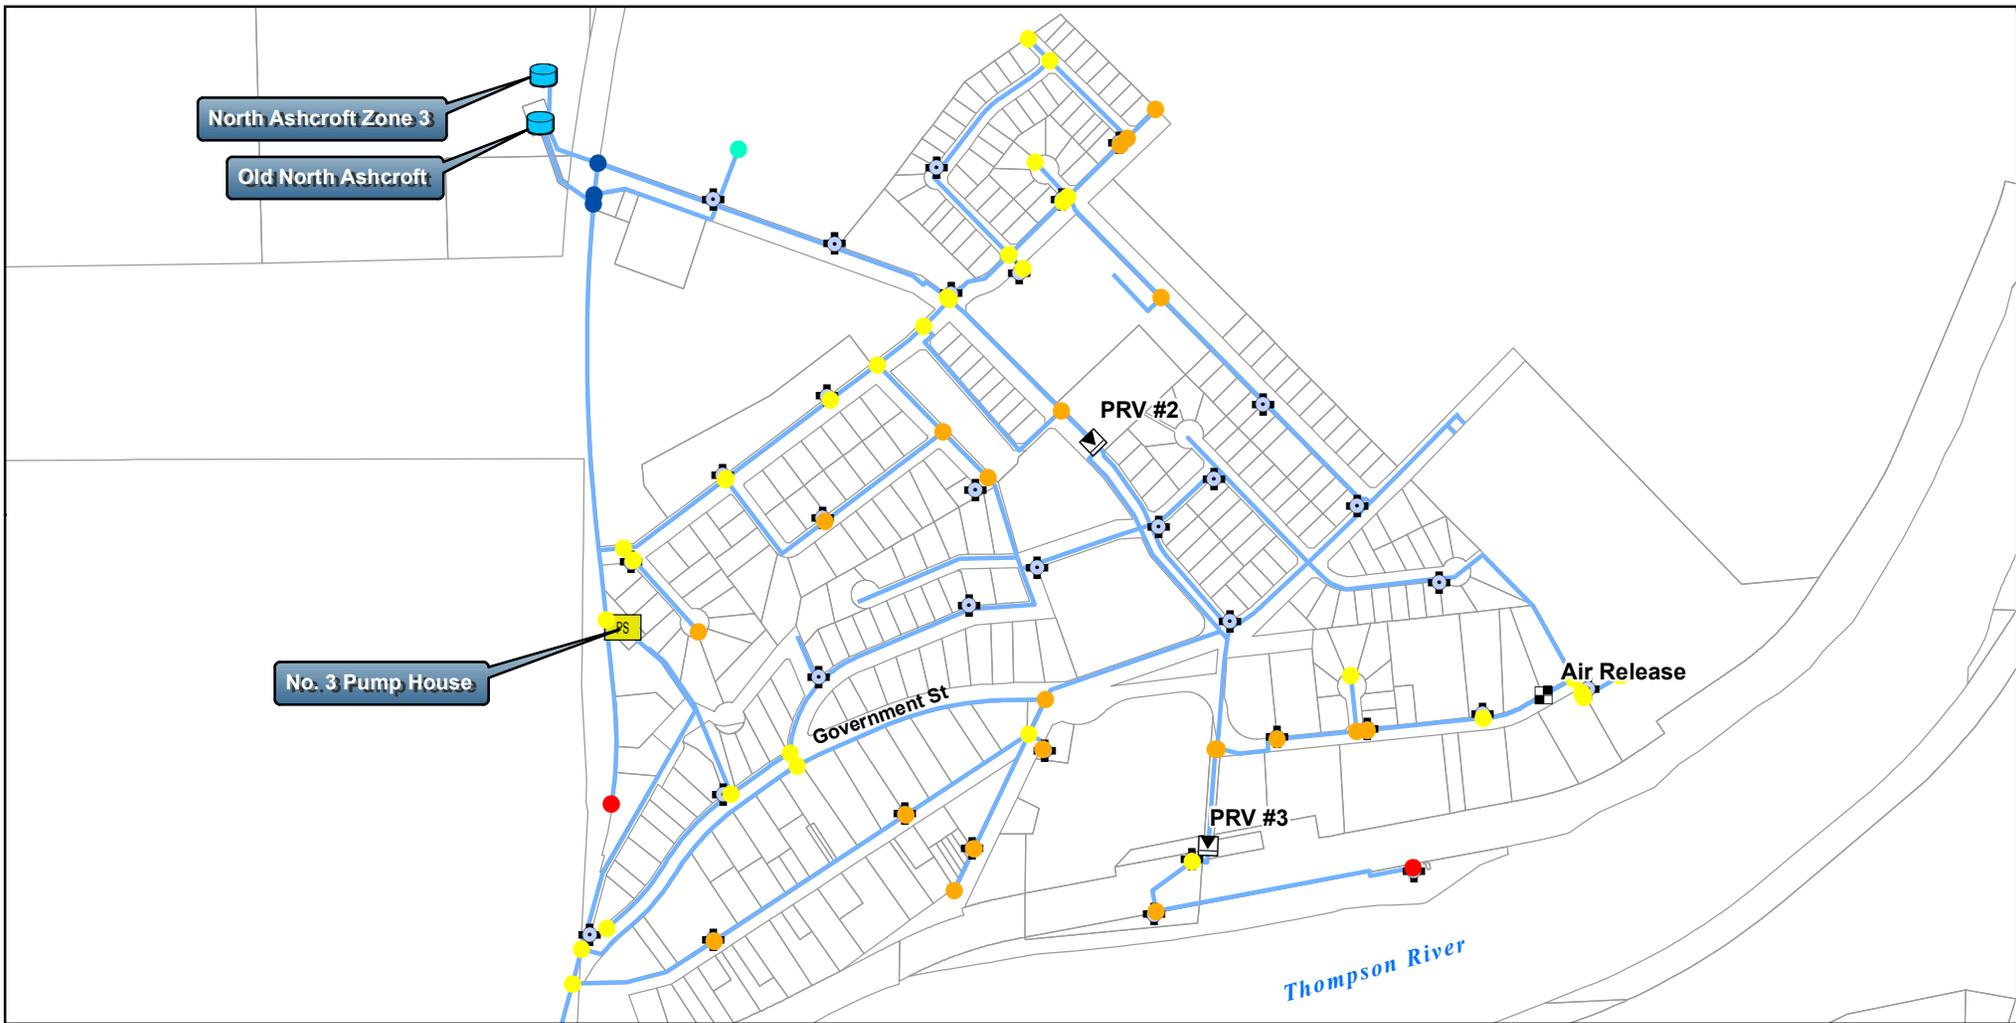
Water Master Plan
North Ashcroft System
Pressures - Capital Upgrade #2
