Village of Ashcroft

Water Master Plan

November 2014

URBAN
systems

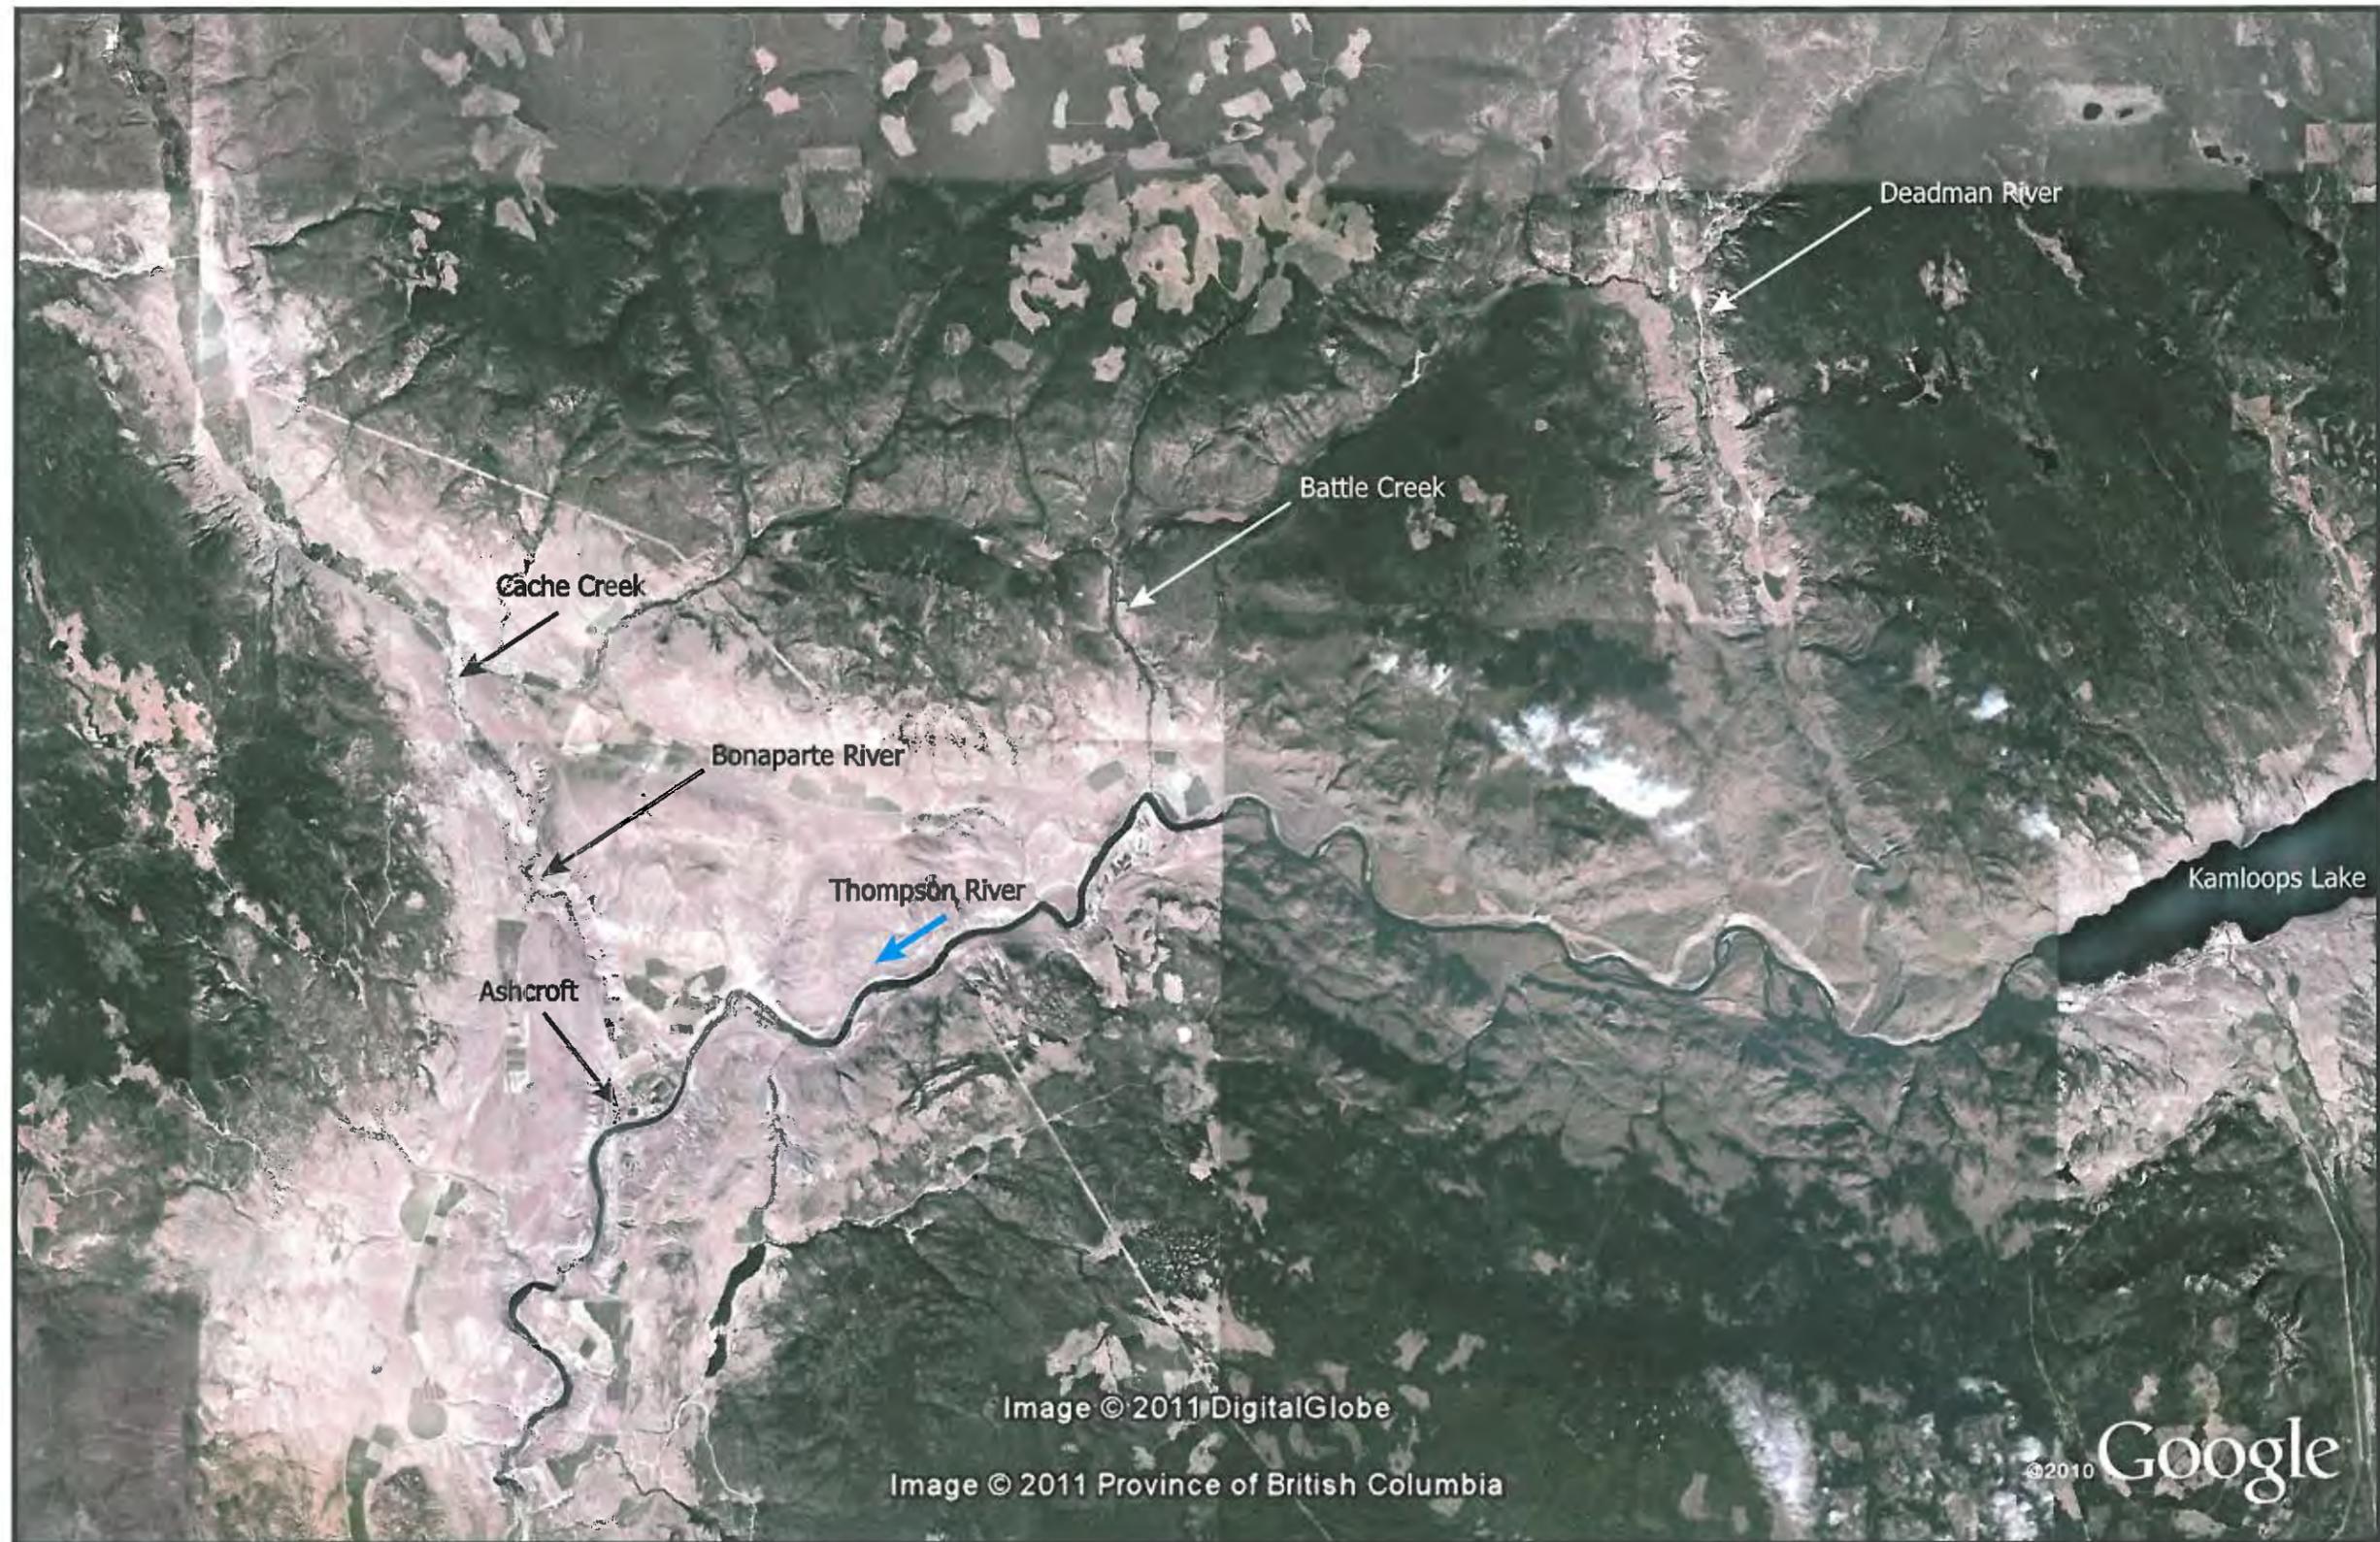
Figure 3.1.1: Google Earth (2004 & 2005) imagery of the regional study area.

Ashcroft is located on Thompson River 35 km downstream of Kamloops Lake. Sizeable tributaries to this section of channel include Deadman River, Battle Creek and Bonaparte River (*Figure 3.1.1*). The VOA spans both sides of Thompson River in the vicinity of the Highway 97C bridge (*Figure 3.1.2*). The water supply intake is located near the left bank approximately 170 m upstream of the Highway Bridge and 2.3 km downstream of the Bonaparte River confluence.

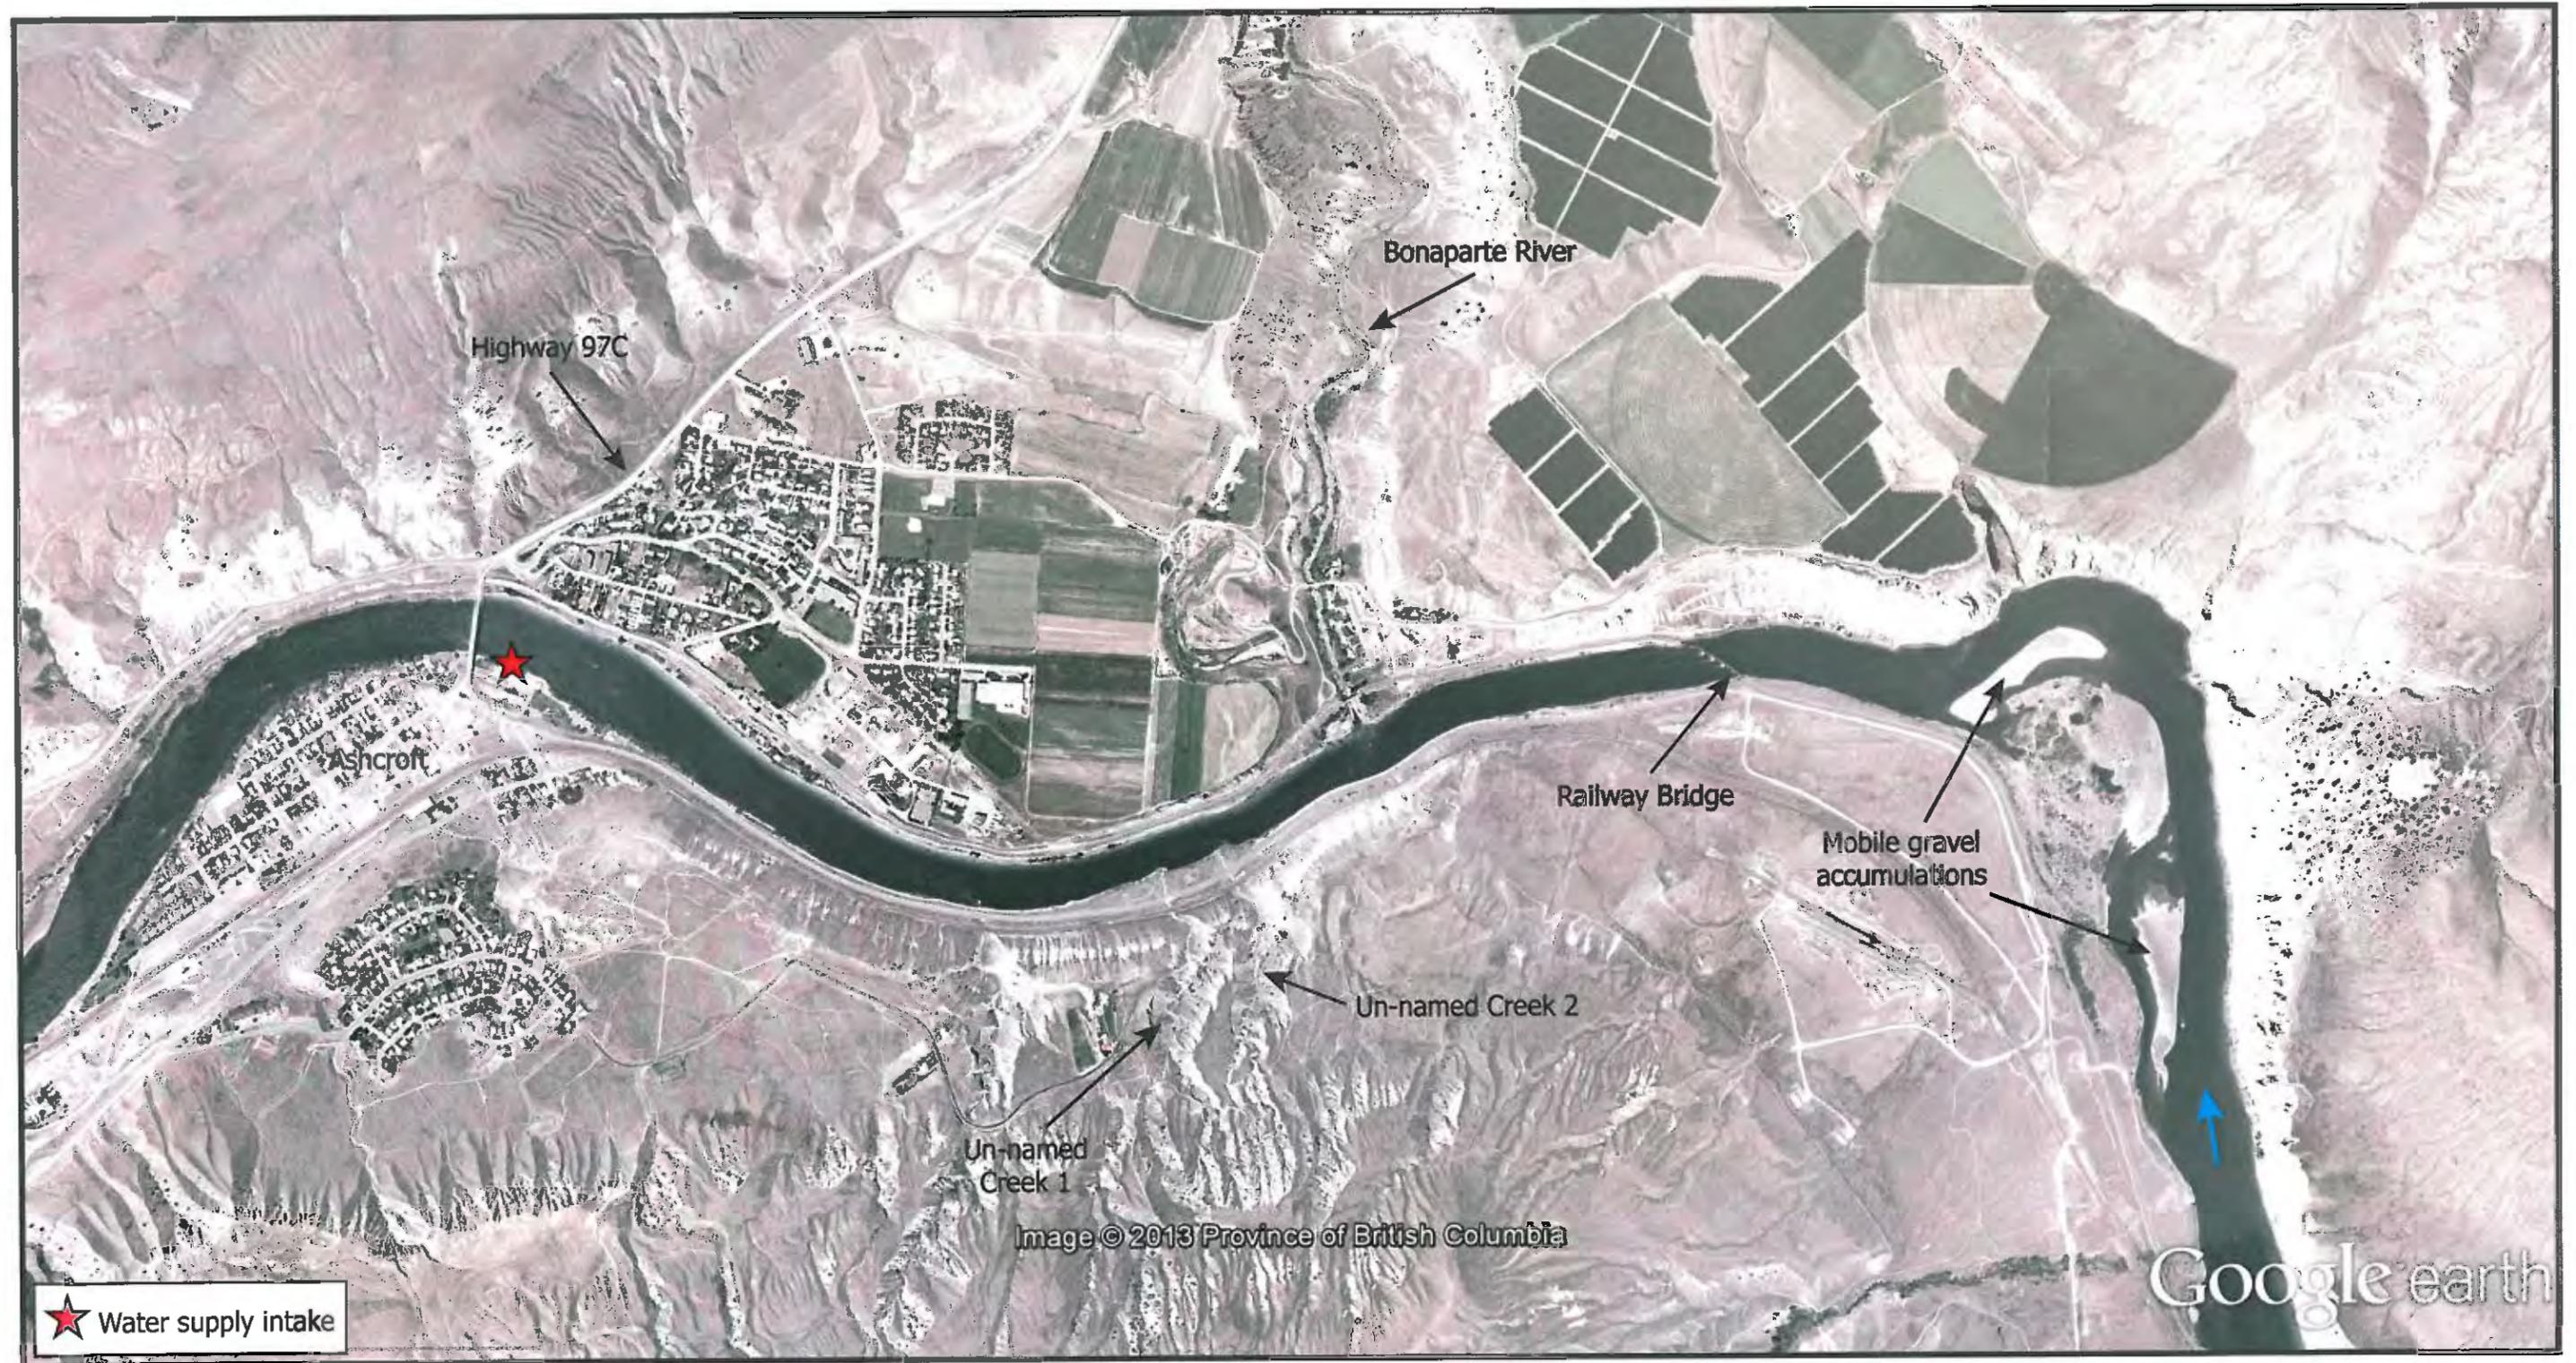
Figure 3.1.2: Google Earth image of Thompson River in the vicinity of Ashcroft.

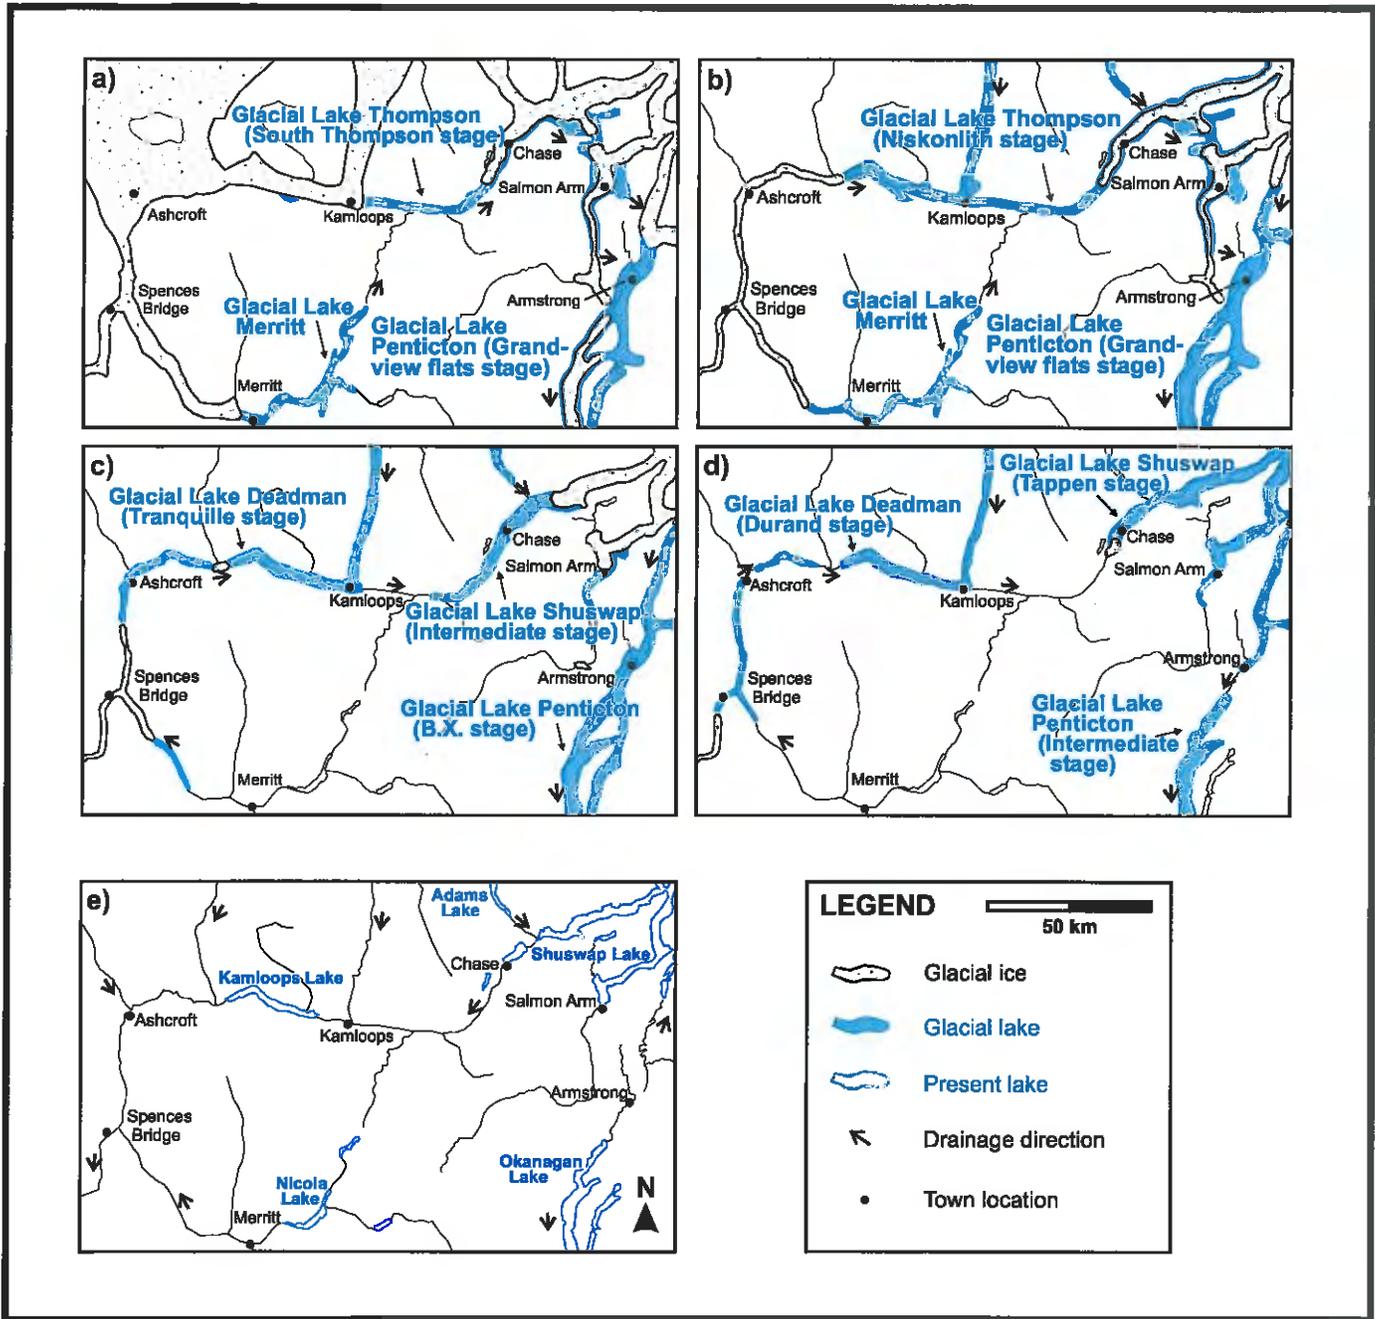
Figure 3.1.3: Evolution of late glacial lakes in the southern interior of British Columbia as proposed by Fulton (1969) and Ryder (1981). (From Johnsen, 2004).

As summarized in *Johnsen (2004)* and *Johnsen and Brennard (2004)*, a complex series of lakes formed during deglaciation in the Thompson River valley at Ashcroft (*Figure 3.1.3*). Surficial geology mapping (*Figures 3.1.4 & 3.1.5*) illustrate the resulting distribution of deep unconsolidated and readily erodible sediment deposits which occur along the river valley downstream of Kamloops Lake. *Figure 3.1.6* illustrates a typical section across the Kamloops River Valley at Ashcroft. Upland surfaces are typically covered with either till or colluvium. Surficial materials along the lower valley walls are commonly 100 to 150 m thick and typically include comparatively recent alluvial fan material overlying glacio-fluvial outwash deposits, various aged tills and glacio-lacustrine silt and sand (*see Figure 3.1.6*). Materials within present day Thompson River include a surface deposit of fluvial sediments overlying glacio-lacustrine silts and sands overlying till, which may overlie older glacio-lacustrine sediments.

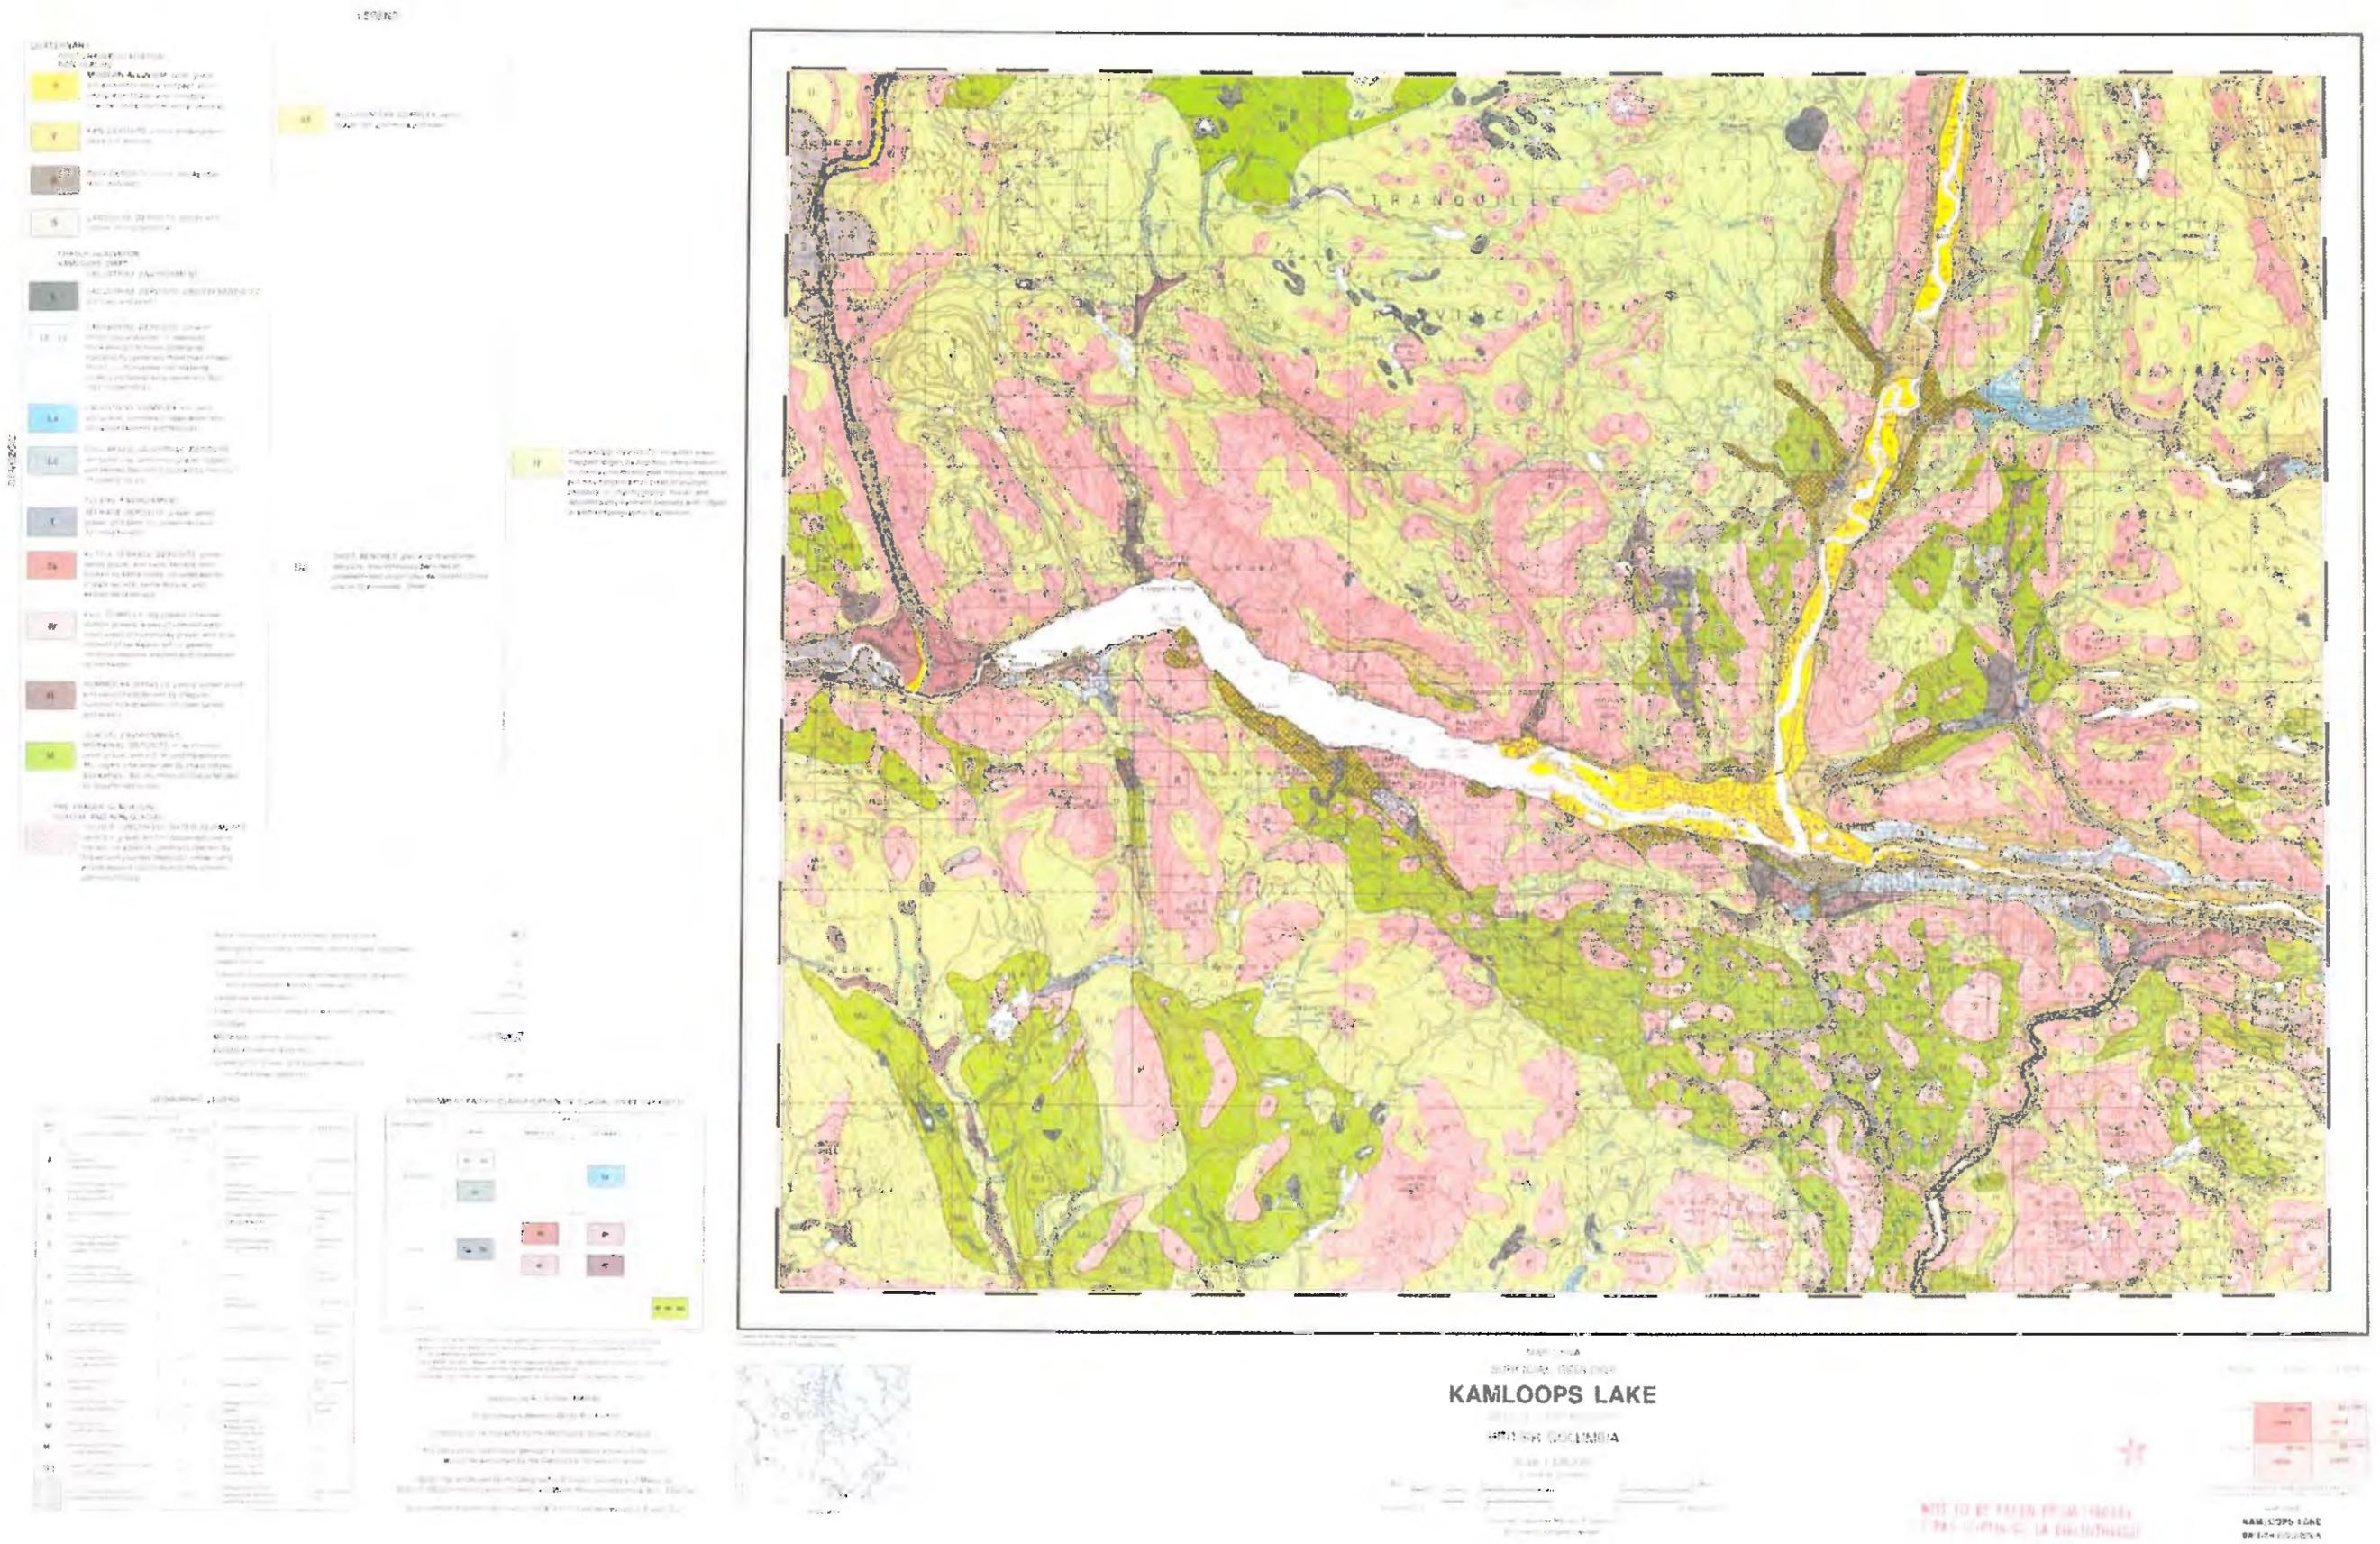
Figure 3.1.4: Surficial geology of Kamloops.

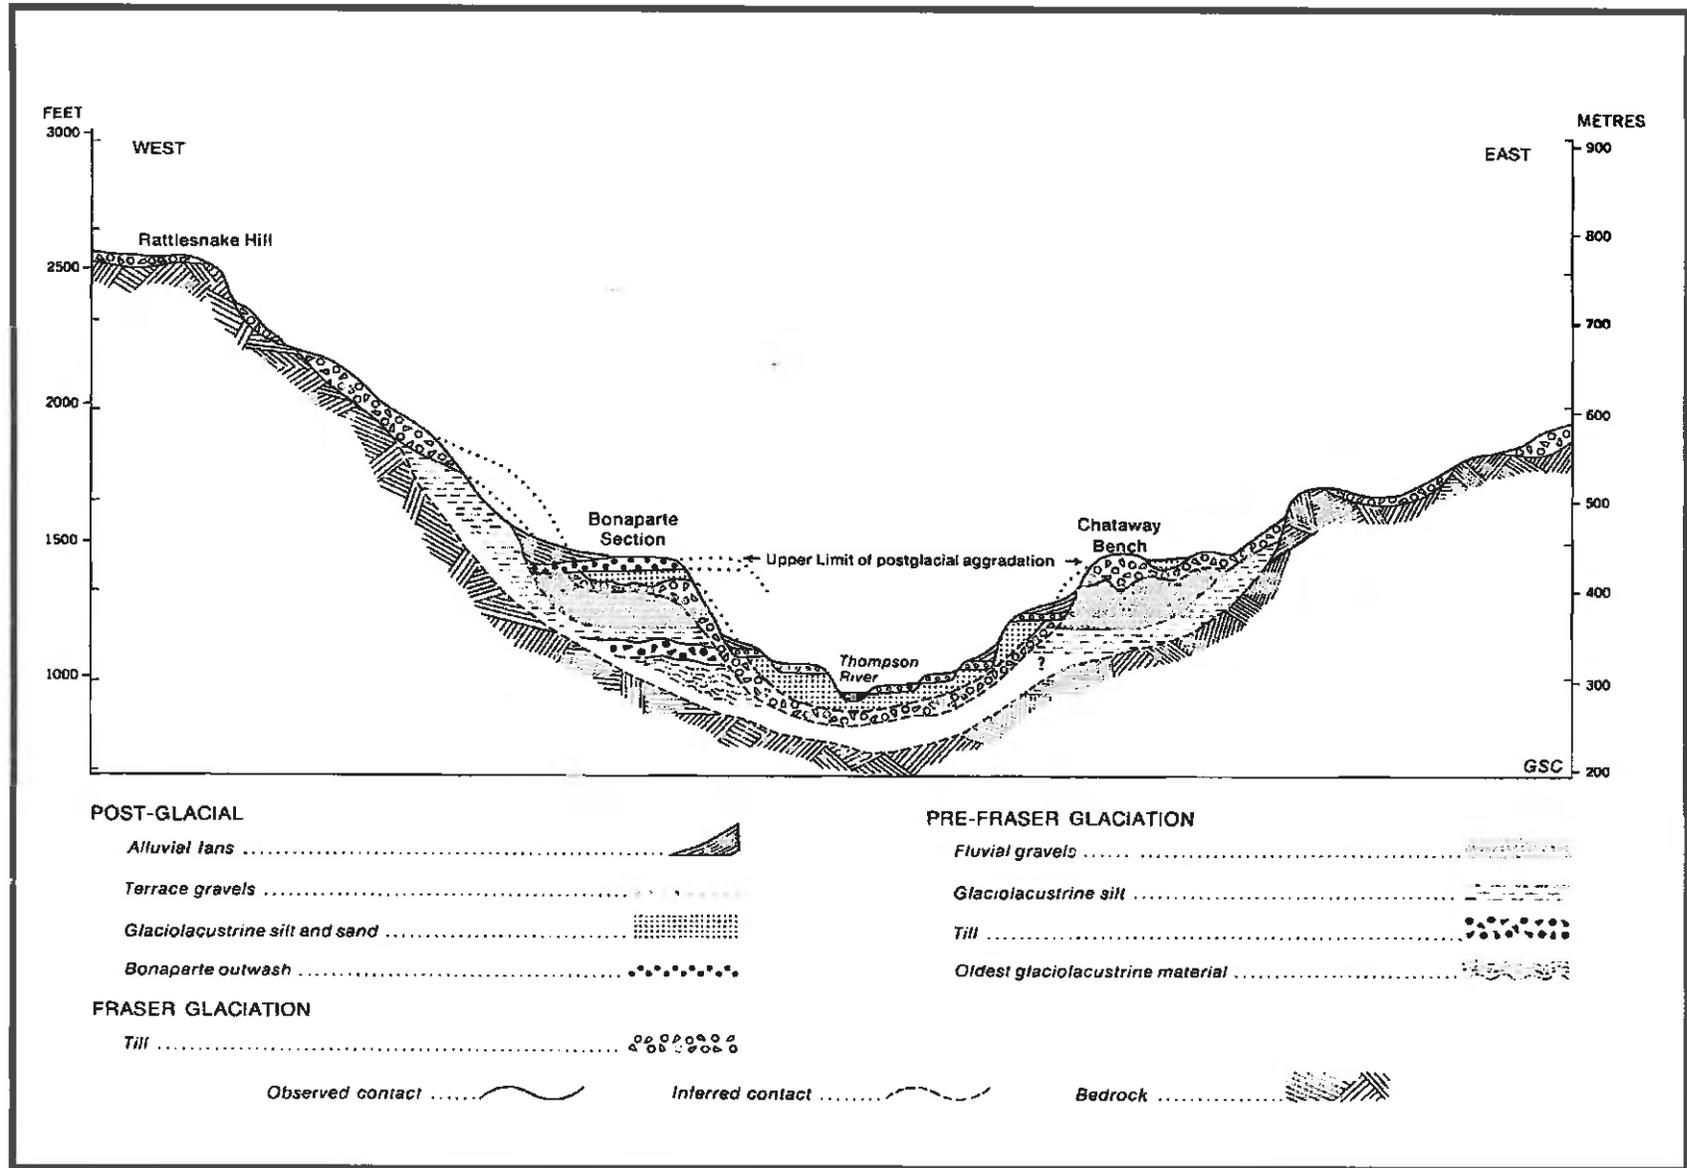
Figure 3.1.6: Schematic diagram illustrating inferred interrelationship of Quaternary sediments in the Thompson Valley near Ashcroft (after Ryder, 1976).

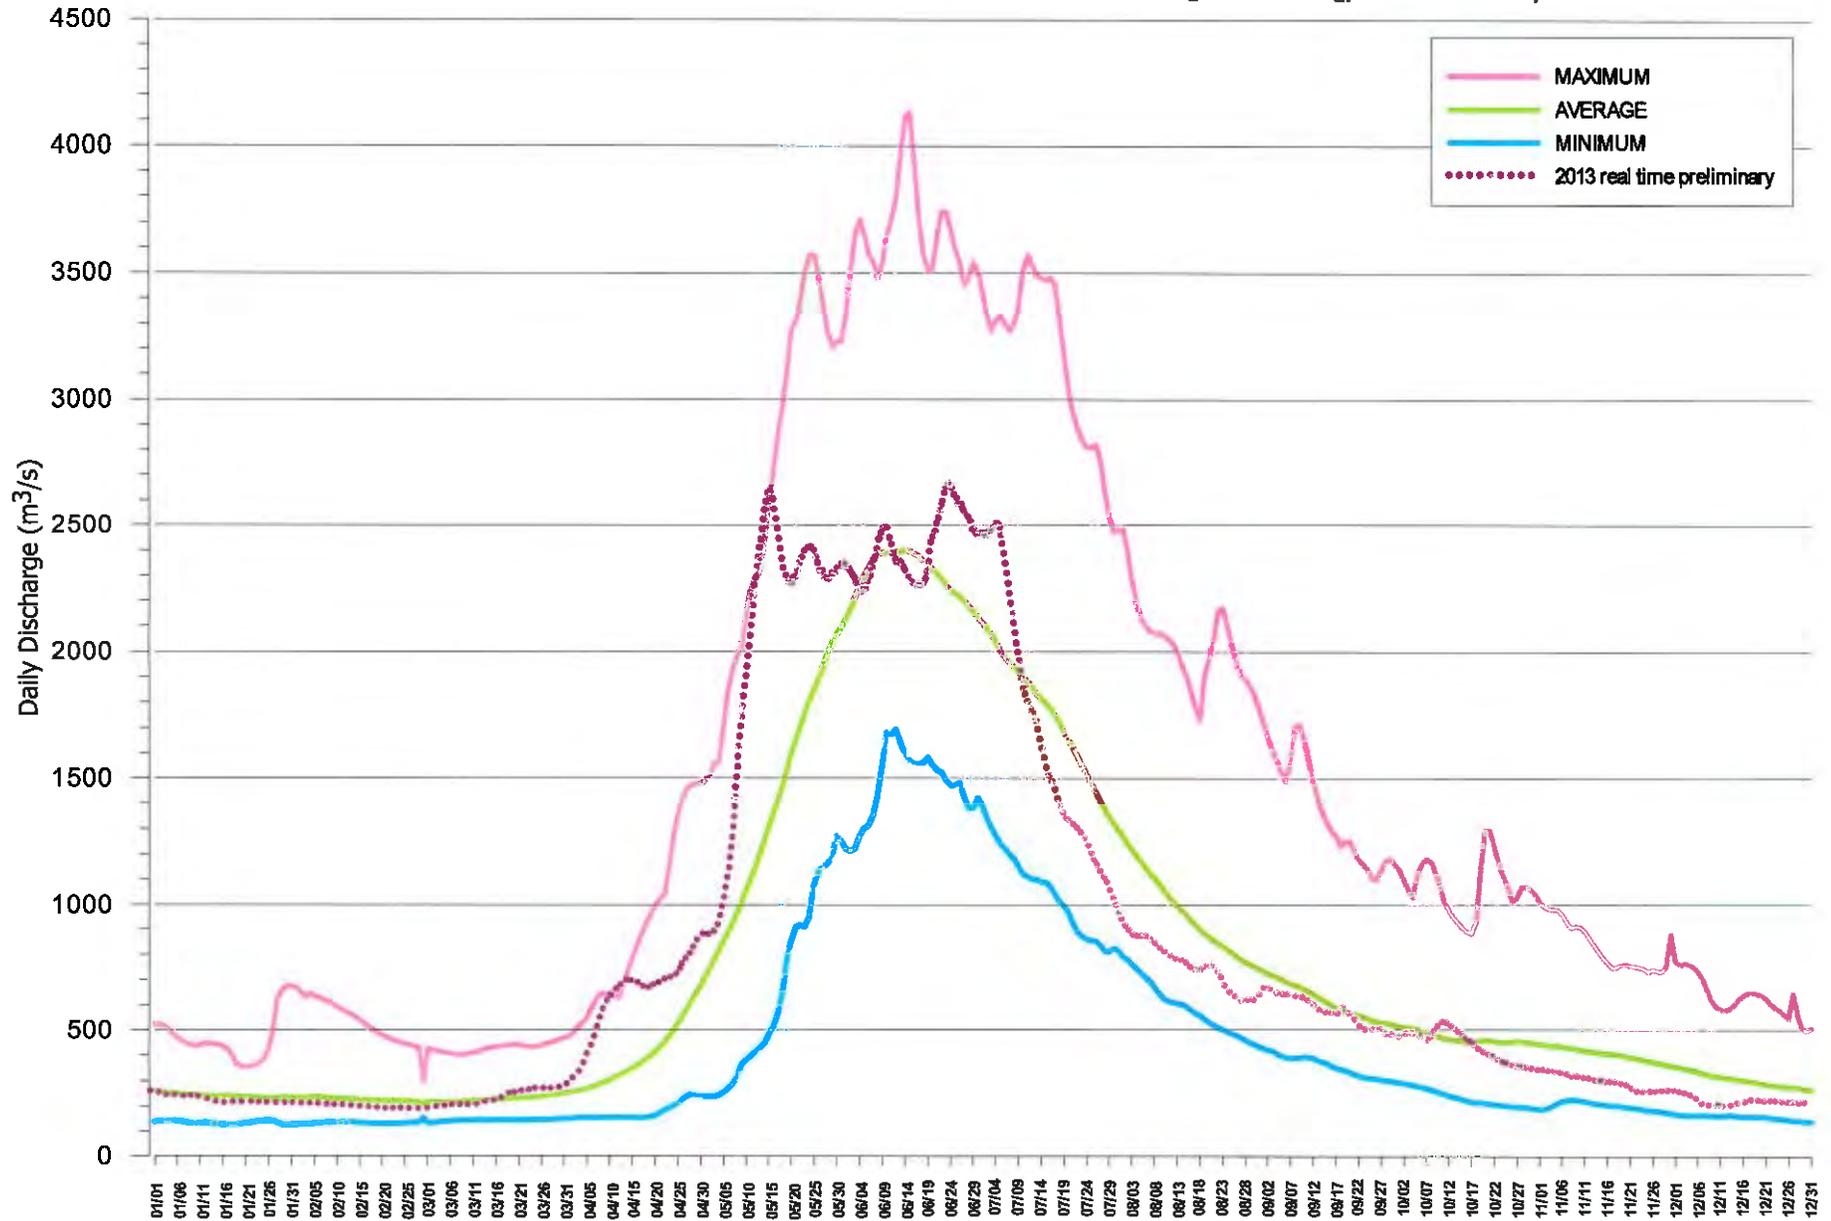
SEASONAL VARIATION IN FLOW - THOMPSON RIVER NR SPENCES BRIDGE [05LF051], 1951-2011, & 2013 PRELIM.

Figure 3.2.1: Seasonal Variation in Flow, Thompson River near Spences Bridge, 1951 to 2011, plus 2013 preliminary.

The seasonal variation in discharge on "*Thompson River near Spences Bridge*" is illustrated on *Figure 3.2.1*. This analysis indicates that streamflow starts to increase between late-March and late-April. The peak flow can occur between early-May and late-July and streamflows then gradually decrease to winter minimum flow values which typically occur between January and March. Fall rain or rain-on-snow events can result in elevated flows until November or December.

No measurements are available to document rates of bedload transport or to quantify suspended sediment concentrations or loadings. However, the BC Ministry of Environment is conducting a water quality sampling program in cooperation of the Village of Ashcroft [Jennifer Puhallo, R.P.Bio, pers. comm.] Seasonal data has been collected on Thompson River at Ashcroft and on lower Bonaparte River. All data available in March 2014 have been compiled on *Tables 4.3.1 & 4.3.2*, and this information includes 'turbidity' measurements. Information is only available for the winter low flow months when turbidity values will be at their seasonal minimum values. The collected data, which are plotted on *Figure 4.3.1*, suggest that fall and winter turbidity values on Bonaparte River are roughly twice as high as those observed on Thompson River. Measured values on Thompson River are typically less than 2 NTU and reached a maximum of 13 NTU. In contrast, turbidity observations on Bonaparte River are generally less than 4 NTU, occasionally reach values of 16 NTU and the maximum observed winter value is 42 NTU. Previous experience in the Bonaparte watershed suggest that these comparatively elevated values reflect the lack of upstream lake regulation, the occurrence of fine-textured surficial materials and land use related impacts. Turbidity values in the spring and summer (*see Figures 3.2.1 & 3.2.4*) are expected to be much higher than those observed in the winter low flow period.

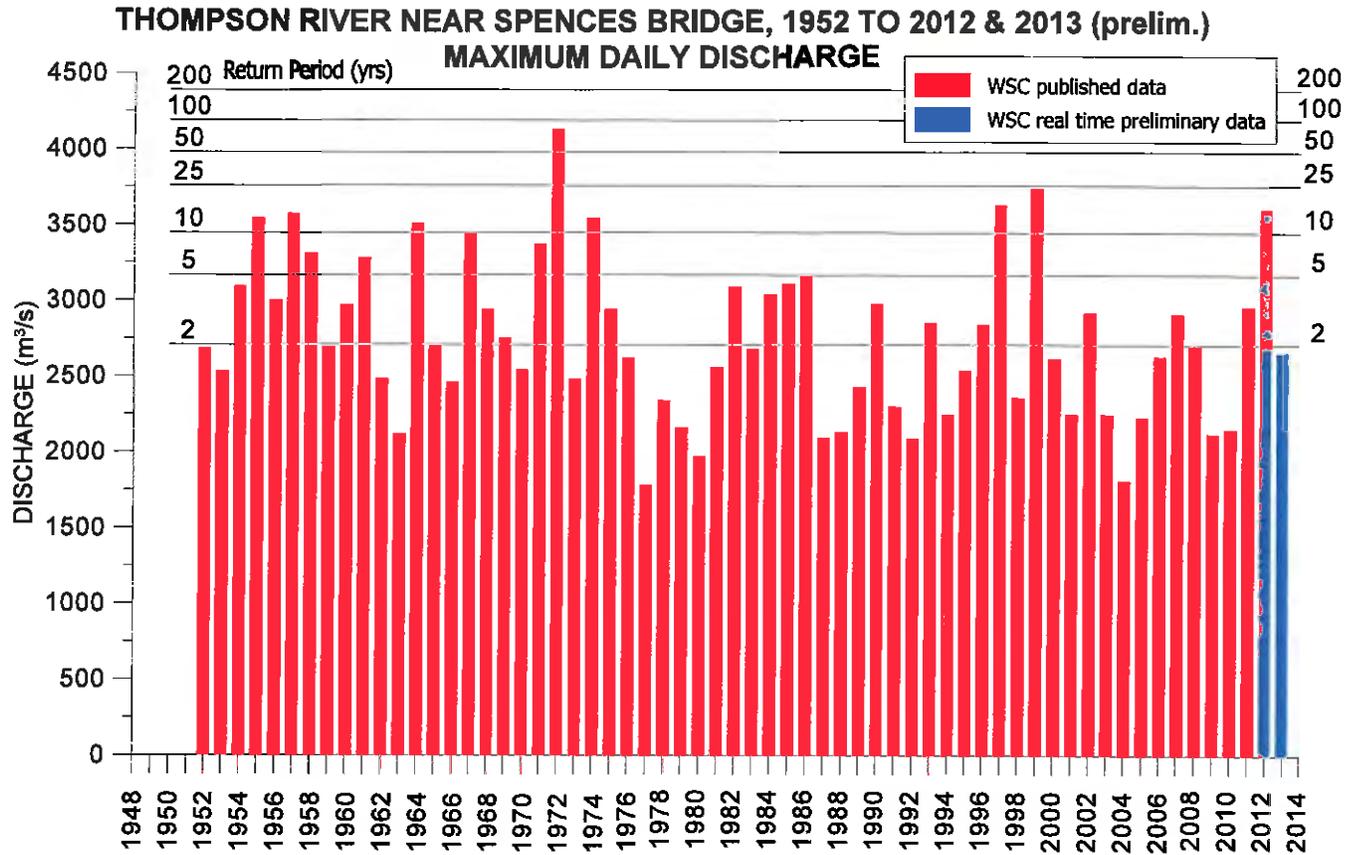
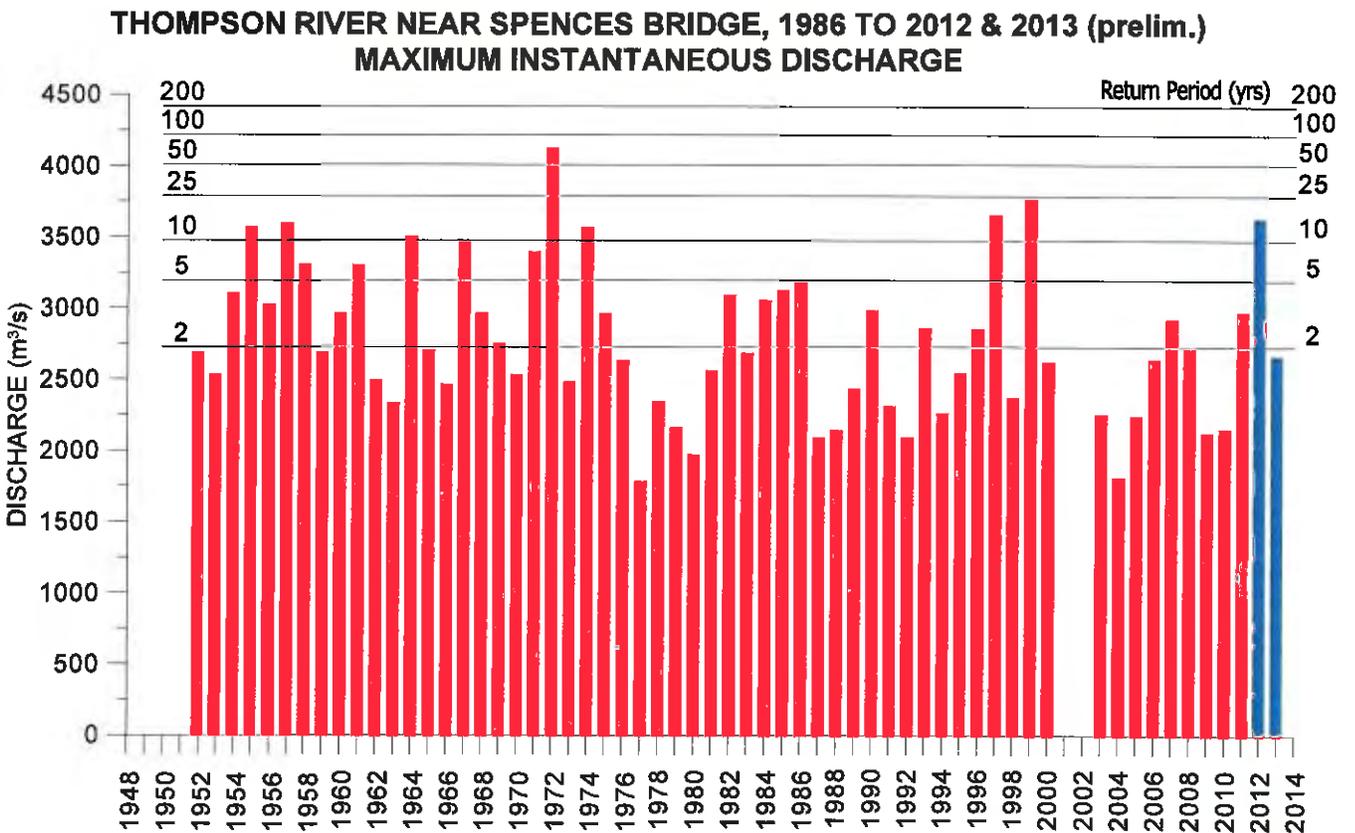
Figure 3.2.2: Historical variation in annual maximum daily and instantaneous discharge, Thompson River near Spences Bridge, 1952 to 2012 & 2013 (prelim.).

The historical variation in annual maximum daily and instantaneous discharges observed on *Thompson River near Spences Bridge* is illustrated on *Figure 3.2.2*. A flood frequency analysis has been undertaken using the BC Government computer program 'FREQUAN' ^{*1} and the results are compiled on *Tables 3.2.1 & 3.2.2*. This analysis indicates that the largest recorded flood was in 1972 and has an average return period of approximately 75 years. More recent sizeable events occurred in 1997, 1999 and 2012 and the average return periods are ~15, 25 and 15 years, respectively. The historical variation in annual minimum flows is illustrated on *Figure 3.2.3* and the results of a low flow frequency analysis are compiled on *Table 3.2.3*. These analyses indicate the average annual minimum flow is ~180 m³/s with predicted extreme values at Spences Bridge being as low as ~120 m³/s. The associated flows at Ashcroft could be marginally lower.

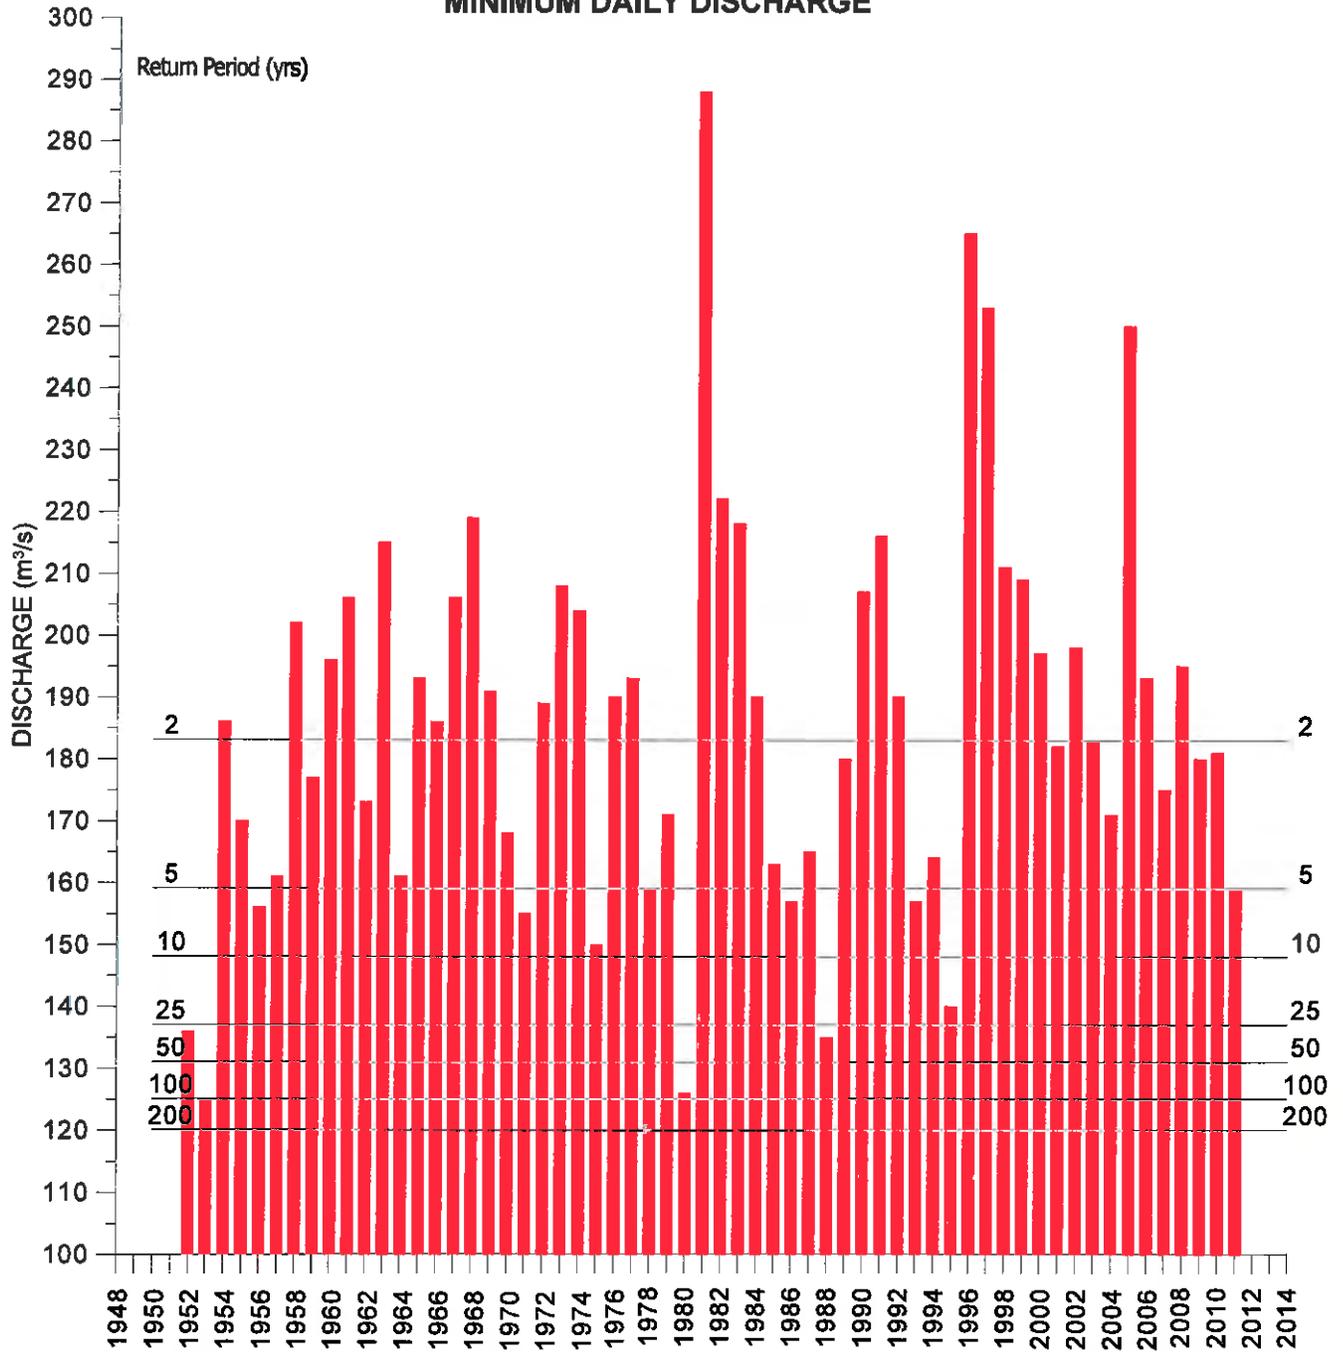
THOMPSON RIVER NEAR SPENCES BRIDGE, 1952 TO 2011
MINIMUM DAILY DISCHARGE

Figure 3.2.3: Historical variation in annual minimum daily discharge, Thompson River near Spences Bridge, 1952 to 2011
