Village of Ashcroft

Water Master Plan

November 2014

URBAN
systems

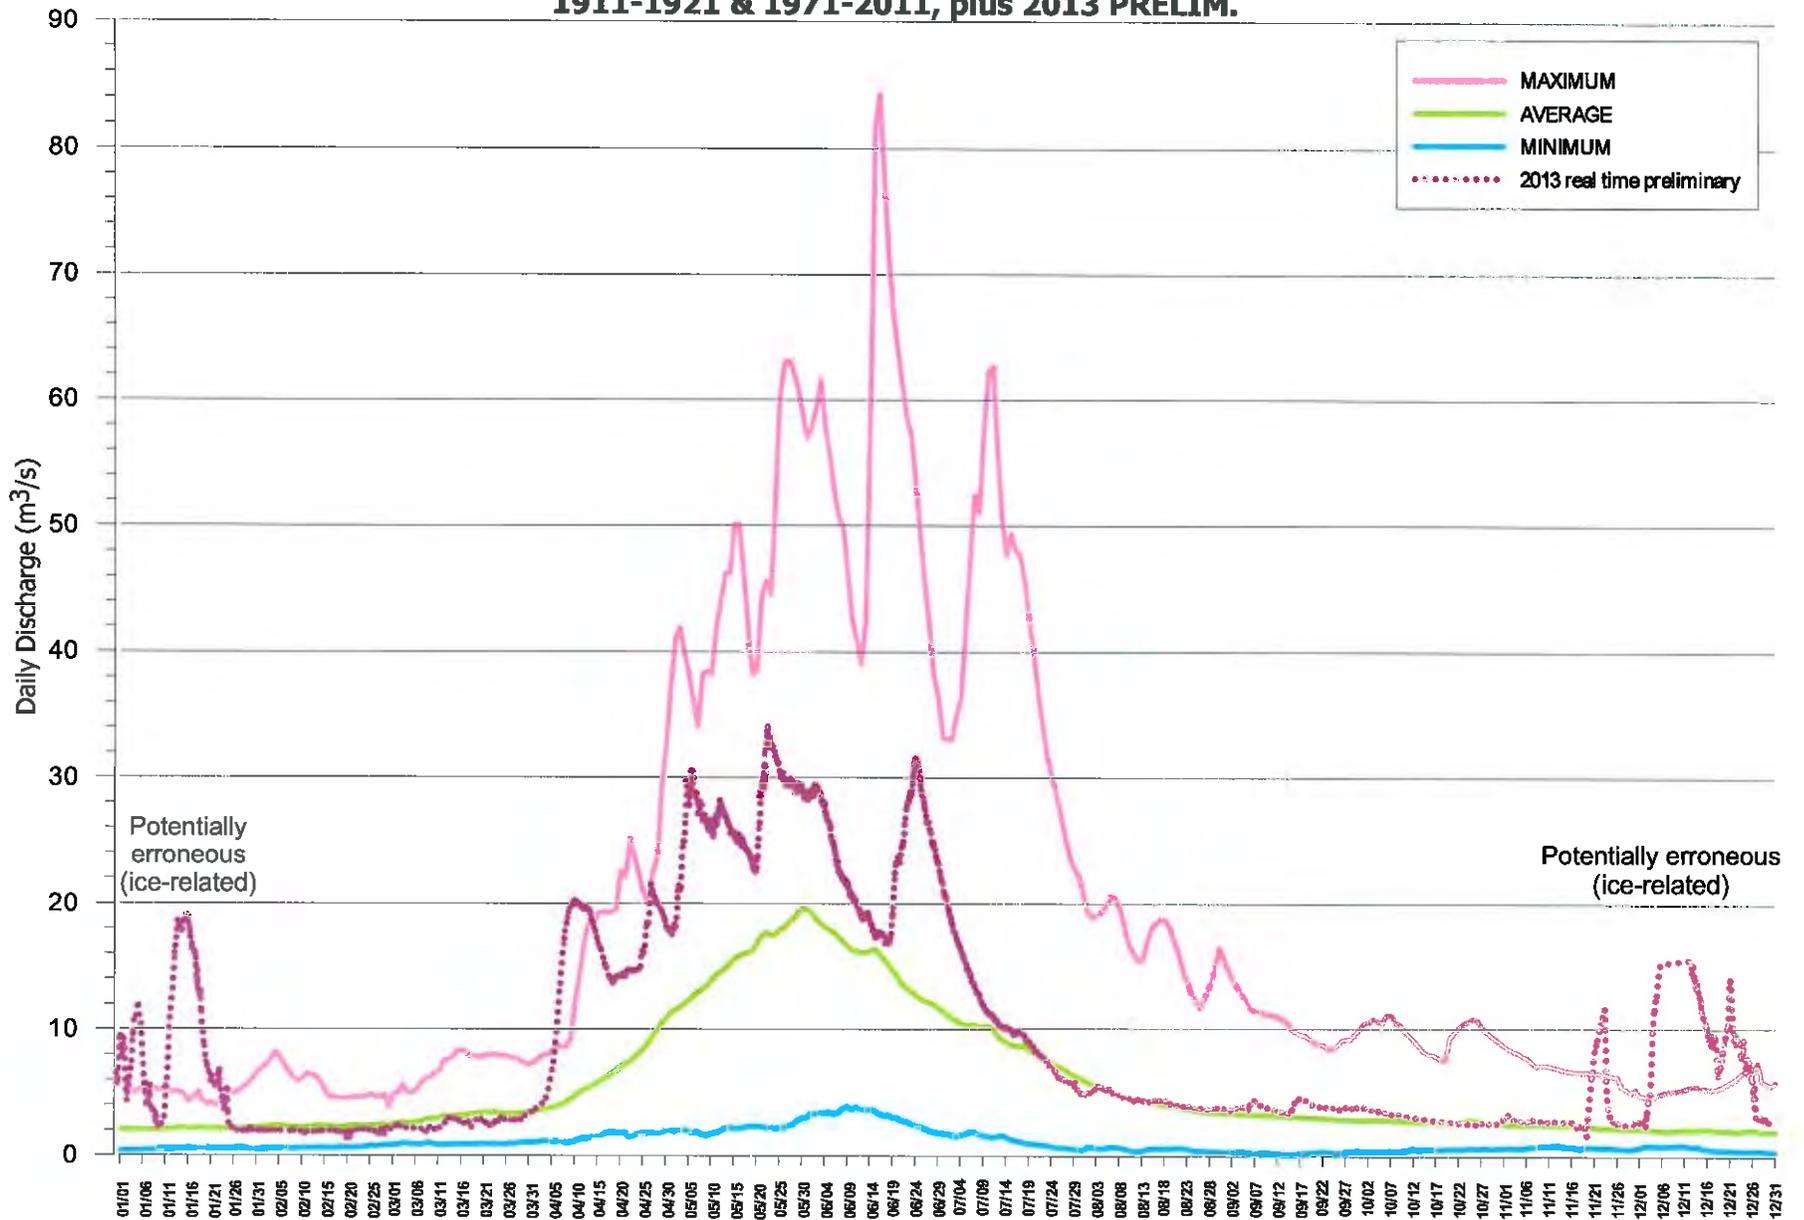
**SEASONAL VARIATION IN FLOW - BONAPARTE RIVER BELOW CACHE CK [05LF002],
1911-1921 & 1971-2011, plus 2013 PRELIM.**

Figure 3.2.4: Seasonal Variation in Flow, Bonaparte River Below Cache Creek, 1911-1921 and 1972 to 2011, plus 2013 preliminary.

Similar analyses have also been undertaken on streamflow data collected at the WSC station "*Bonaparte River below Cache Creek*". The gauge has operated between 1912 and 1921 and post-1972. This site, which has a basin area of 5,020 km², is located 11 km upstream of the Thompson River confluence. The seasonal variation in flow is illustrated on *Figure 3.2.4*. Flows again begin to rise in late-March or April, the snowmelt freshet typically reaches a maximum around early-June, but intense rain-caused runoff can occur into late-July followed by declining discharges through the winter period. Winter ice effects can result in locally increased water levels.

No measurements are available to document rates of bedload transport or to quantify suspended sediment concentrations or loadings. However, the BC Ministry of Environment is conducting a water quality sampling program in cooperation of the Village of Ashcroft [Jennifer Puhallo, R.P.Bio, pers. comm.] Seasonal data has been collected on Thompson River at Ashcroft and on lower Bonaparte River. All data available in March 2014 have been compiled on *Tables 4.3.1 & 4.3.2*, and this information includes 'turbidity' measurements. Information is only available for the winter low flow months when turbidity values will be at their seasonal minimum values. The collected data, which are plotted on *Figure 4.3.1*, suggest that fall and winter turbidity values on Bonaparte River are roughly twice as high as those observed on Thompson River. Measured values on Thompson River are typically less than 2 NTU and reached a maximum of 13 NTU. In contrast, turbidity observations on Bonaparte River are generally less than 4 NTU, occasionally reach values of 16 NTU and the maximum observed winter value is 42 NTU. Previous experience in the Bonaparte watershed suggest that these comparatively elevated values reflect the lack of upstream lake regulation, the occurrence of fine-textured surficial materials and land use related impacts. Turbidity values in the spring and summer (*see Figures 3.2.1 & 3.2.4*) are expected to be much higher than those observed in the winter low flow period.

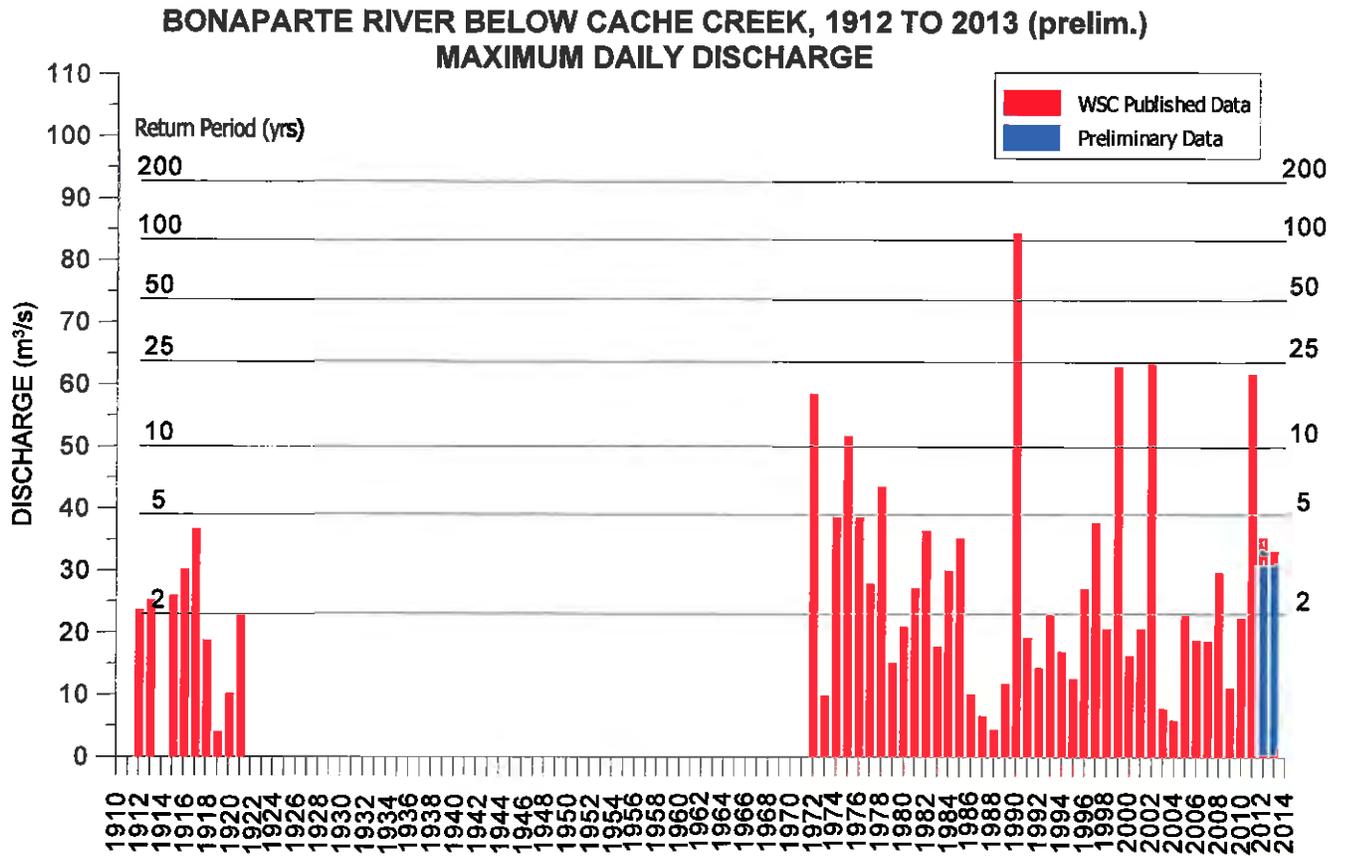
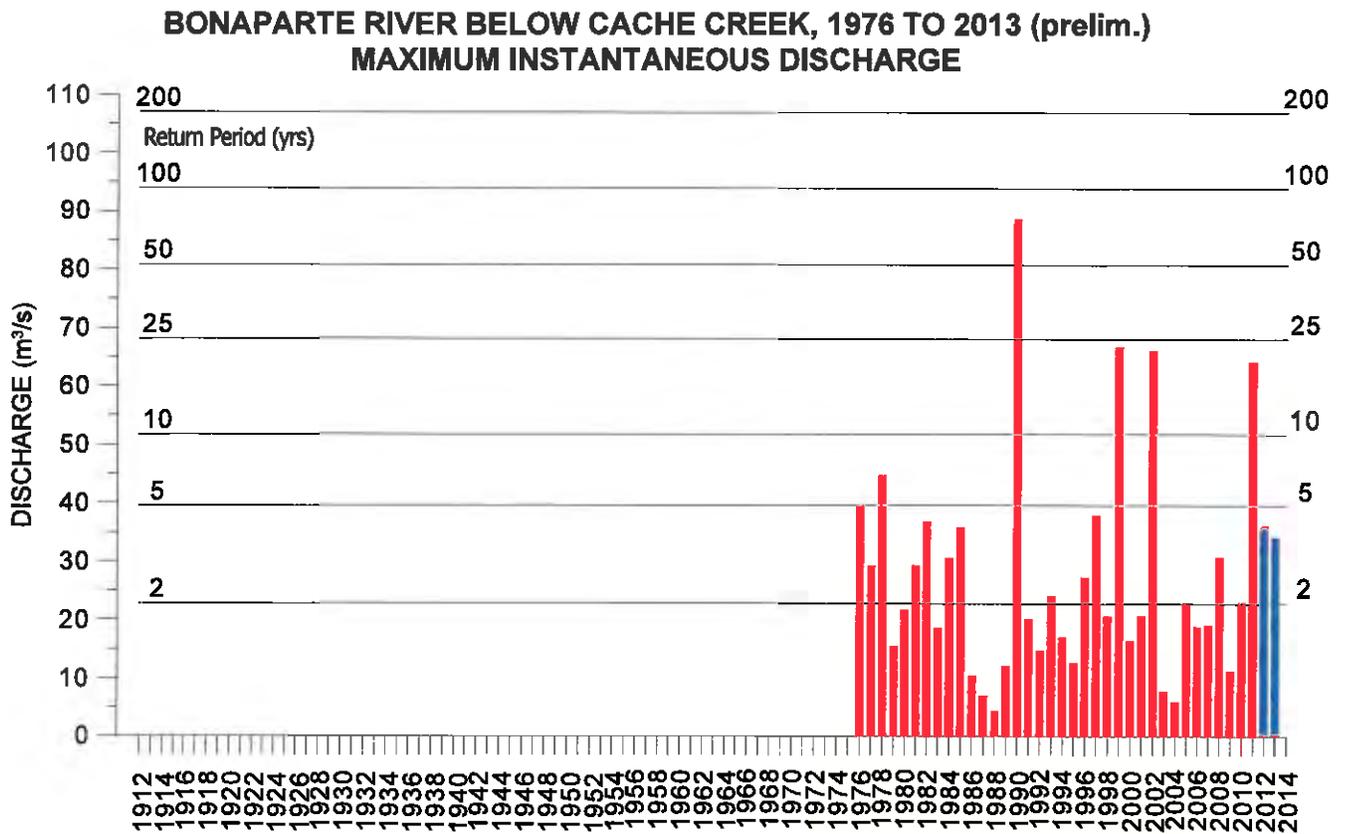
Figure 3.2.5: Historical variation in annual maximum daily and instantaneous discharge, Bonaparte River below Cache Creek, 1912 to 2013 (prelim.).

The historical variation in annual maximum daily and instantaneous discharges on Bonaparte River are illustrated on *Figure 3.2.5*. The results of flood frequency analyses are presented on *Tables 3.2.4 & 3.2.5*. This analysis indicates the largest recorded flood occurred in 1980 and has an average return period of 75 to 100 years. Recent sizeable events also occurred in 1999, 2002 and 2011 with average return periods being ~20 years. The historical variation in annual minimum flows on Bonaparte River is illustrated on *Figure 3.2.6* and the results of a low flow frequency analysis are presented on *Table 3.2.6*. This analysis indicates that the average annual minimum flow is 1.2 m³/s and extreme values can be ~0.1 m³/s.

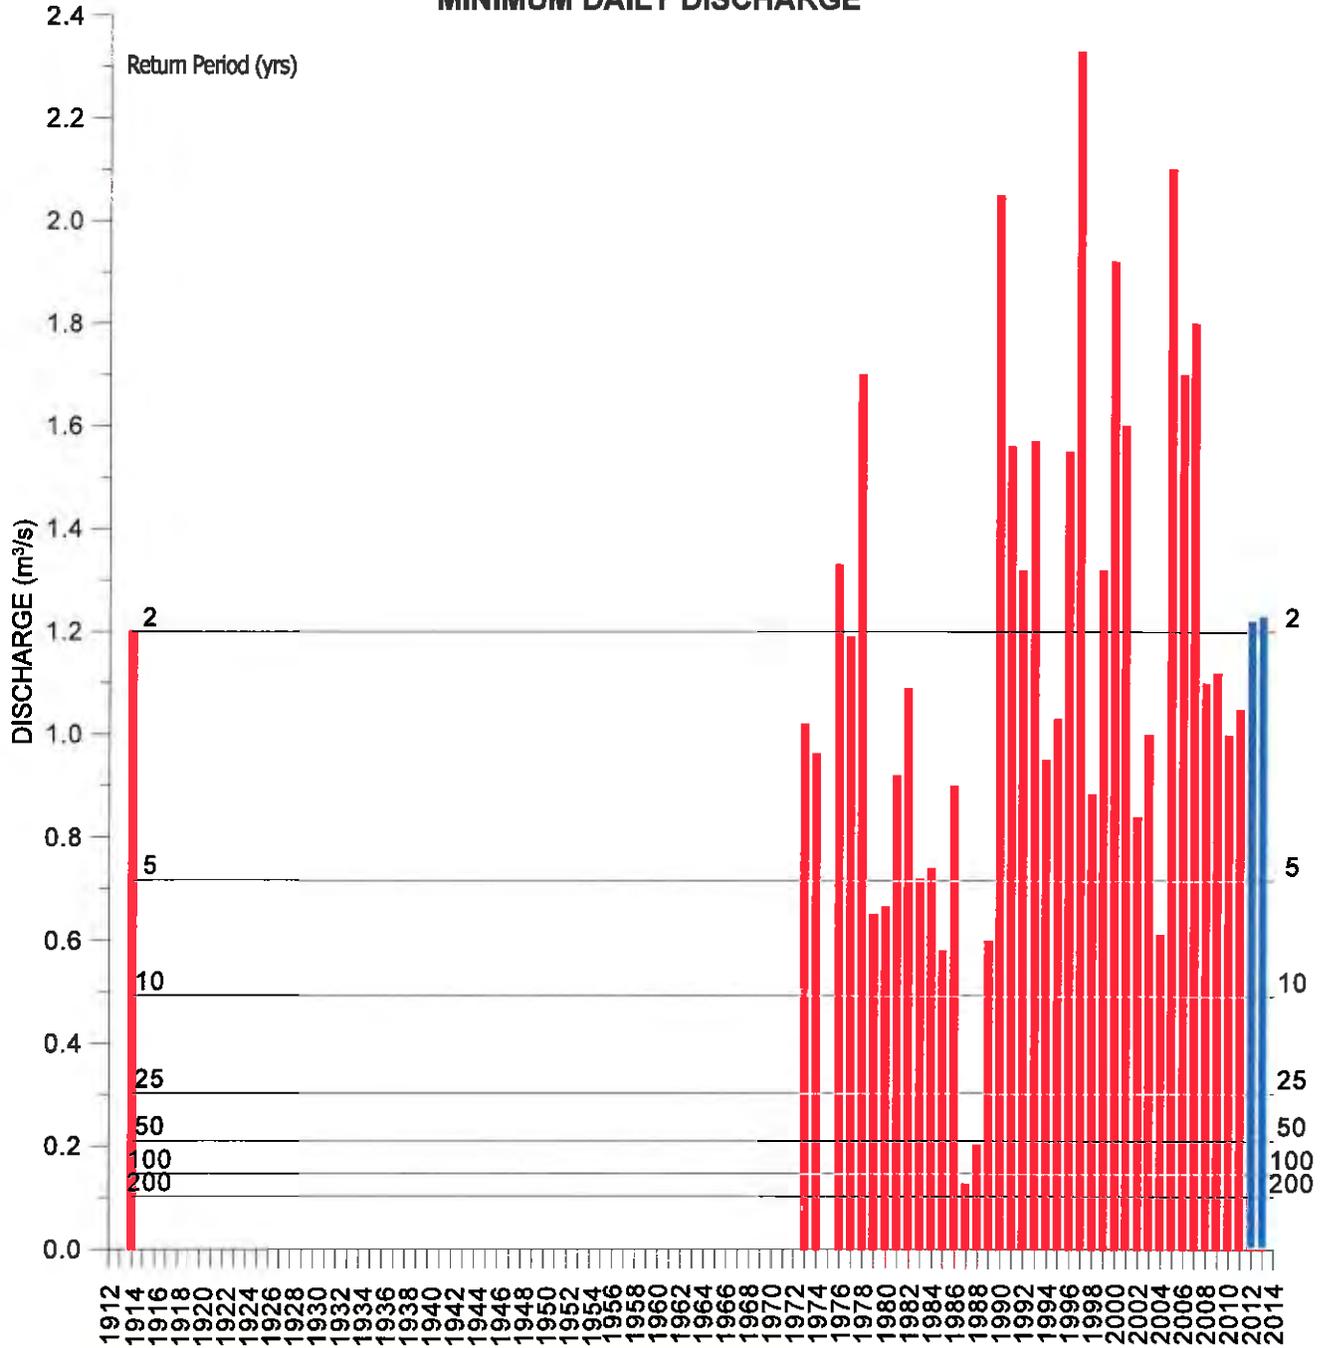
**BONAPARTE RIVER BELOW CACHE CREEK, 1914 TO 2013 (PRELIMINARY)¹
MINIMUM DAILY DISCHARGE**

Figure 3.2.6: Historical variation in annual minimum daily discharge, Bonaparte River below Cache Creek, 1912 to 2013 (preliminary).

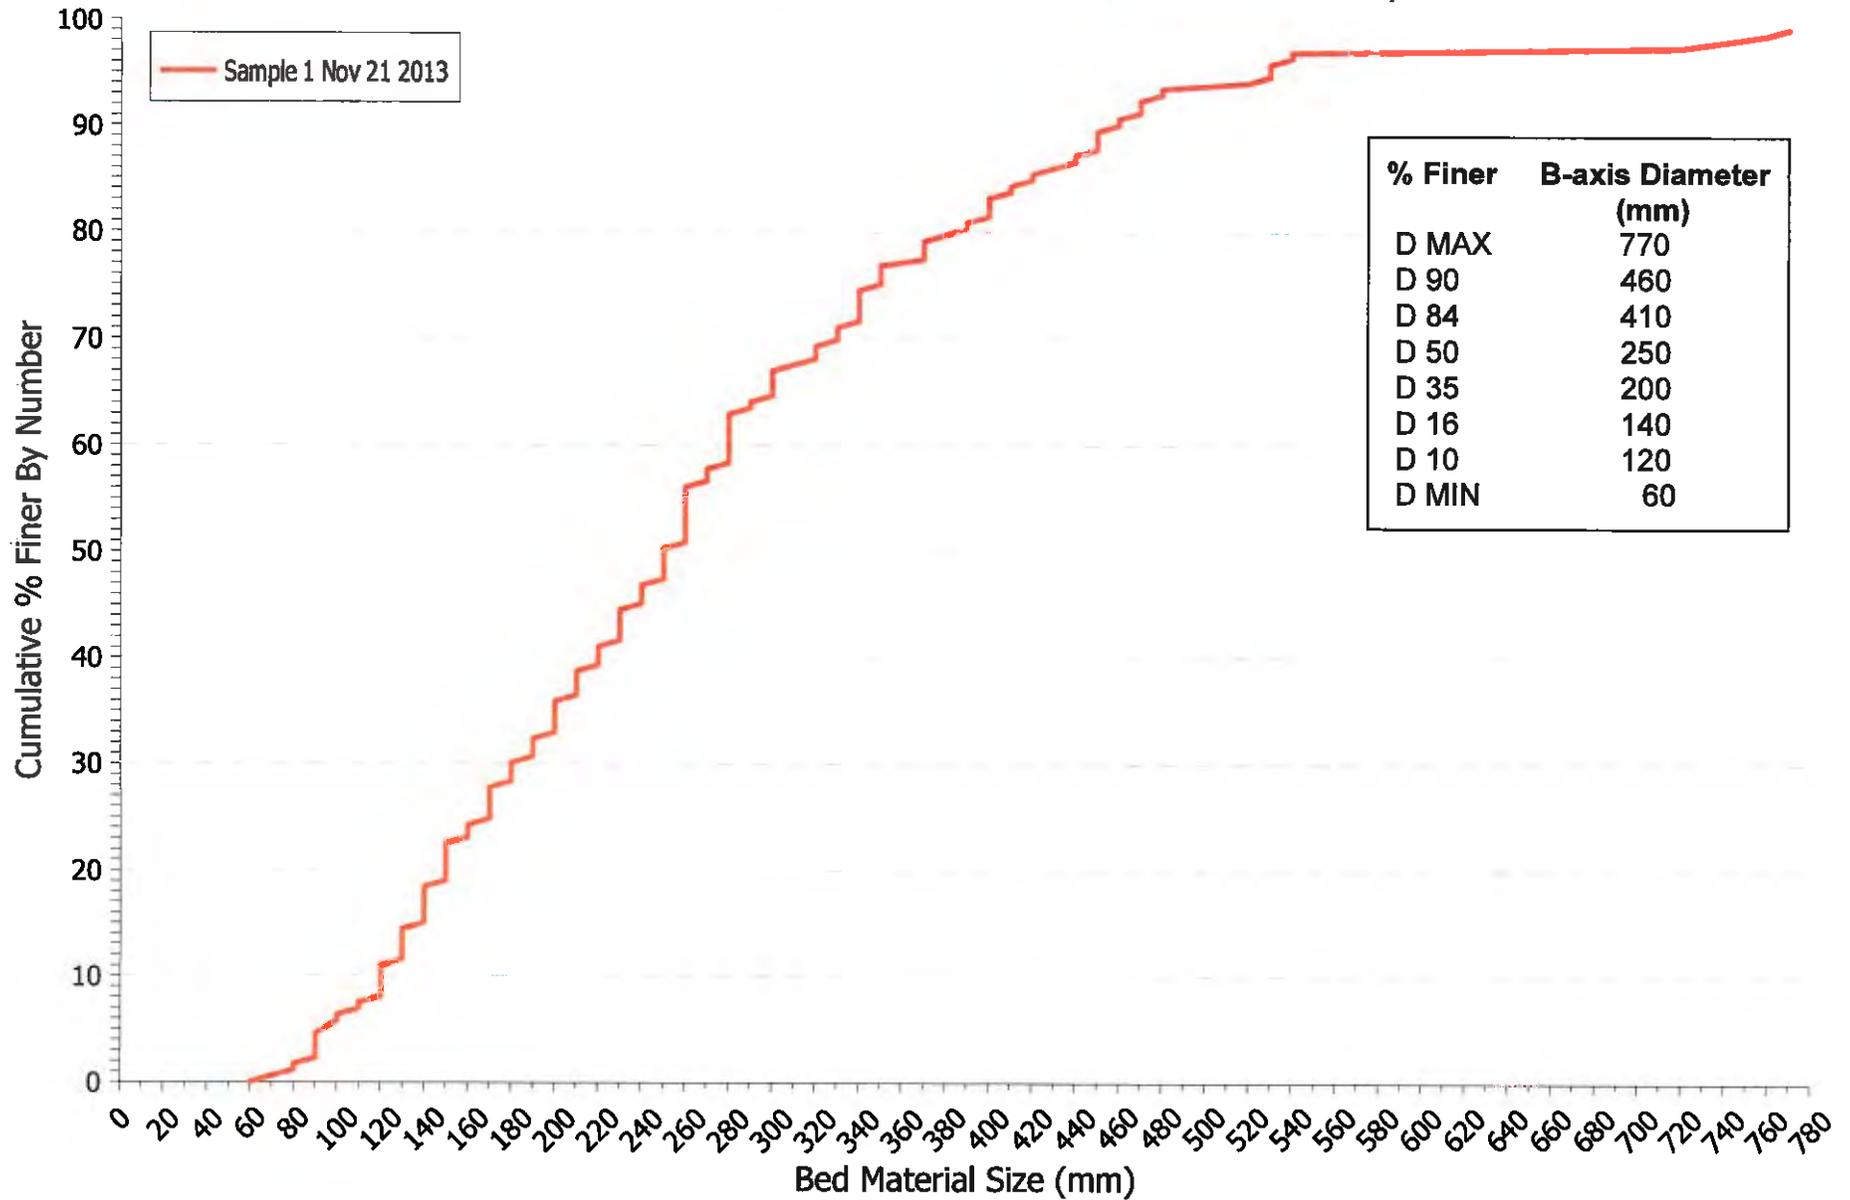
THOMPSON RIVER - TAPE GRID SAMPLE - NOVEMBER 21, 2013

Figure 4.1.1: Bed material size distribution on the left bank downstream of the water supply intake.

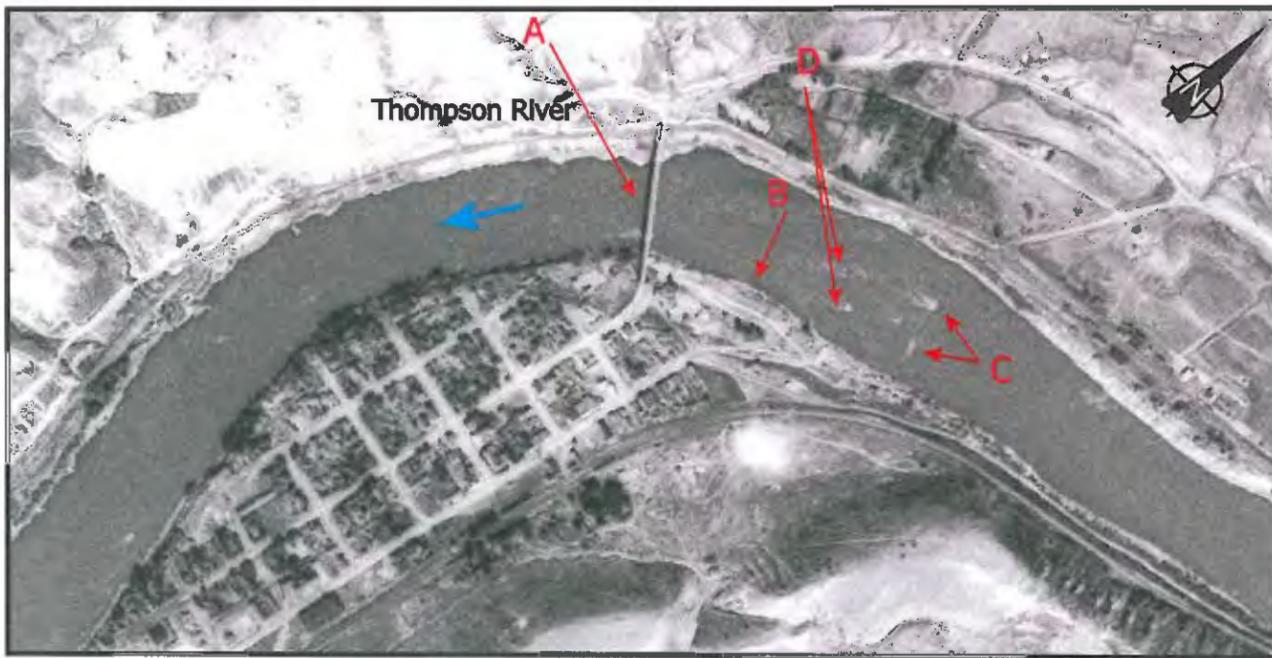
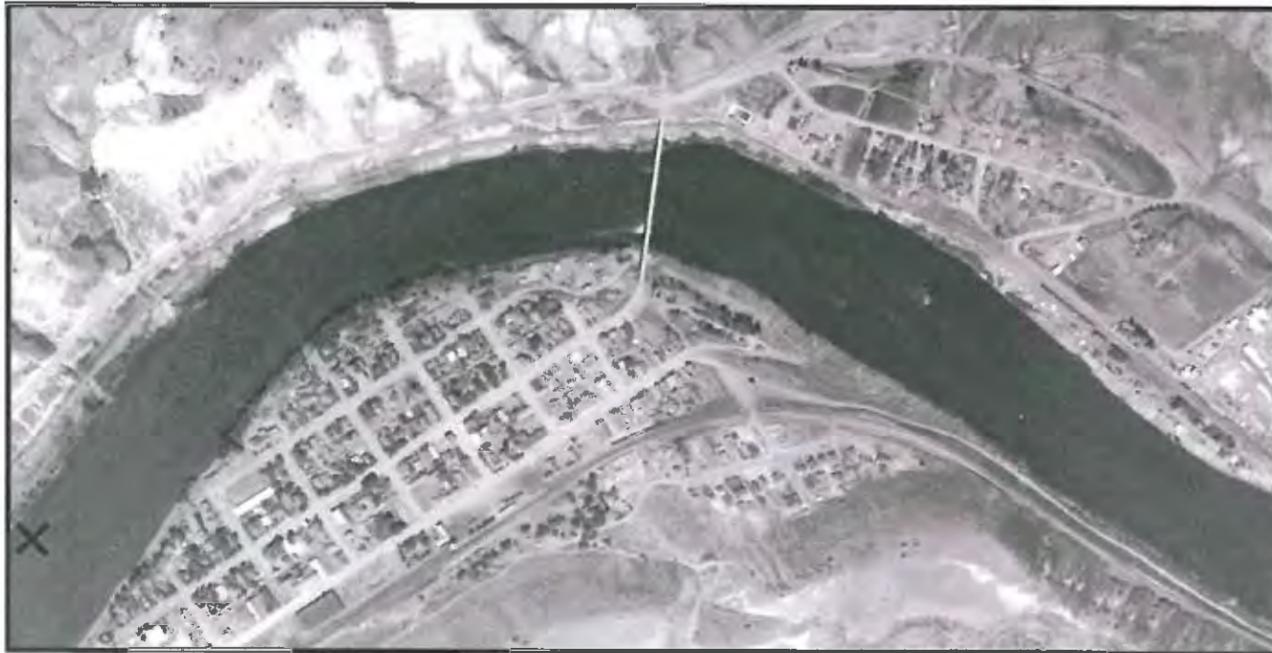
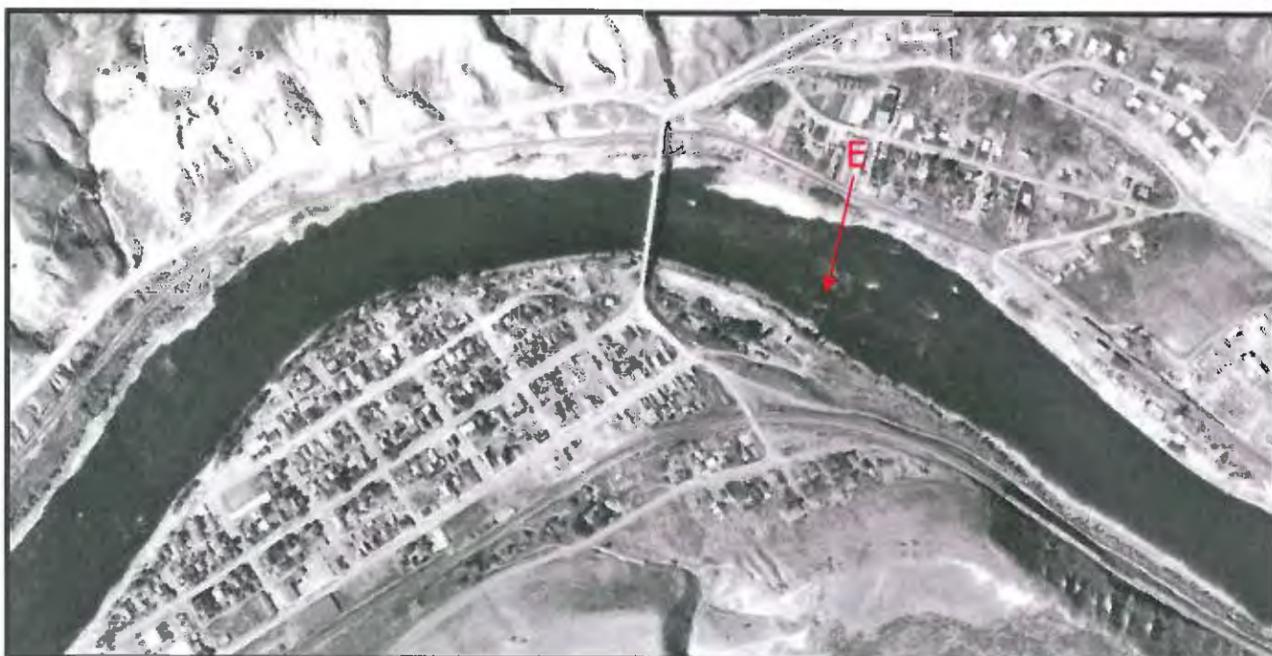
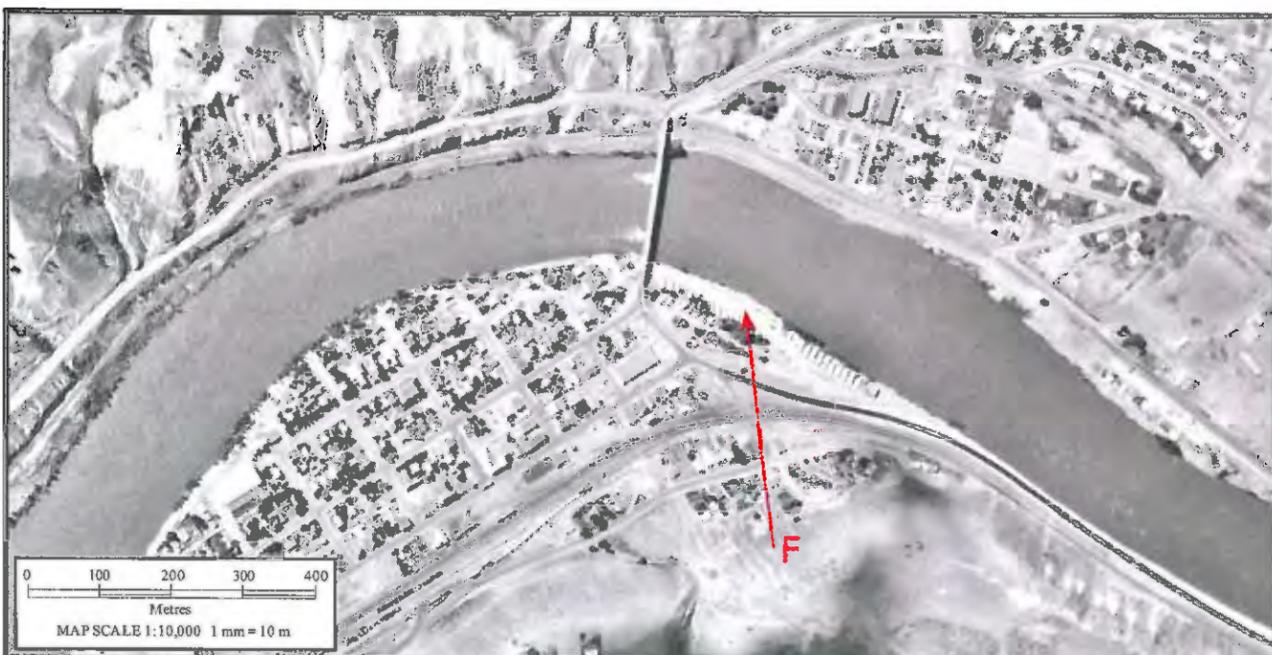
(i)
Date: July 31, 1948
BC625 #15

Bonaparte River below Cache Creek na
Thompson River near Spences Bridge 2,070 m³/s

Bonaparte River below Cache Creek na
Thompson River near Spences Bridge 518 m³/s

Bonaparte River below Cache Creek 33.7 m³/s
Thompson River near Spences Bridge 3,030 m³/s

Figure 4.2.1A: Historical changes in channel morphology, Thompson River at Ashcroft.

A series of larger scale historical air photos centred on the water supply intake is presented as *Figures 4.2.1A & B*. These photos further illustrate the stability of this section of channel. The persistence of individual large boulders on the channel bed and remnants of former upstream bridge piers suggest that the bed elevation has remained quite stable over the last sixty years. However, high water levels generally cover the mid-channel bar at the water supply intake site and prevent detailed comparisons of river bed characteristics. The cessation or reduction of gravel removal in the upstream channel has the potential to increase the bed elevation on the mid-channel bar located at the existing infiltration gallery. The stability of this site over the last 60 years suggests that this effect will likely be small as the incoming sediment load appears to be carried through this reach. Improved riparian and upslope land use practices on Deadman River or Battle Creek could also be reducing rates of coarse textured sediment production and might mitigate the effects of any reduction in future volumes of upstream gravel extraction.

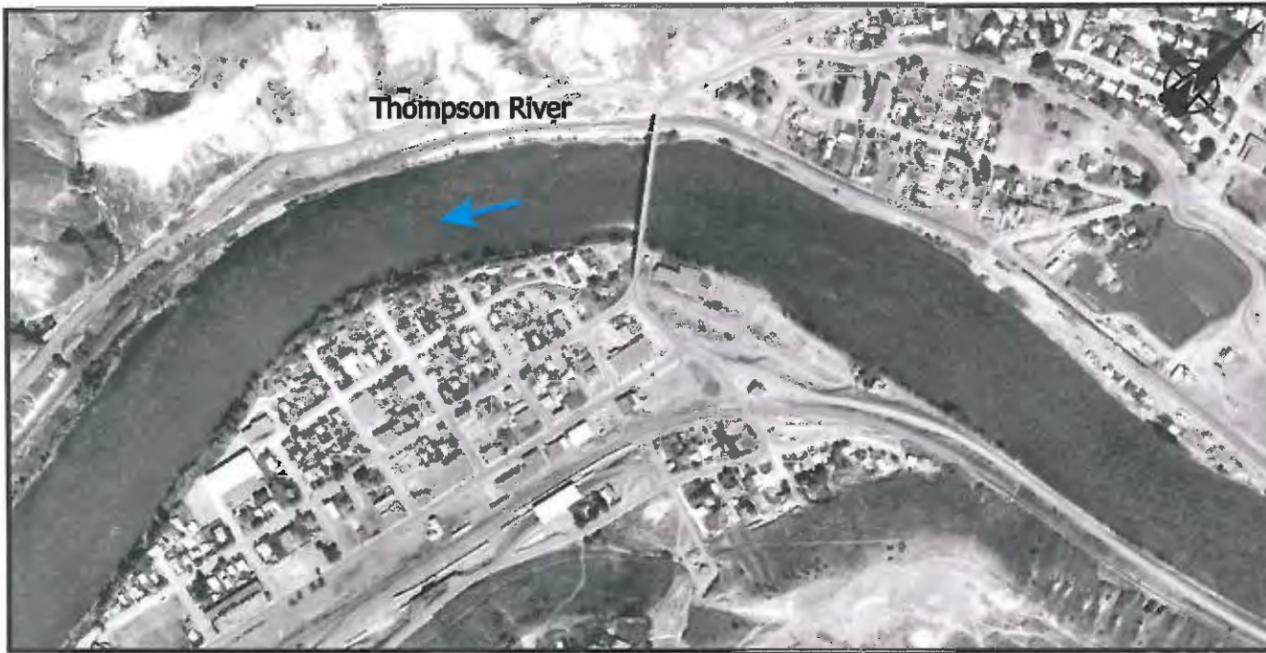
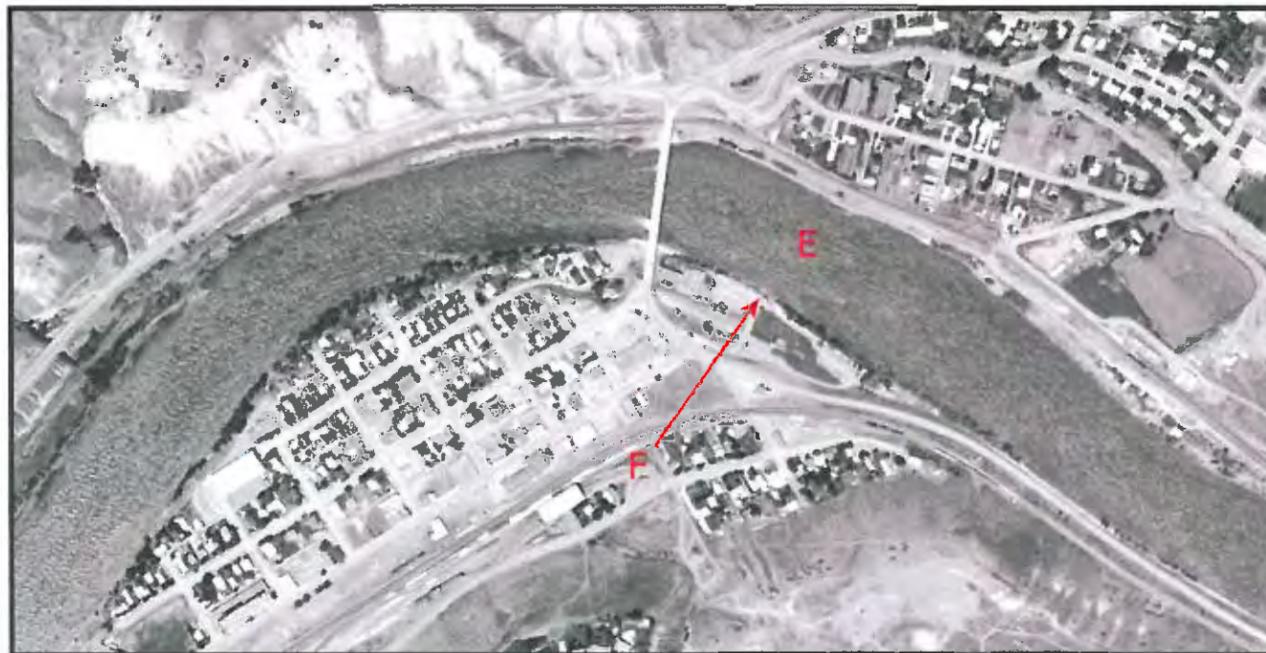
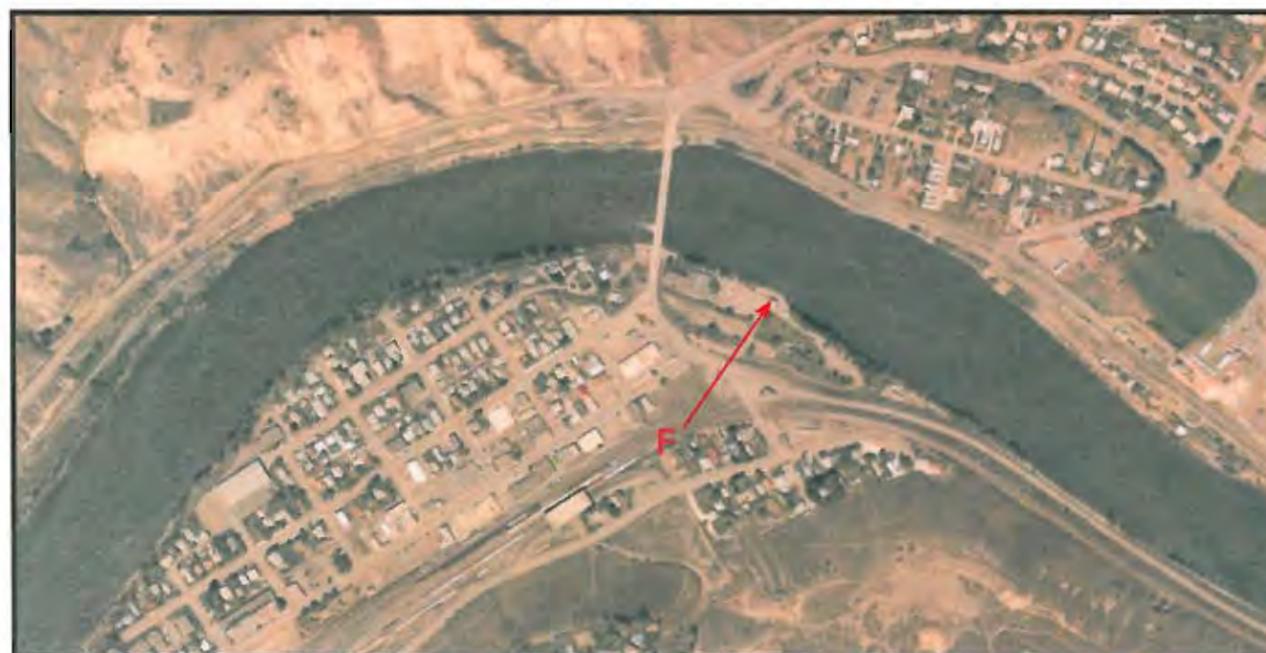
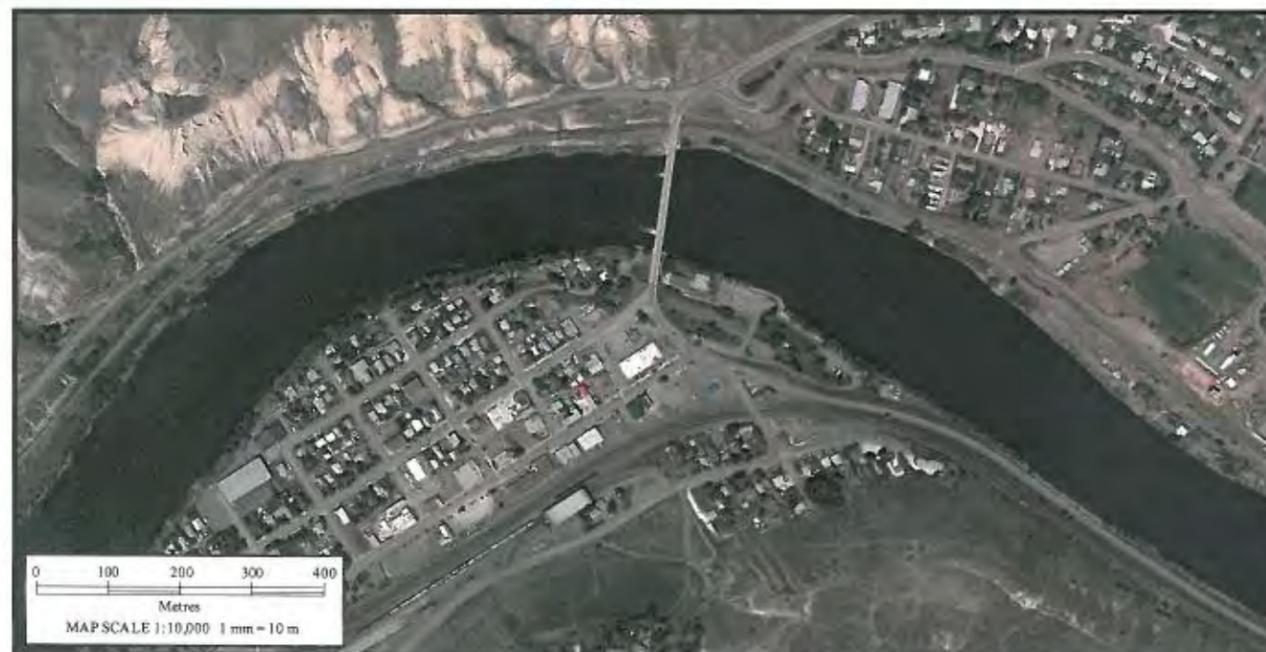
Bonaparte River below Cache Creek 5.01 m³/s
Thompson River near Spences Bridge 2,130 m³/s

Bonaparte River below Cache Creek 7.51 m³/s
Thompson River near Spences Bridge 632 m³/s

Bonaparte River below Cache Creek 7.50 m³/s
Thompson River near Spences Bridge 2,000 m³/s

Bonaparte River below Cache Creek 9.06 m³/s
Thompson River near Spences Bridge 1,680 m³/s

Figure 4.2.1B: Historical changes in channel morphology, Thompson River at Ashcroft.

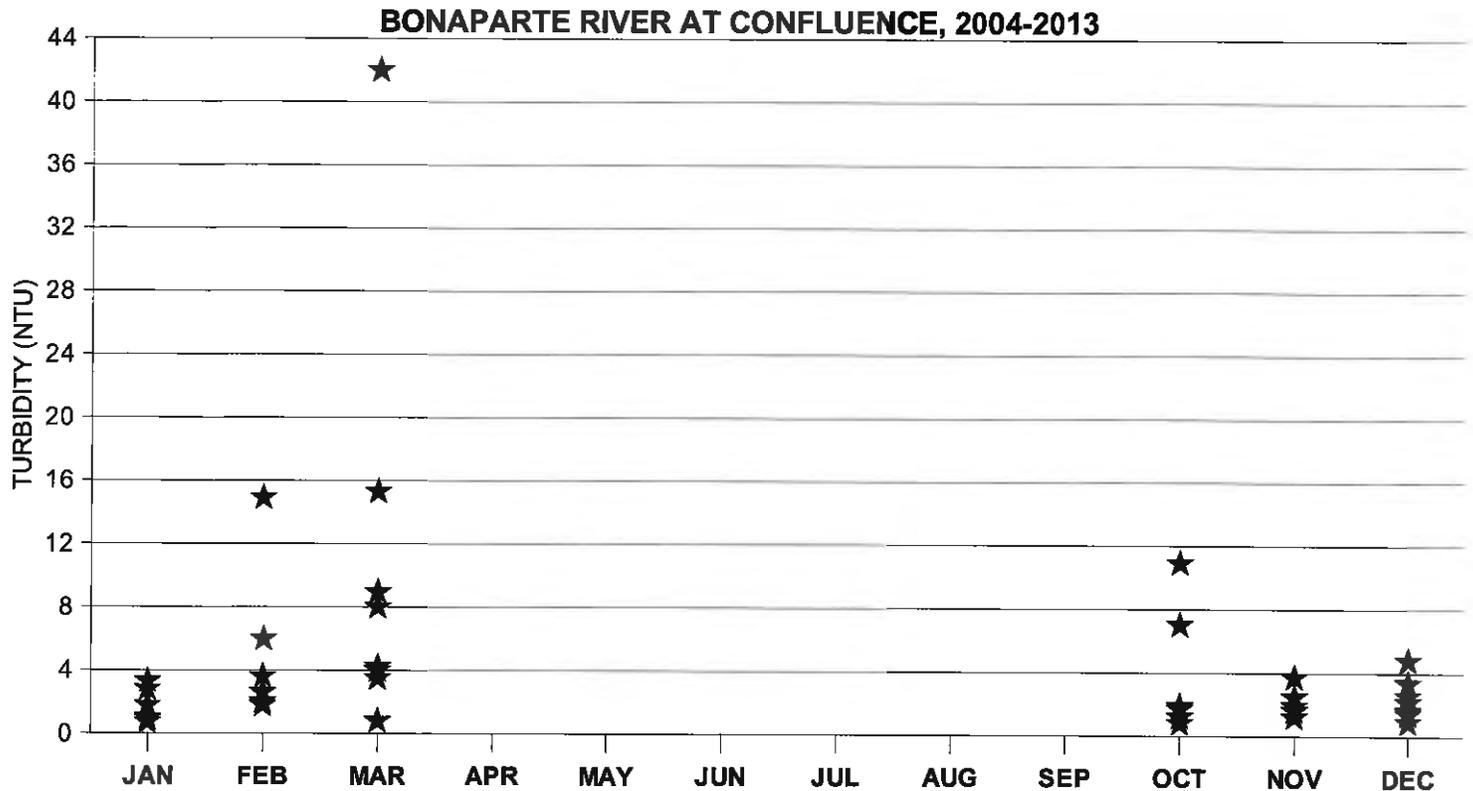
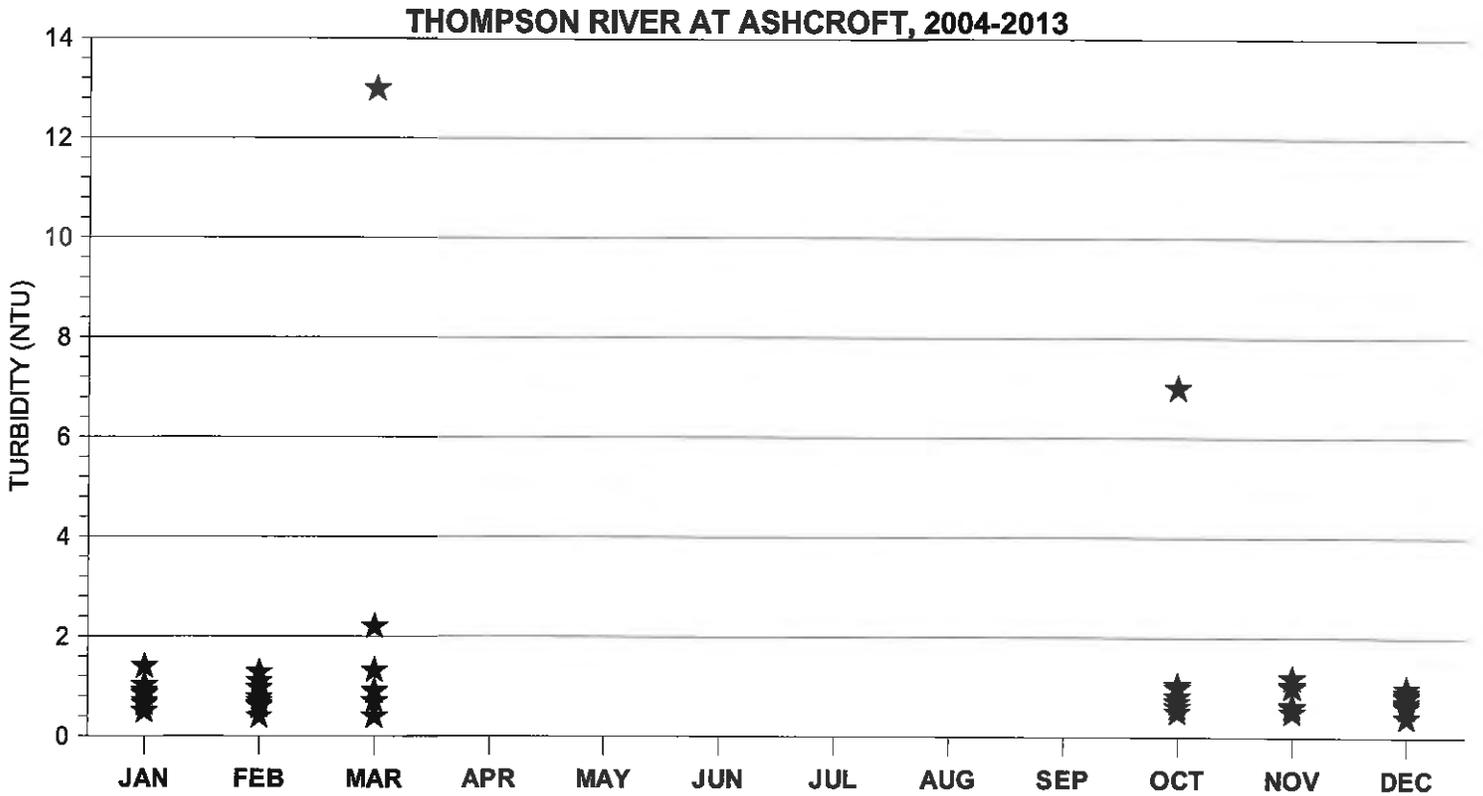
Figure 4.3.1: Seasonal variability in turbidity at Bonaparte River at Confluence and Thompson River at Ashcroft. [Data from BC Ministry of Environment.]

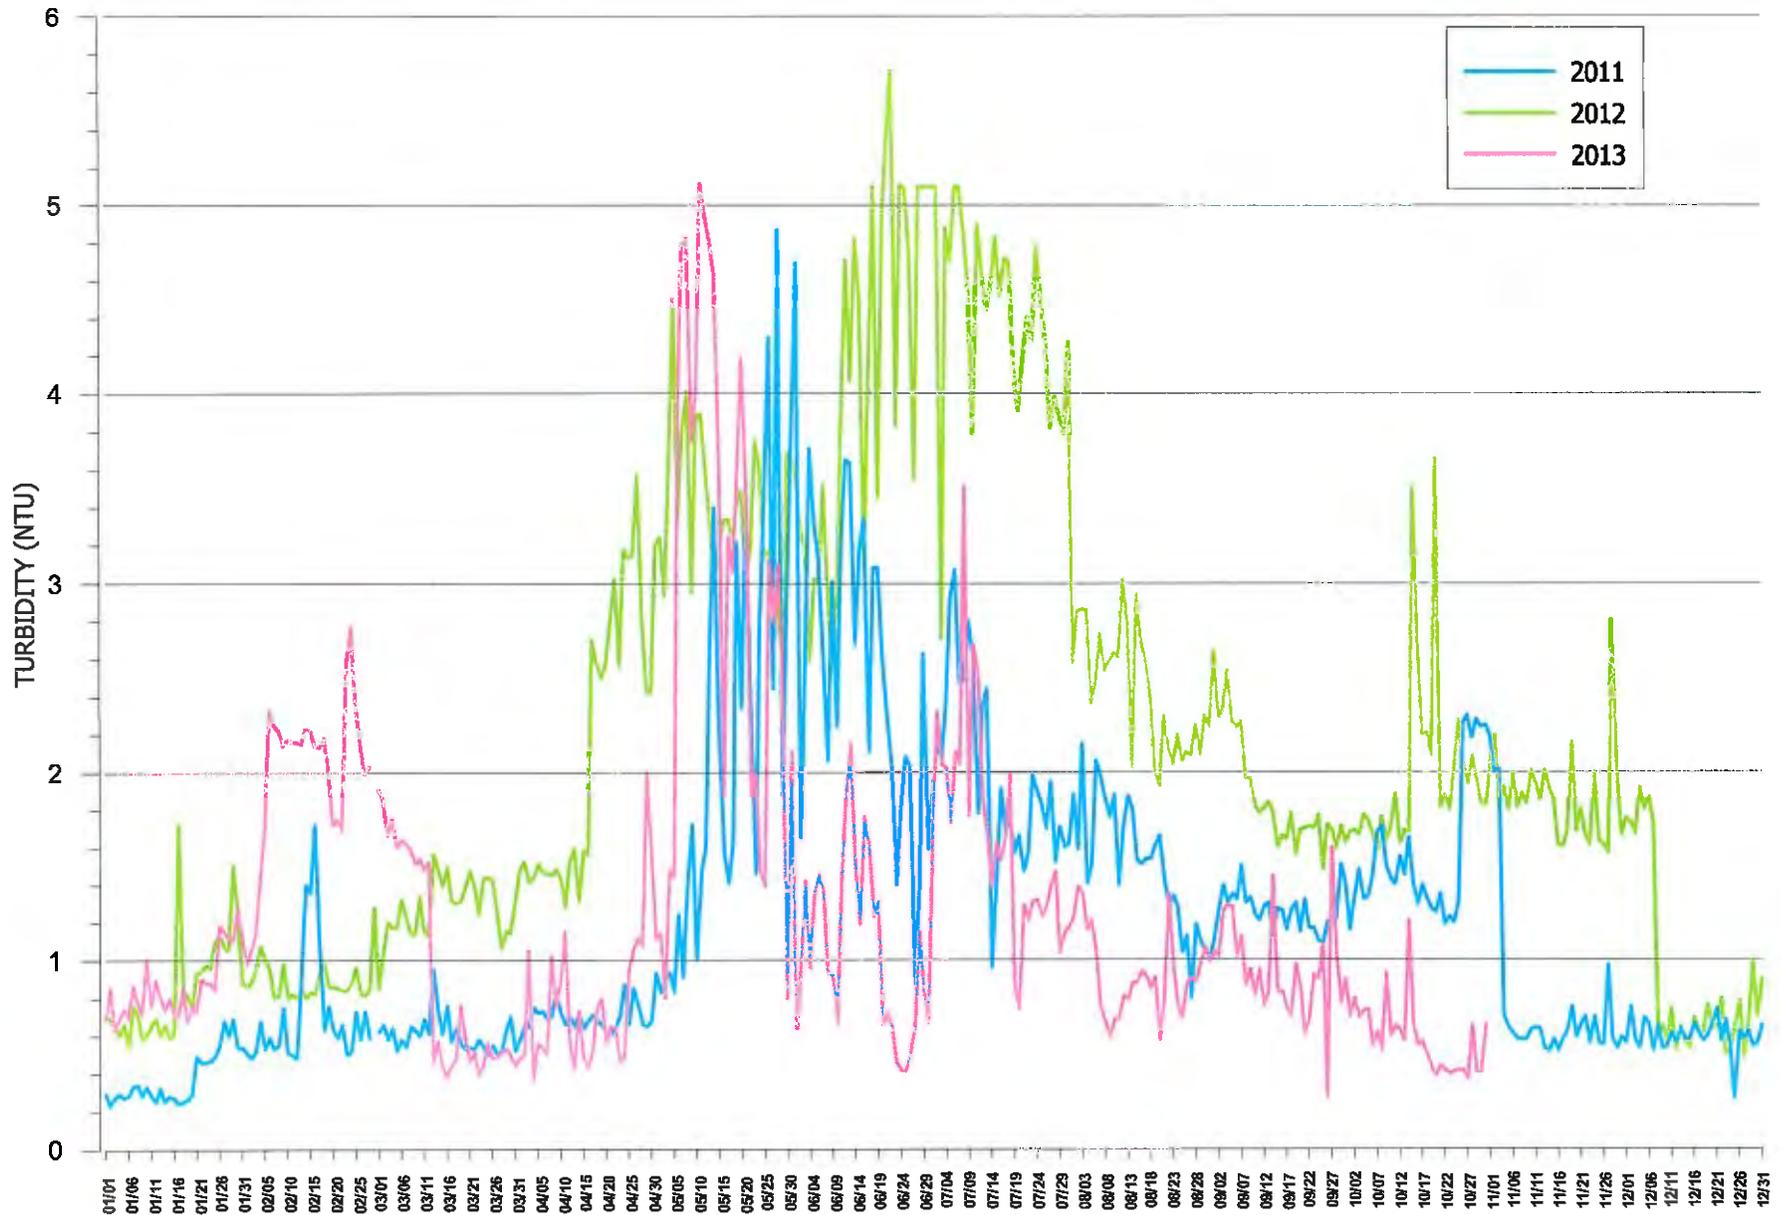
WATER TURBIDITY VALUES - VILLAGE OF ASHCROFT #1 PUMPHOUSE, JANUARY 2011 TO OCTOBER 2013

Figure 4.3.2: Water Turbidity Values - Village of Ashcroft #1 Pumphouse, January 1, 2011 to October 31, 2013.

4.3.2 Water turbidity values - Village of Ashcroft #1 Pumphouse, January 1, 2011 to October 31, 2013	F-16
5.3.1 Design cross-section of the intake pipe installed to augment or replace the infiltration gallery	F-17

The VOA routinely measures turbidity values along with other parameters in the raw water supplied to the #1 Pumphouse. These data have been extracted for the period between January, 2011 and October 2013 and the results are summarized on *Figure 4.3.2*. The seasonal variation in turbidity values generally follows the previously discussed seasonal variations in flow. Maximum observed values of ~5 NTU have occurred in May, June and July. To put these values in perspective, the maximum recommended drinking water turbidity values for treated water are summarized below, based on guidelines prepared by *Health Canada (2012)*.

The 'raw water' data shown on *Figure 4.3.2* periodically exceed the recommended 1.0 NTU treated water value.
