Village of Ashcroft

Water Master Plan

November 2014

URBAN
systems

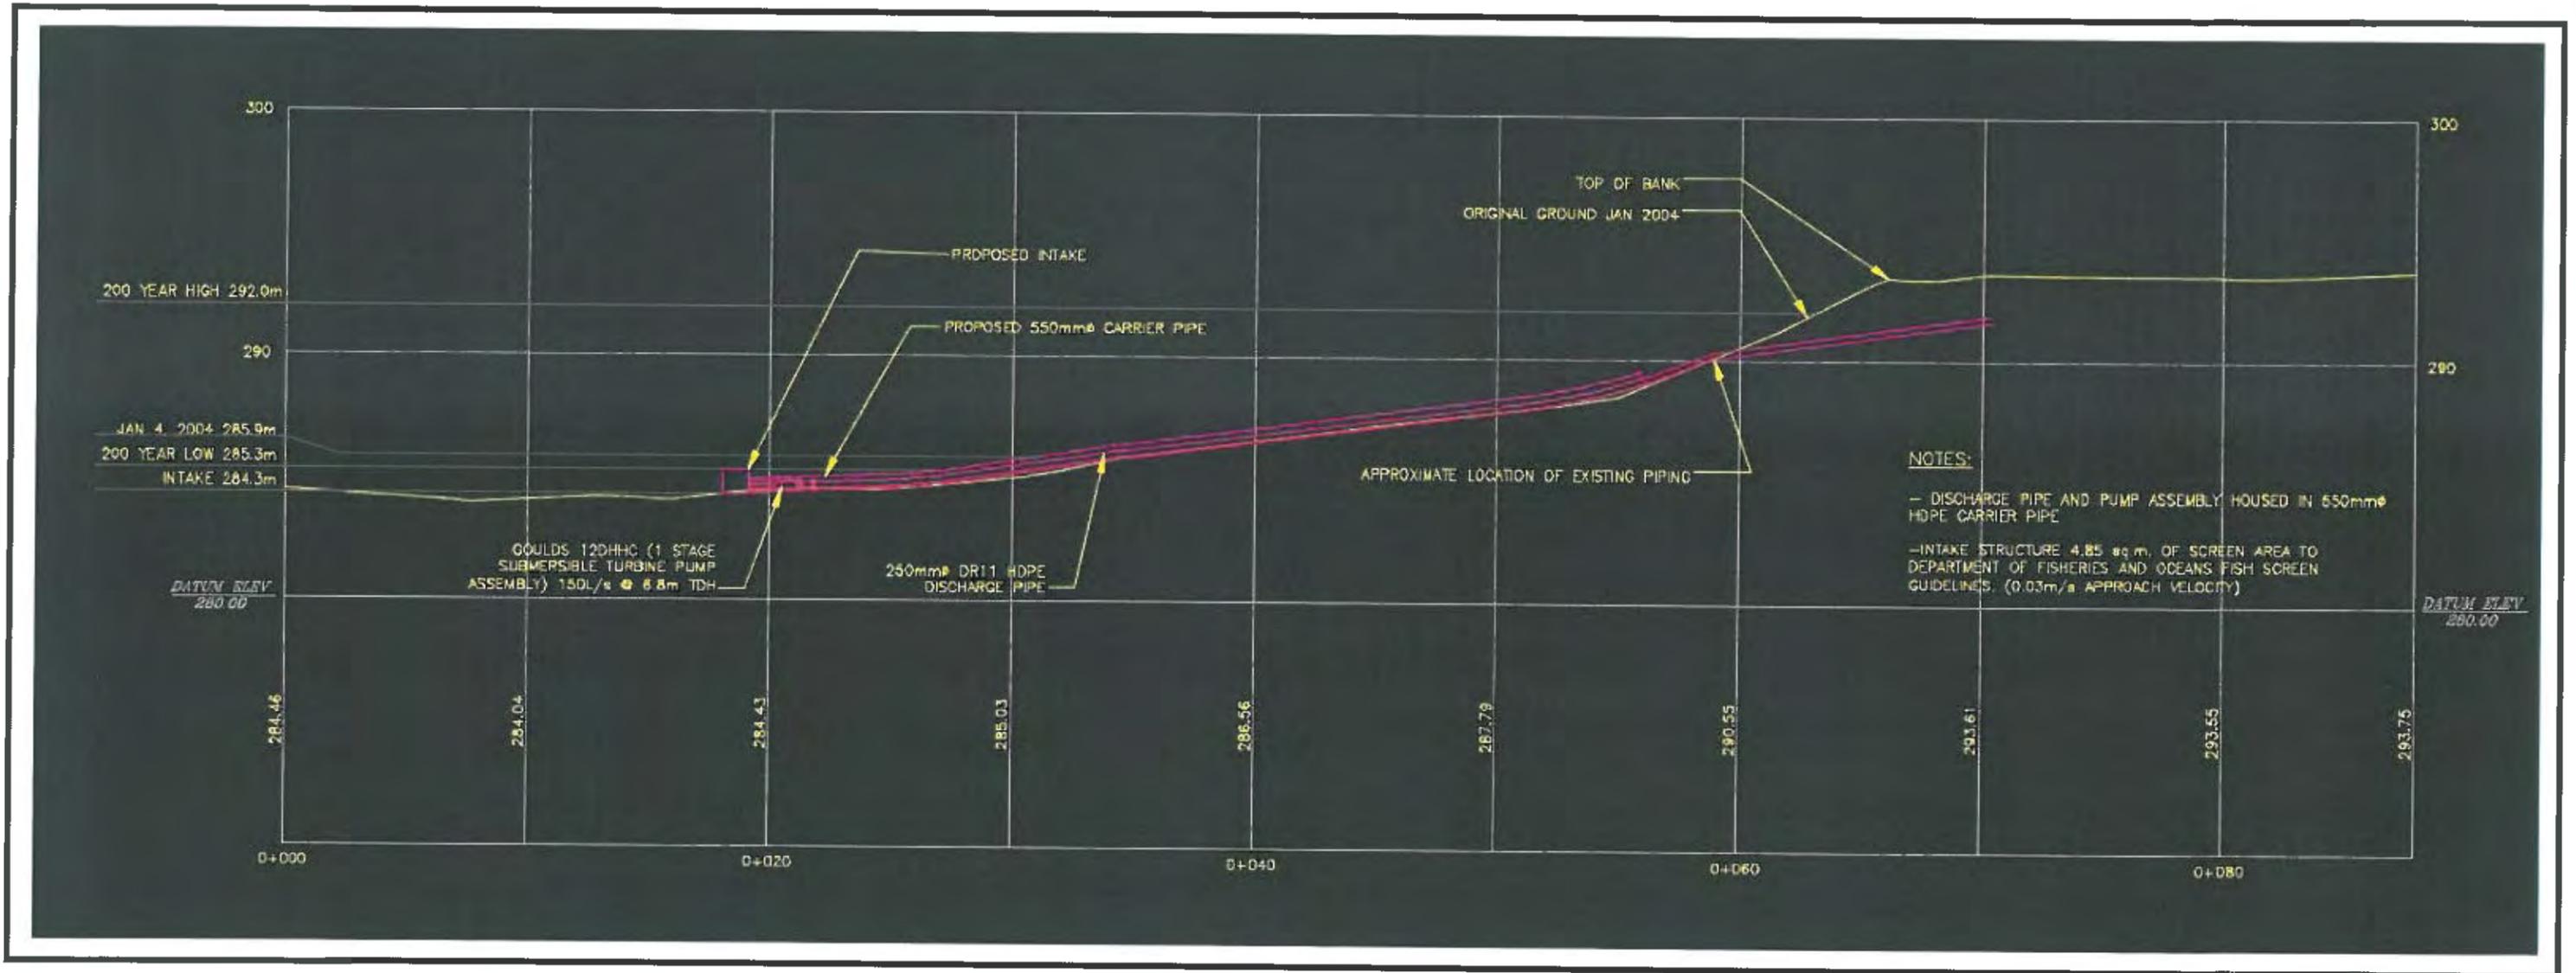
Figure 5.3.1: Design cross-section of the intake pipe installed to augment or replace the infiltration gallery (from Urban Systems Ltd.).

4.3.2 Water turbidity values - Village of Ashcroft #1 Pumphouse, January 1, 2011 to October 31, 2013	F-16
5.3.1 Design cross-section of the intake pipe installed to augment or replace the infiltration gallery	F-17

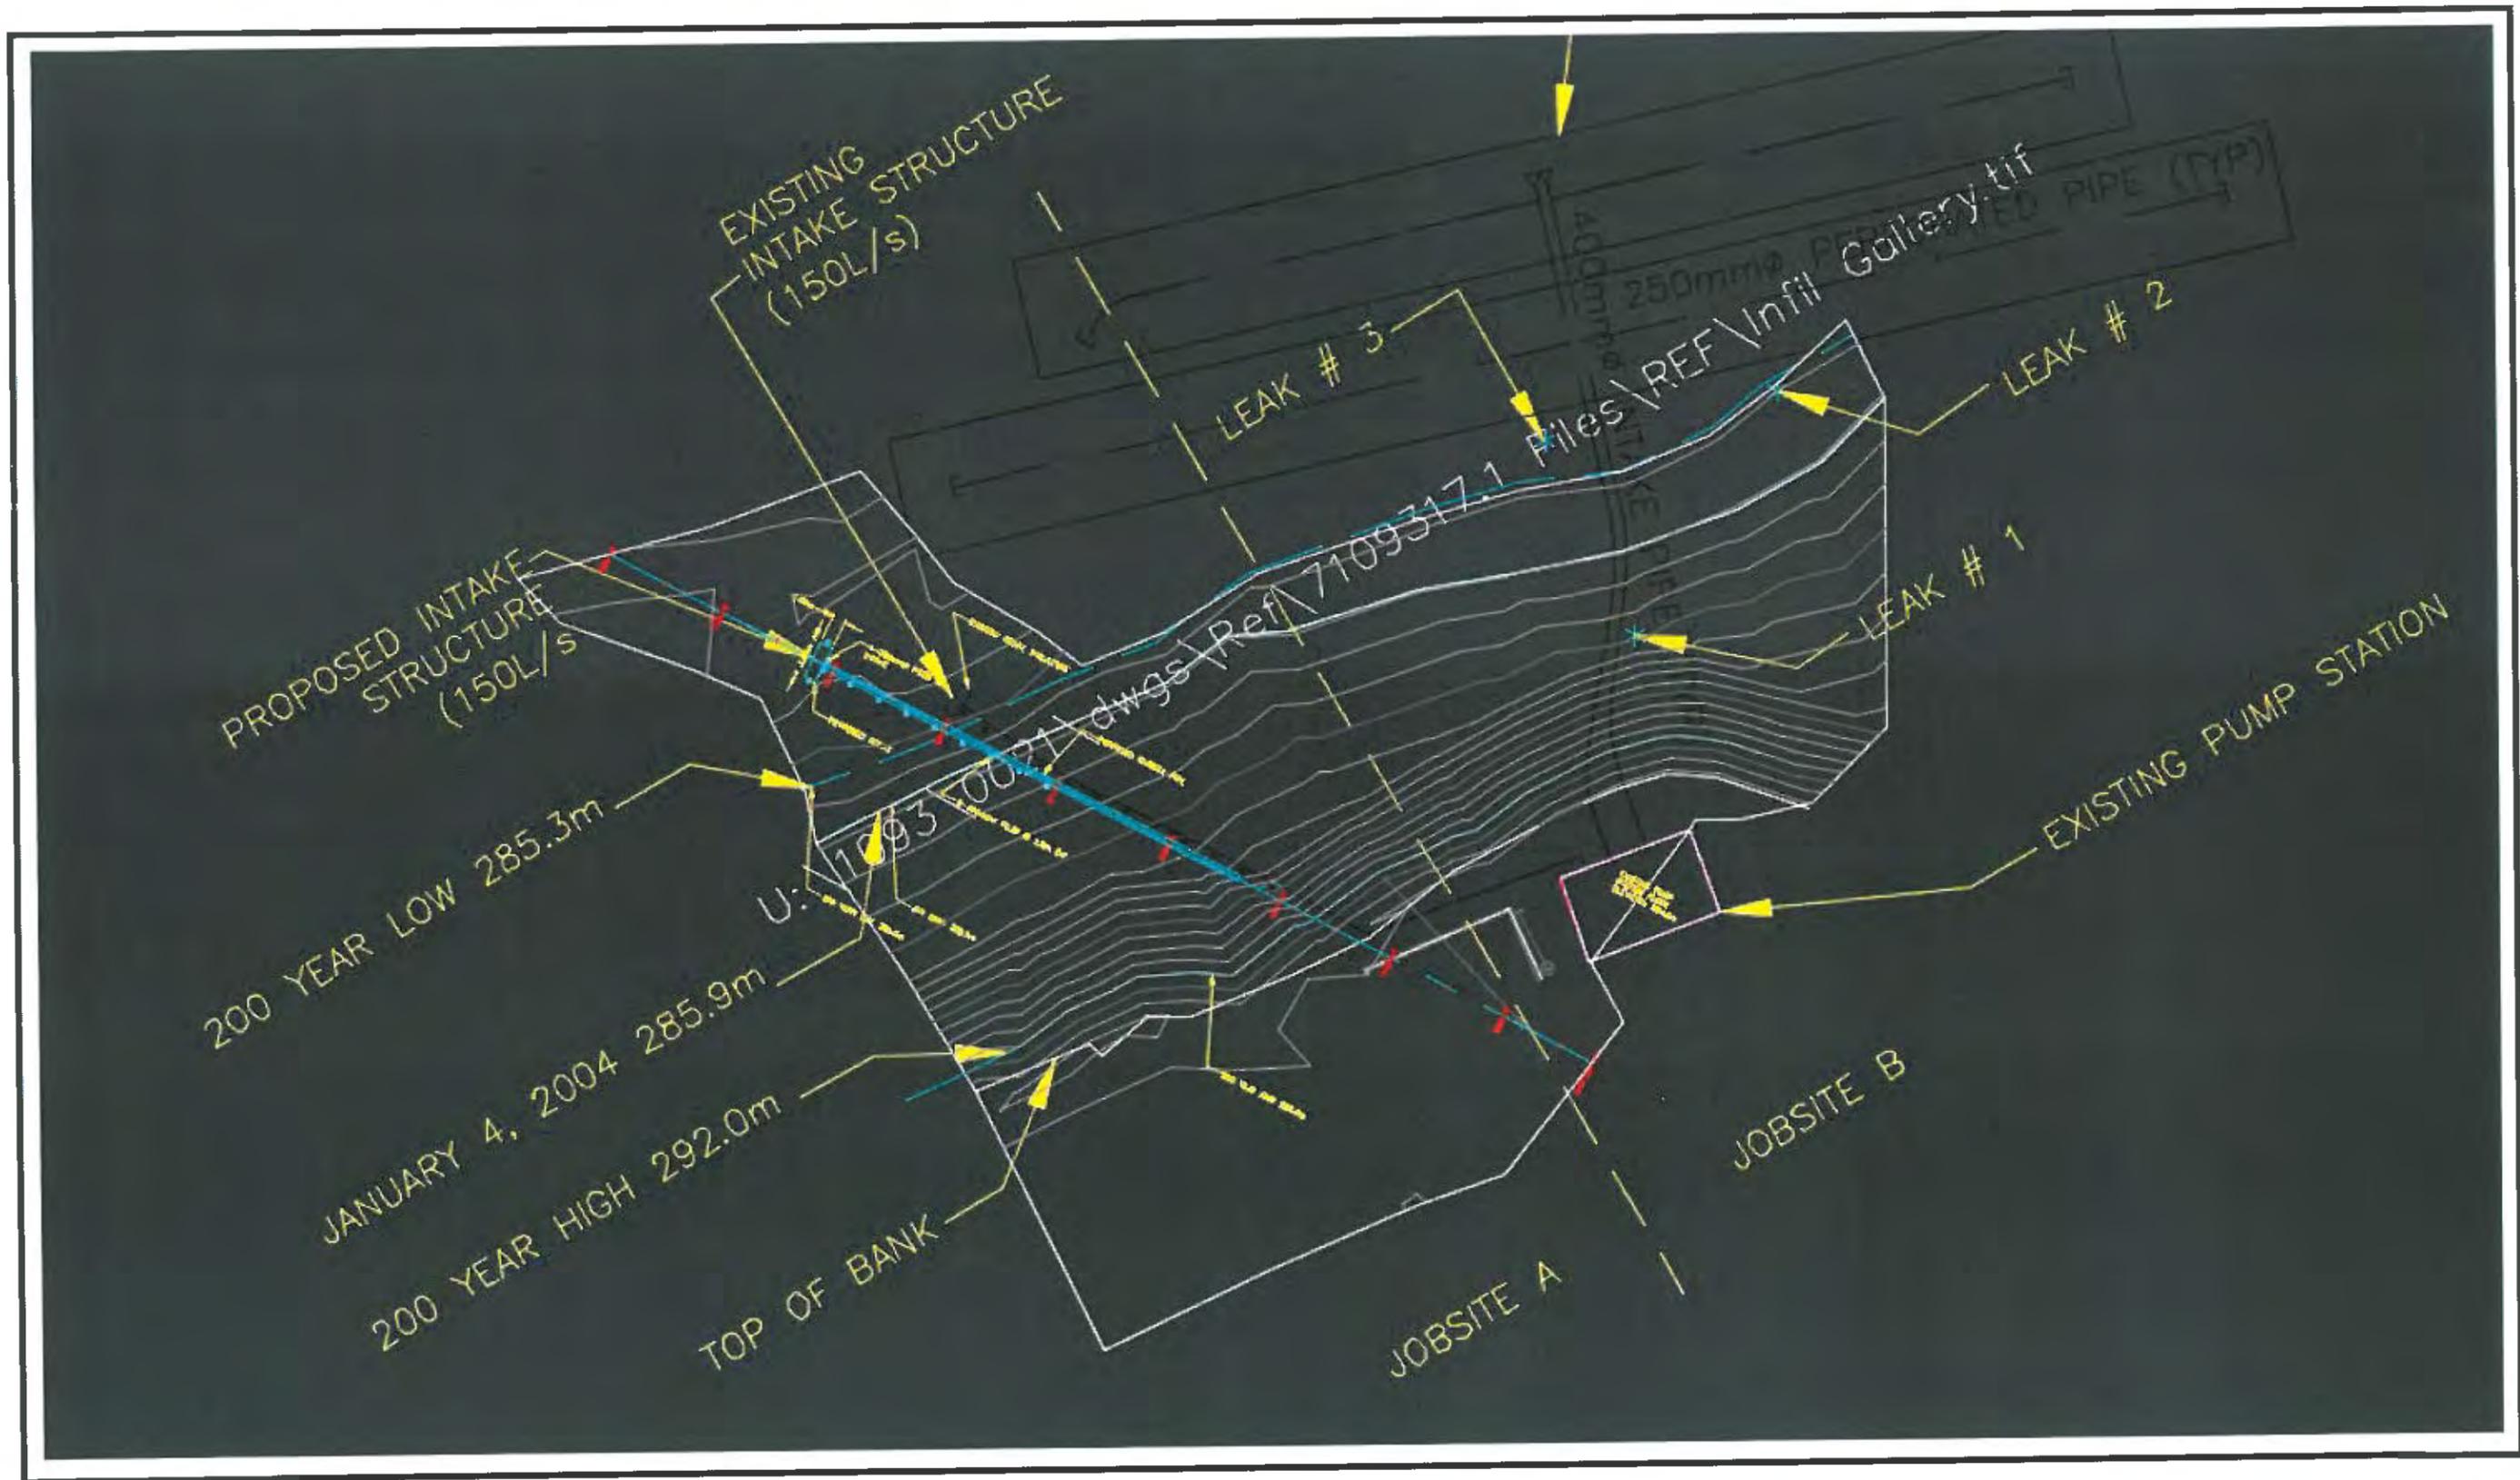
Figure 5.3.2: Design plan of the intake pipe installed to augment or replace the infiltration gallery (from Urban Systems Ltd.).

5.3.2 Design plan of the intake pipe installed to augment or replace the infiltration gallery	F-18

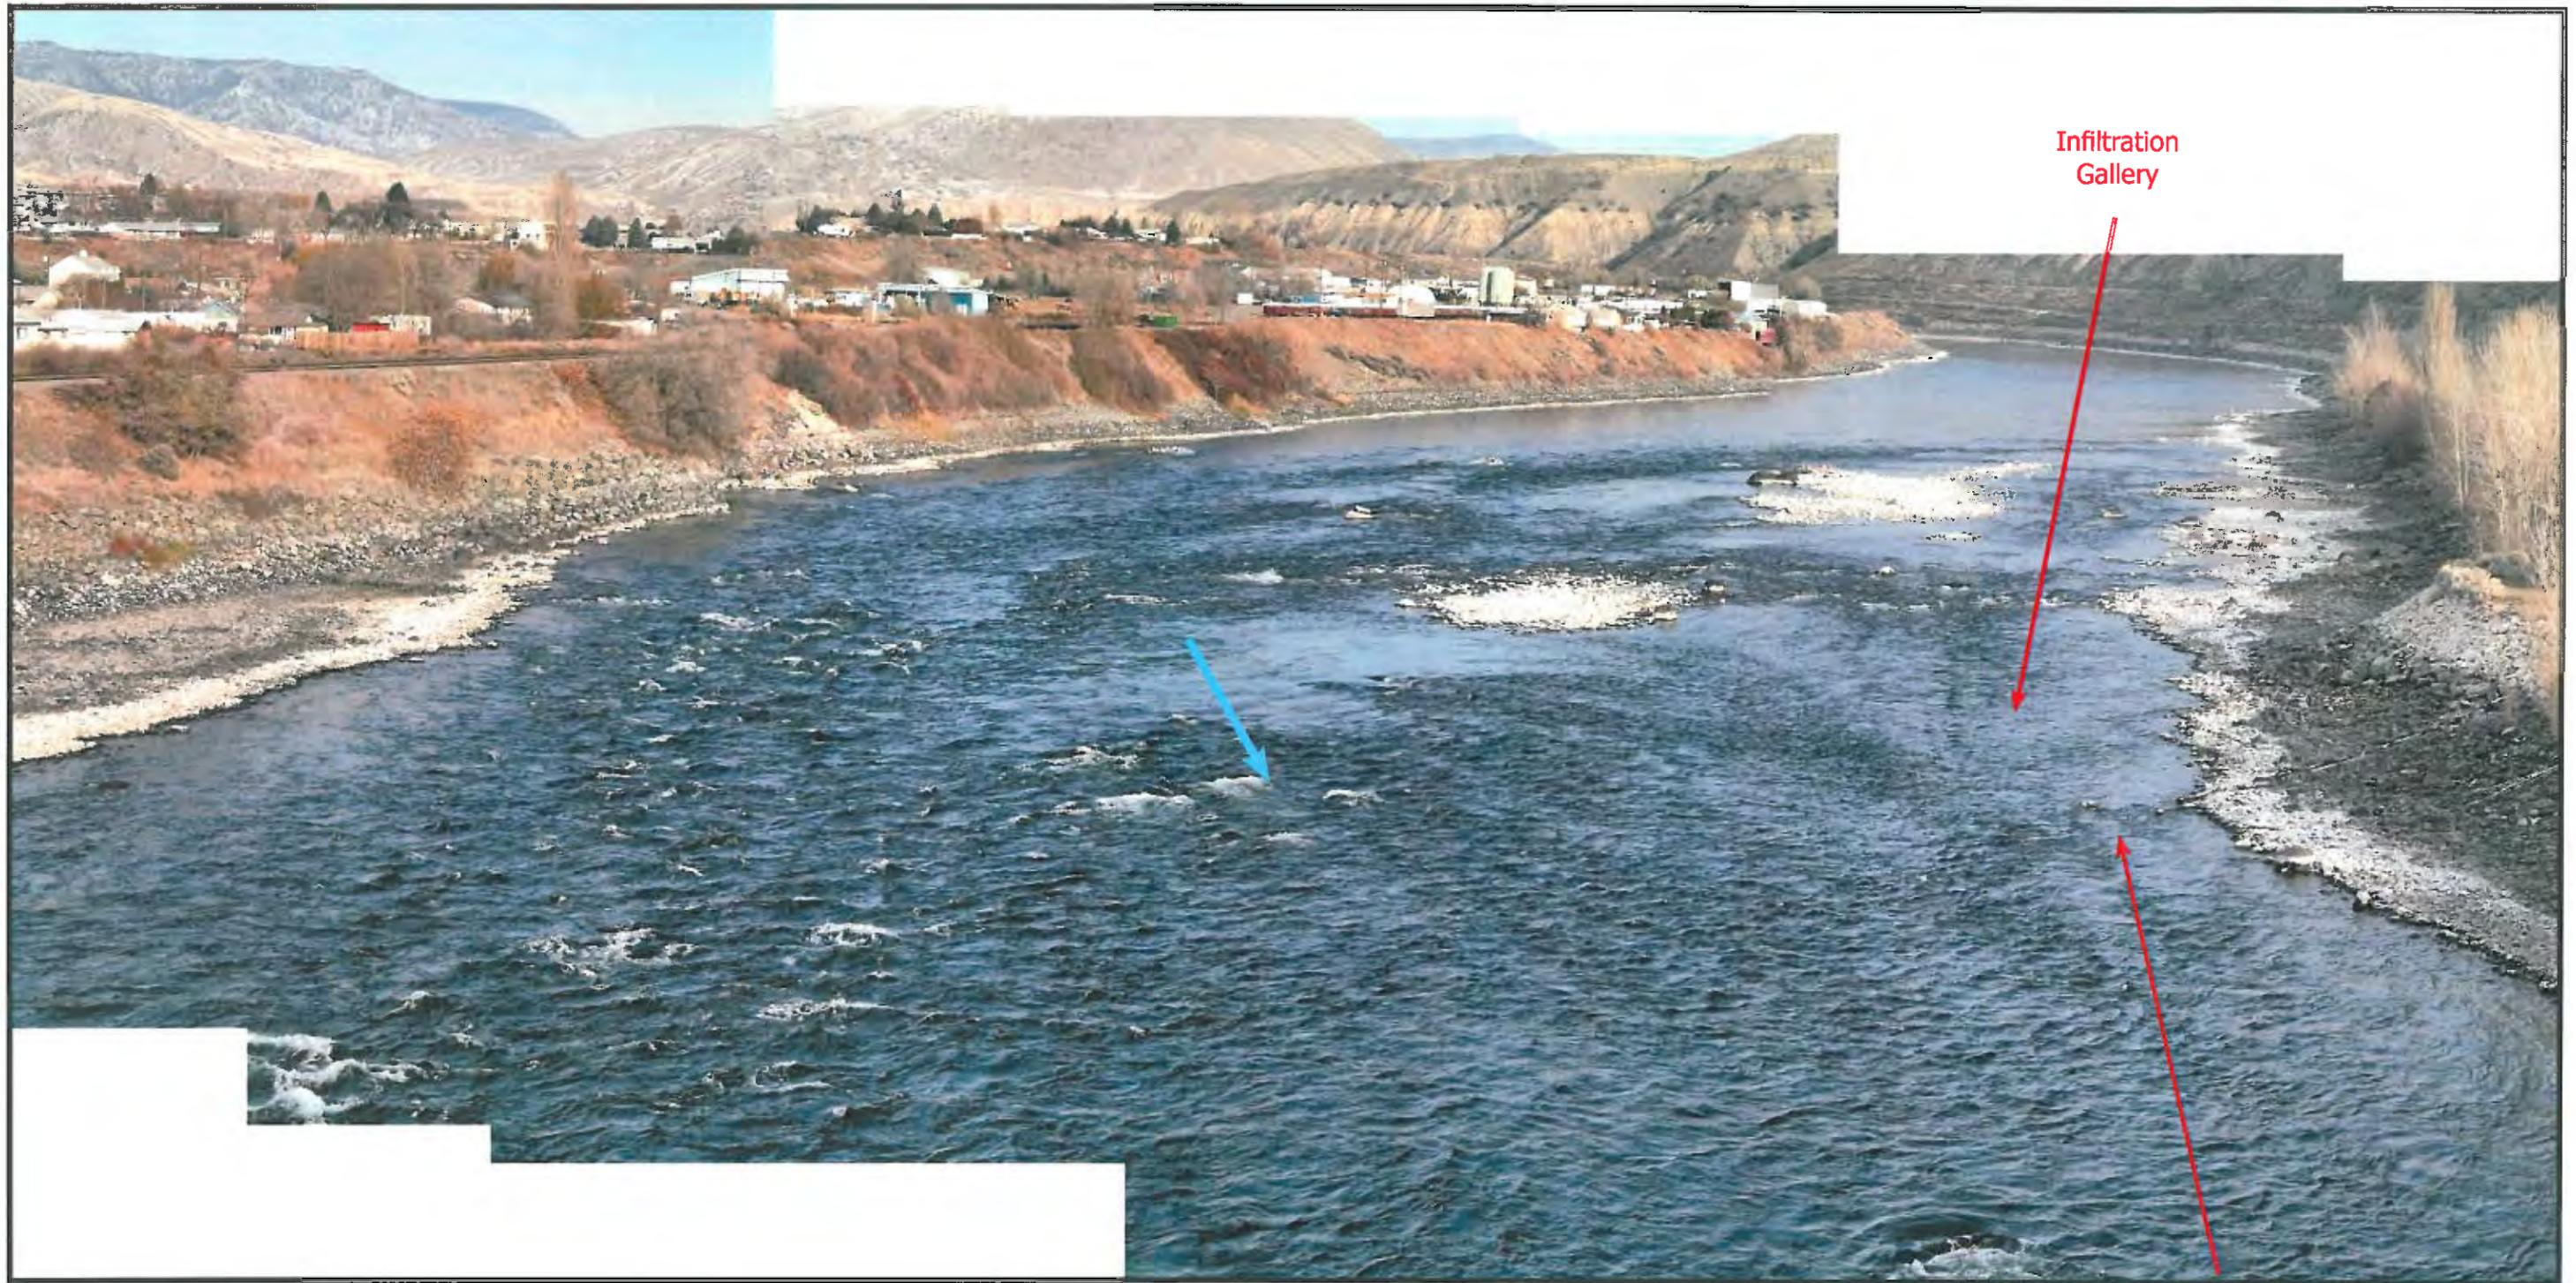
Infiltration
Gallery

Emergency Water
Supply Intake

Plate 4.1.1: Looking upstream from the Highway 97C Bridge on November 21, 2013, illustrating the extent of the mid-channel bar at a discharge of 283 m³/s (measured near Spences Bridge).

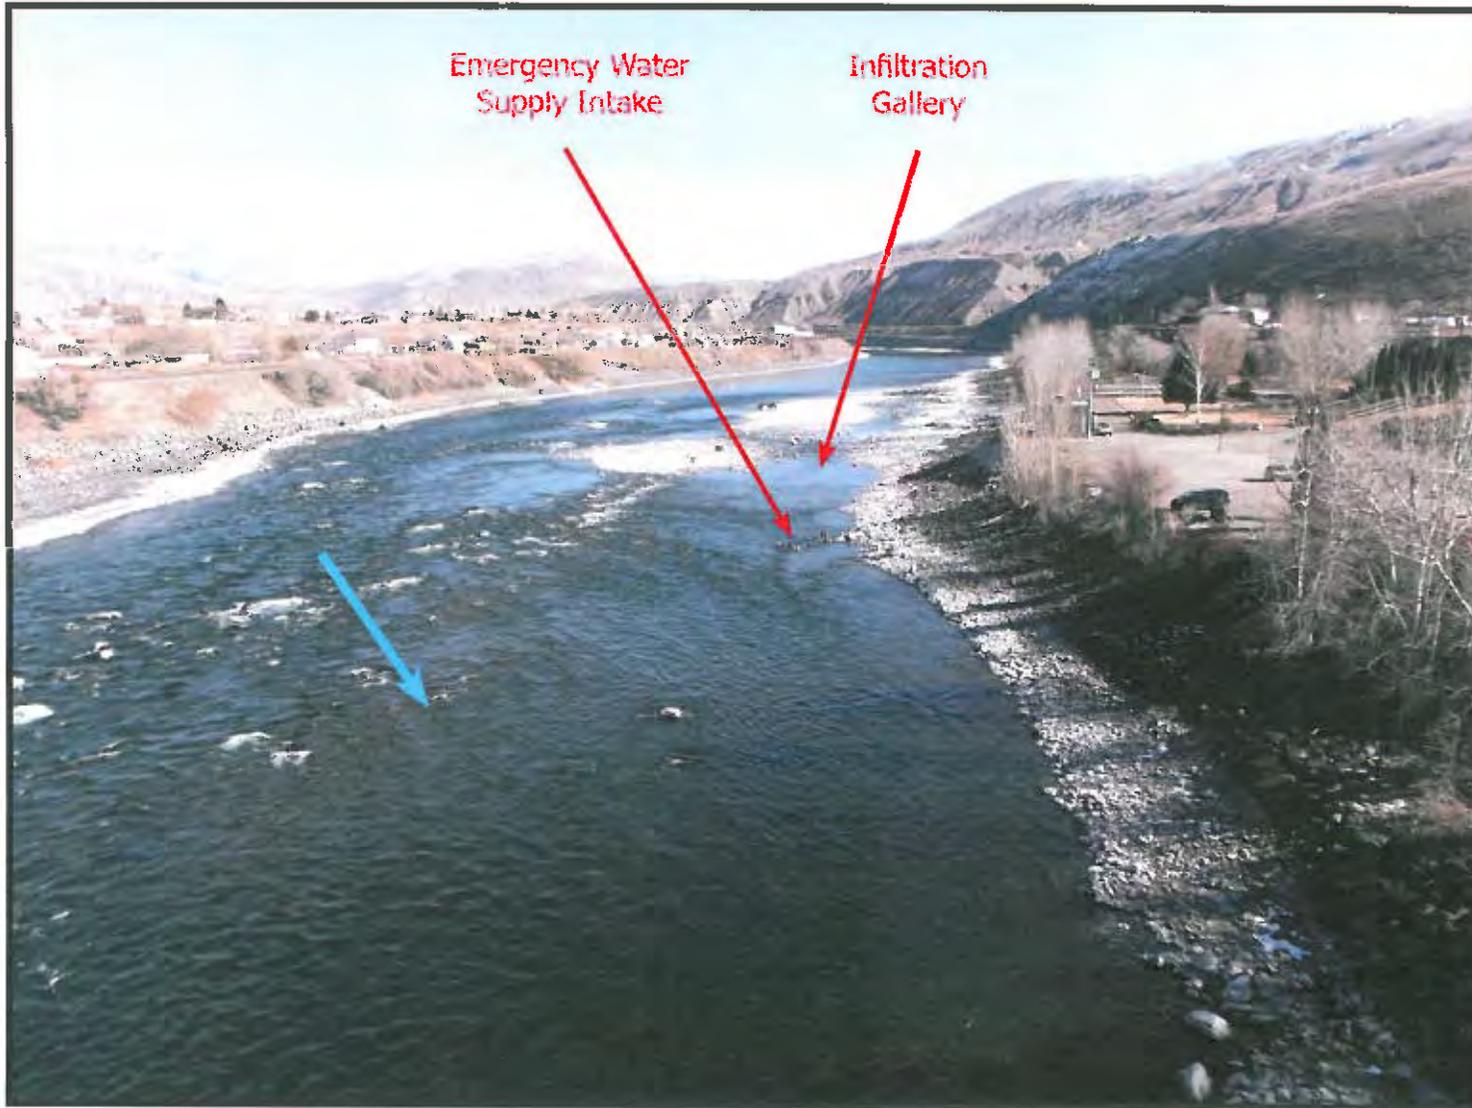
Plate 4.1.2: Looking upstream from the Highway 97C Bridge on February 25, 2014, illustrating the extent of the mid-channel bar at a discharge of $164.5 \text{ m}^3/\text{s}$ (measured near Spences Bridge).

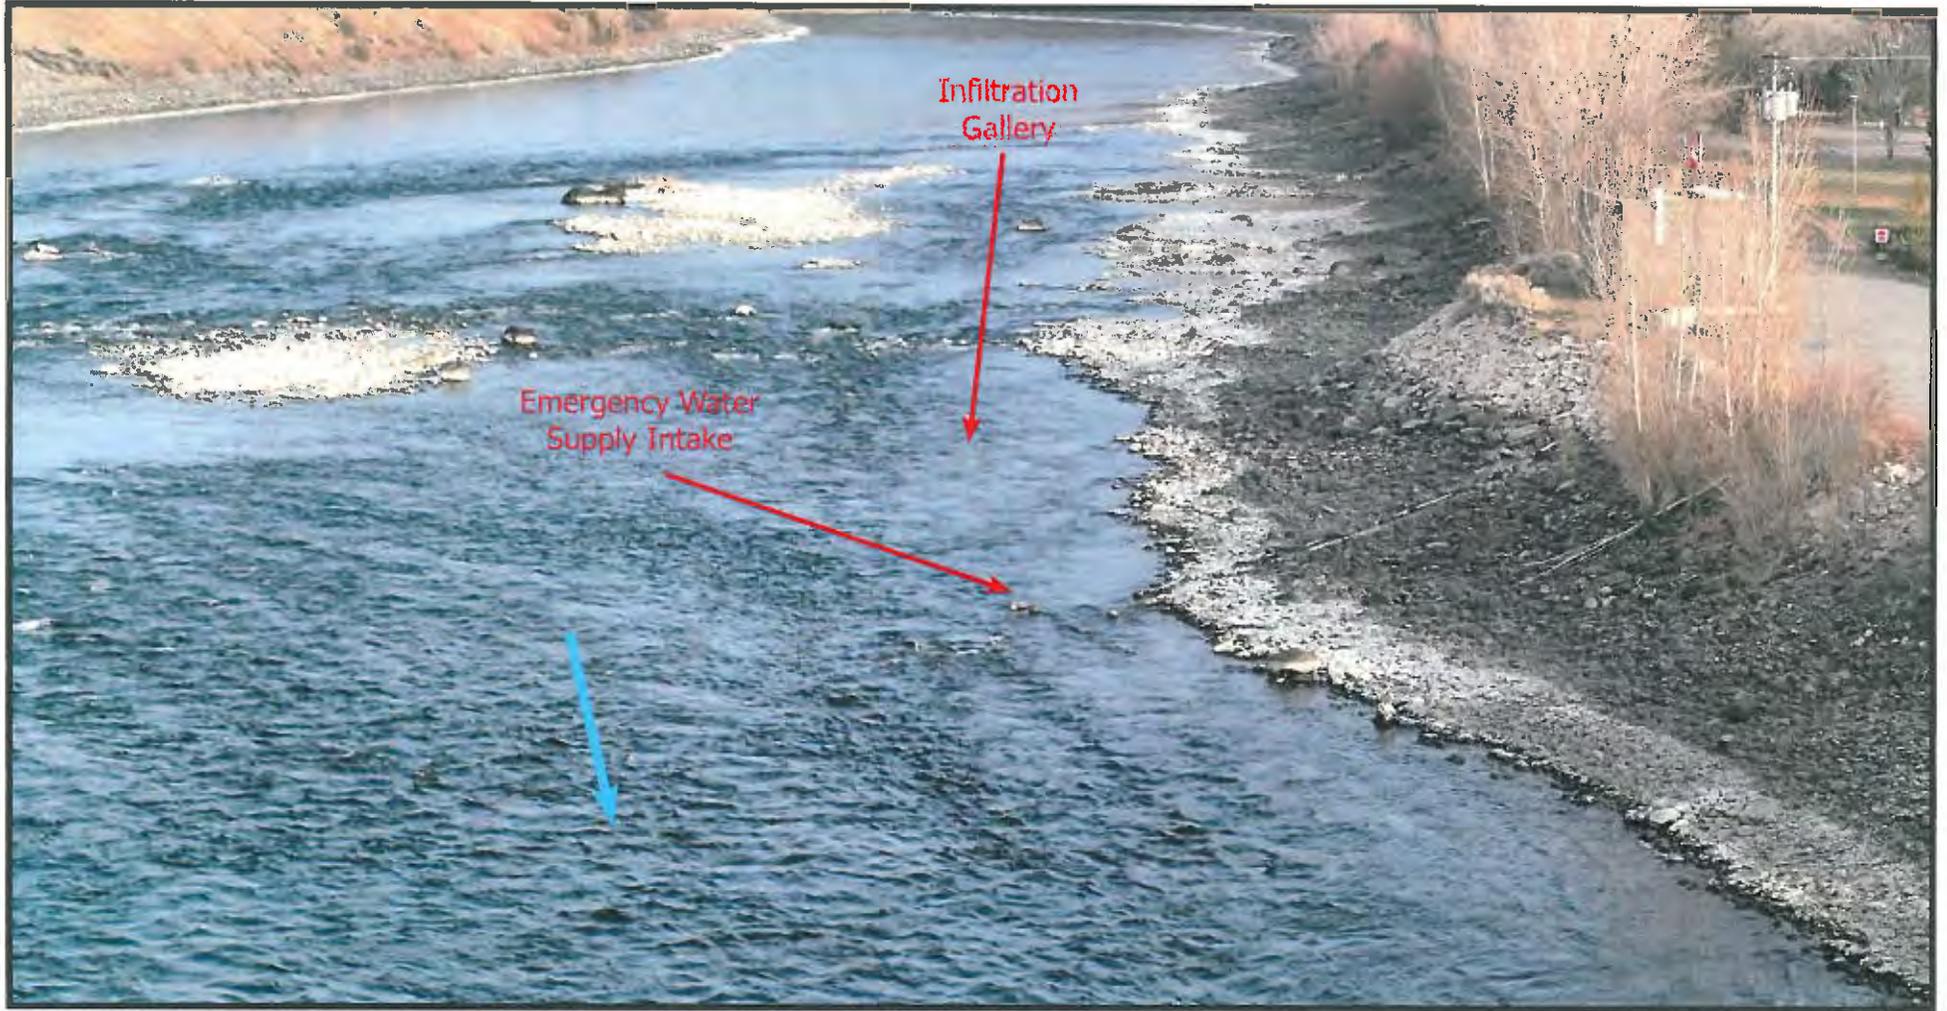
Plate 4.1.3: Looking upstream from the Highway 97C Bridge on November 21, 2013, illustrating flow conditions at the emergency intake pipe and the upstream infiltration gallery during a discharge of $283 \text{ m}^3/\text{s}$ (measured near Spences Bridge).

4.1.3	Looking upstream from the Highway 97C bridge on November 21, 2013, illustrating flow conditions at the emergency intake pipe and the upstream infiltration gallery during a discharge of 283 m ³ /s	P-3

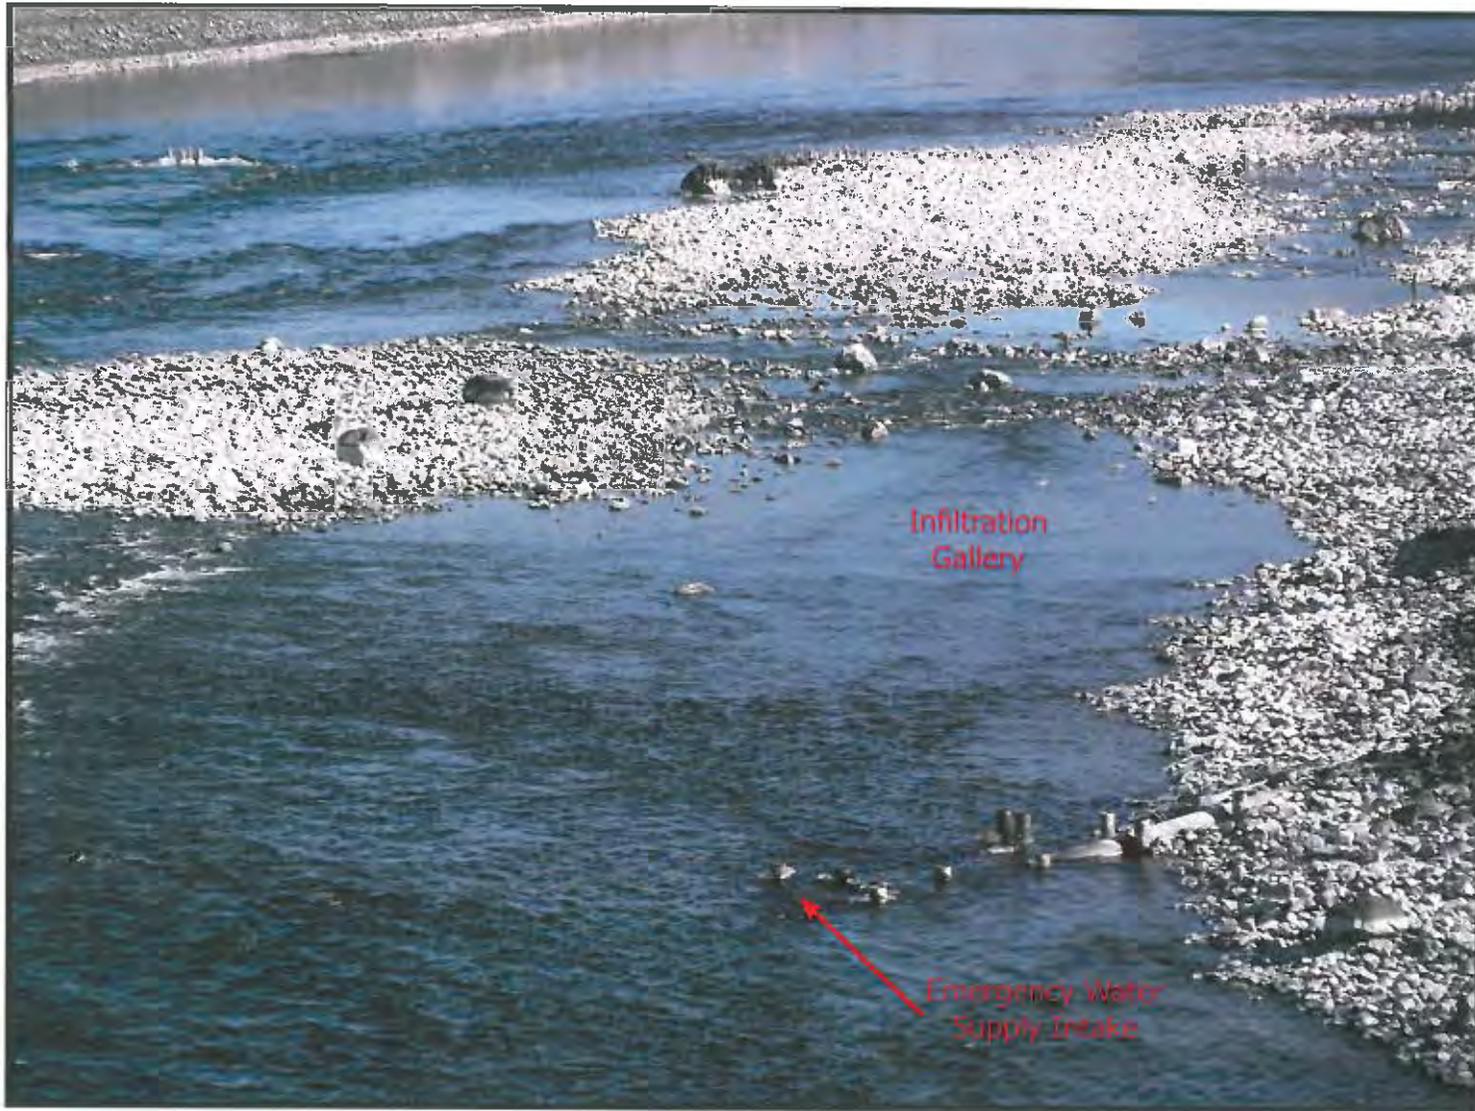
Plate 4.1.4: Looking upstream from the Highway 97C Bridge on February 25, 2014, illustrating flow conditions at the emergency intake pipe and the upstream infiltration gallery during a discharge of $164.5 \text{ m}^3/\text{s}$ (measured near Spences Bridge).

4.1.4	Looking upstream from the Highway 97C bridge on February 25, 2014, illustrating flow conditions at the emergency intake pipe and the upstream infiltration gallery during a discharge of 164.5 m ³ /s	P-4

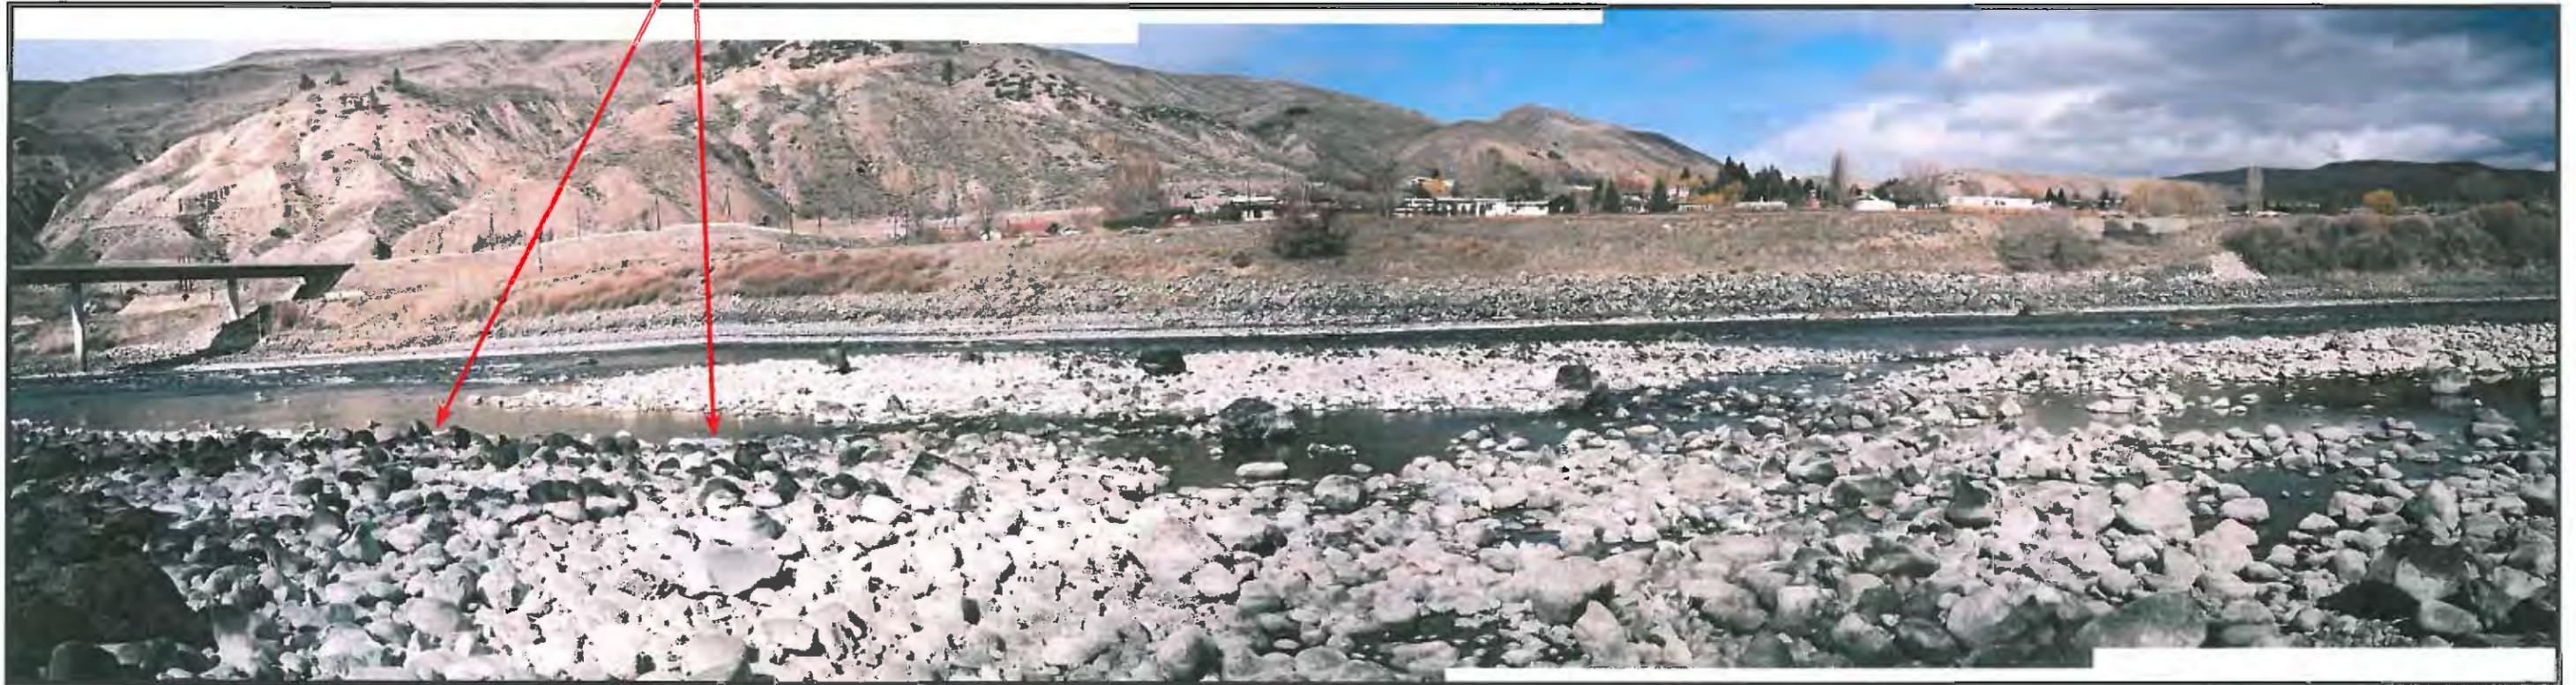
Infiltration
Gallery

Plate 4.1.5: Photograph of the infiltration gallery in 2003 illustrating the limited extent of upstream open water during a discharge of $\geq 183 \text{ m}^3/\text{s}$ (measured near Spences Bridge)

4.1.5	Photograph of the infiltration gallery in 2003 illustrating the limited extent of upstream open water during a discharge of ≥183 m ³ /s at Spences Bridge			P-5

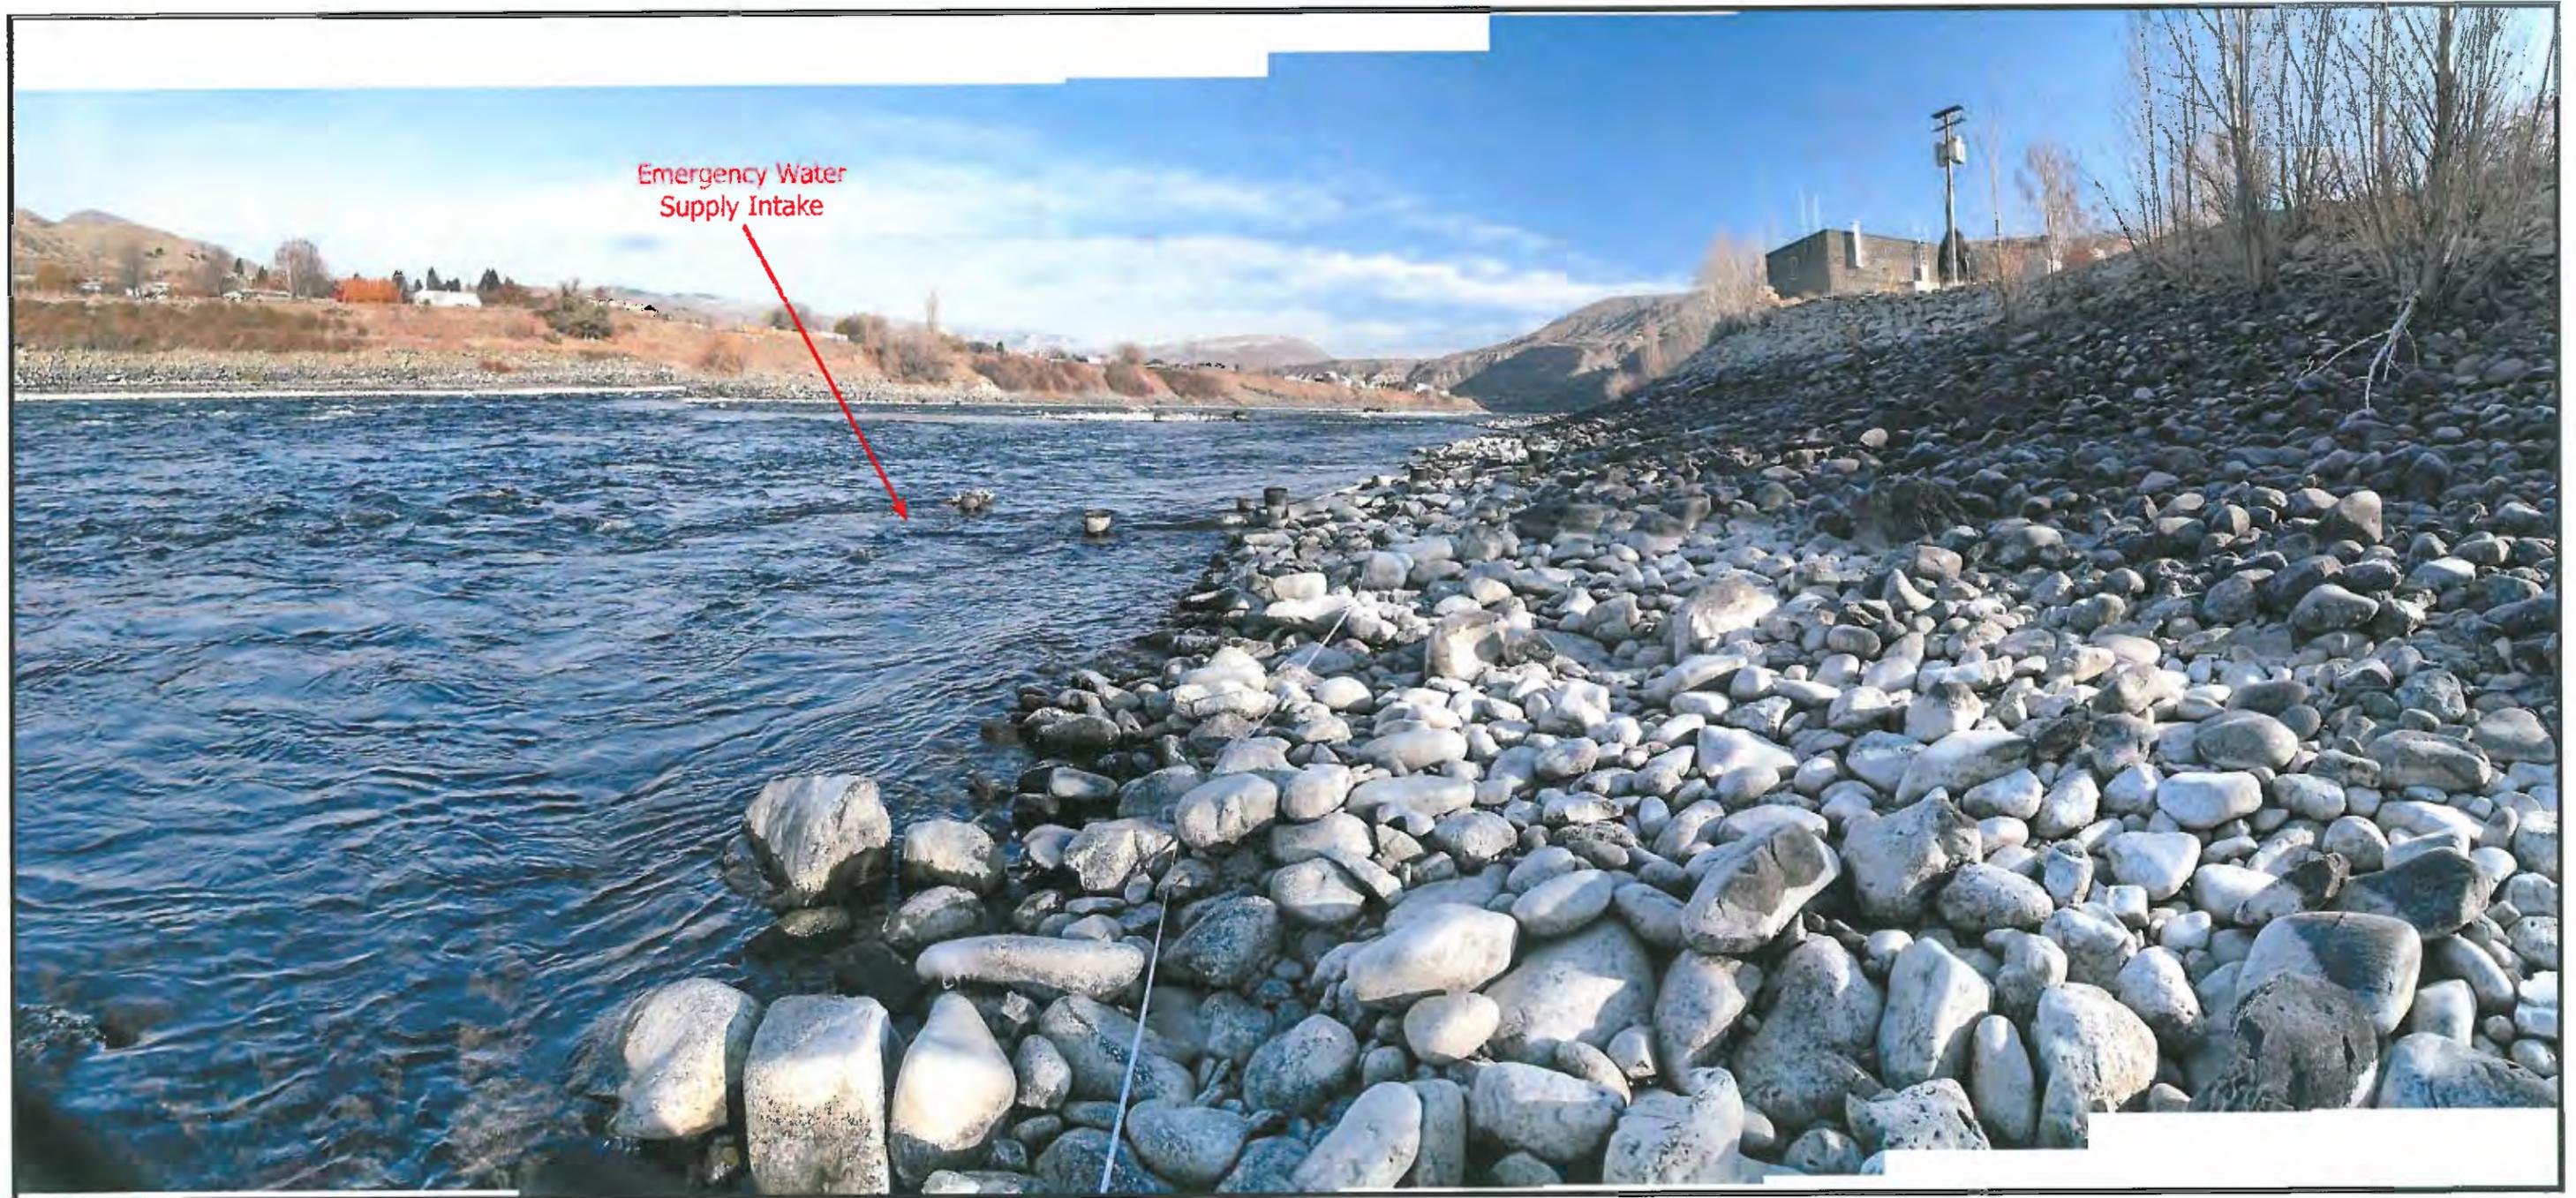
Plate 4.1.6: Looking upstream illustrating the bed material texture on the left bank in the vicinity of the emergency water supply intake.

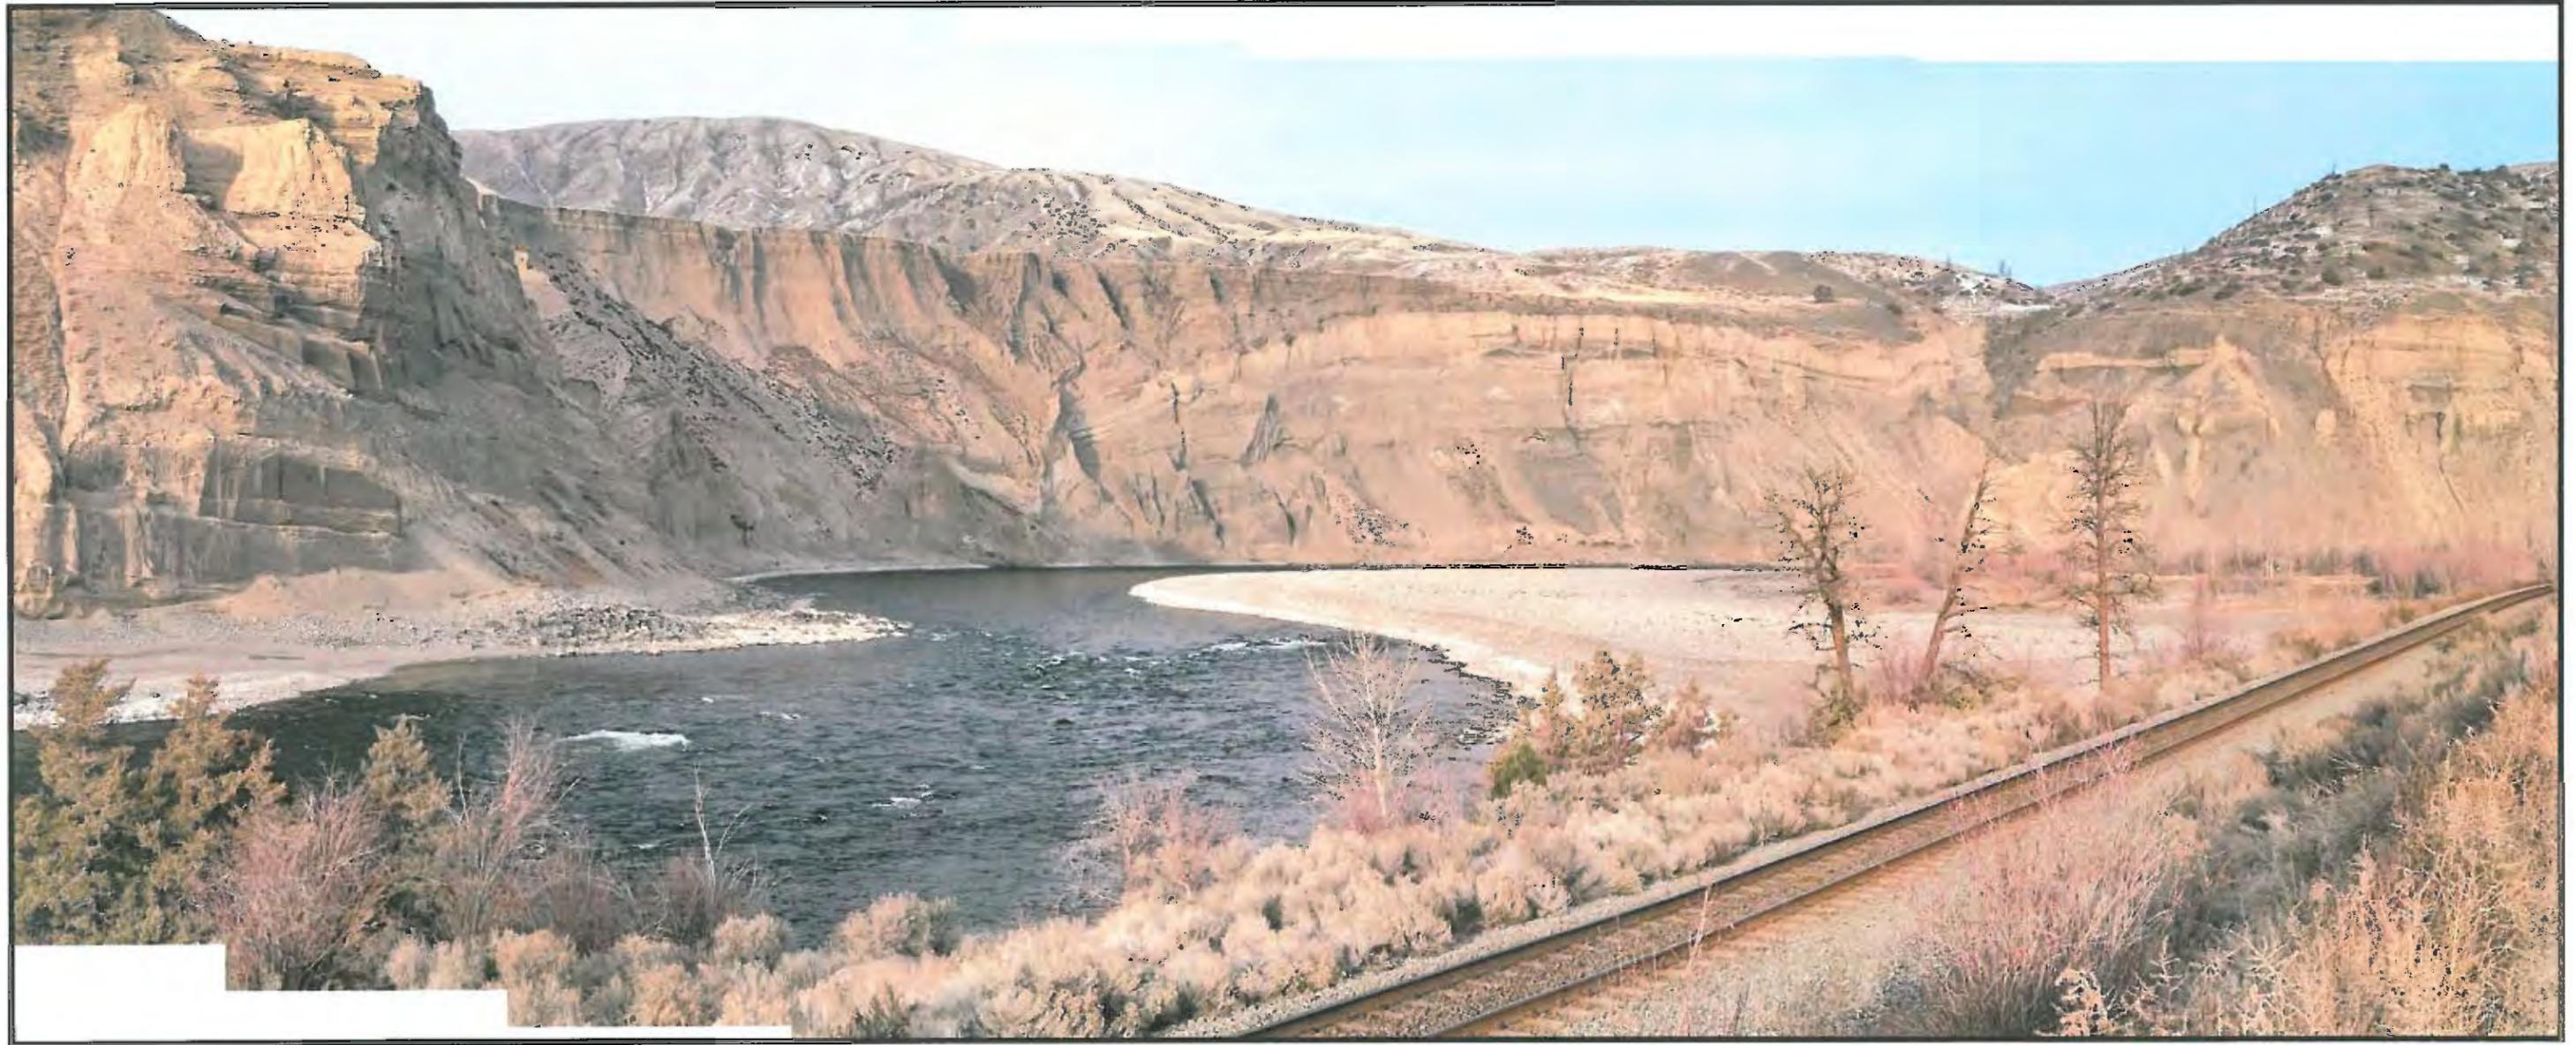
MM 13 1121 166

Plate 4.1.7: Looking upstream from the Highway 97C bridge to the bed material sampling area on the left bank in the vicinity of the emergency water supply intake.
