Village of Ashcroft

Water Master Plan

November 2014

URBAN
systems

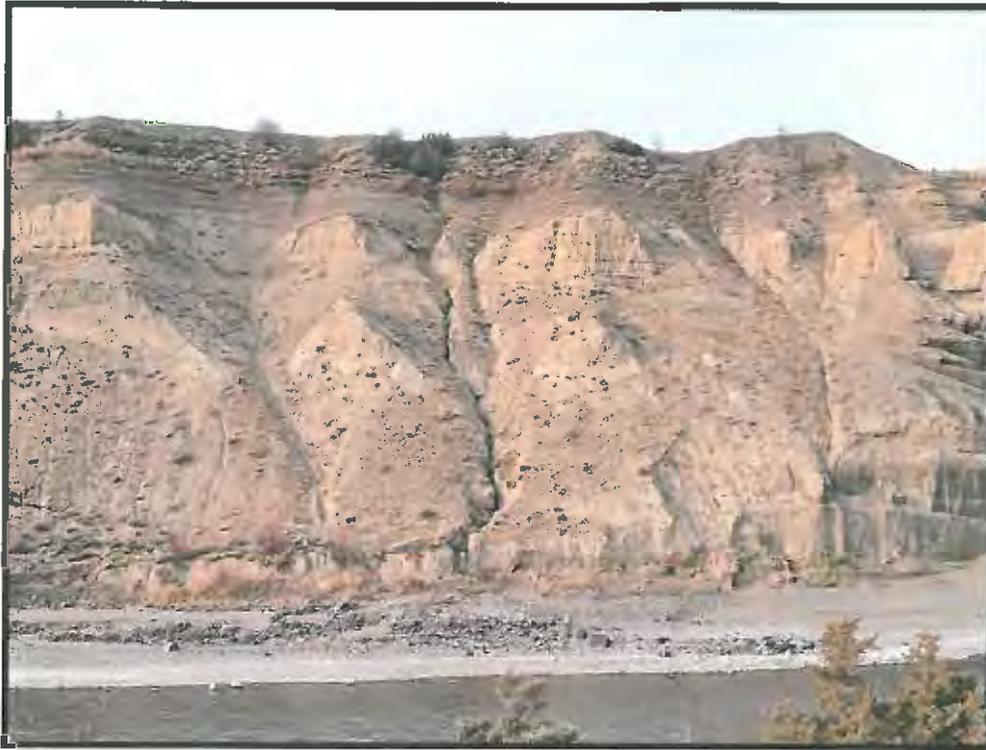
MM 13 1121 240 to 248

Plate 4.3.1: Looking upstream to the eroding right bank terrace and active left bank point bar located 4 km upstream of the Ashcroft water supply intake.

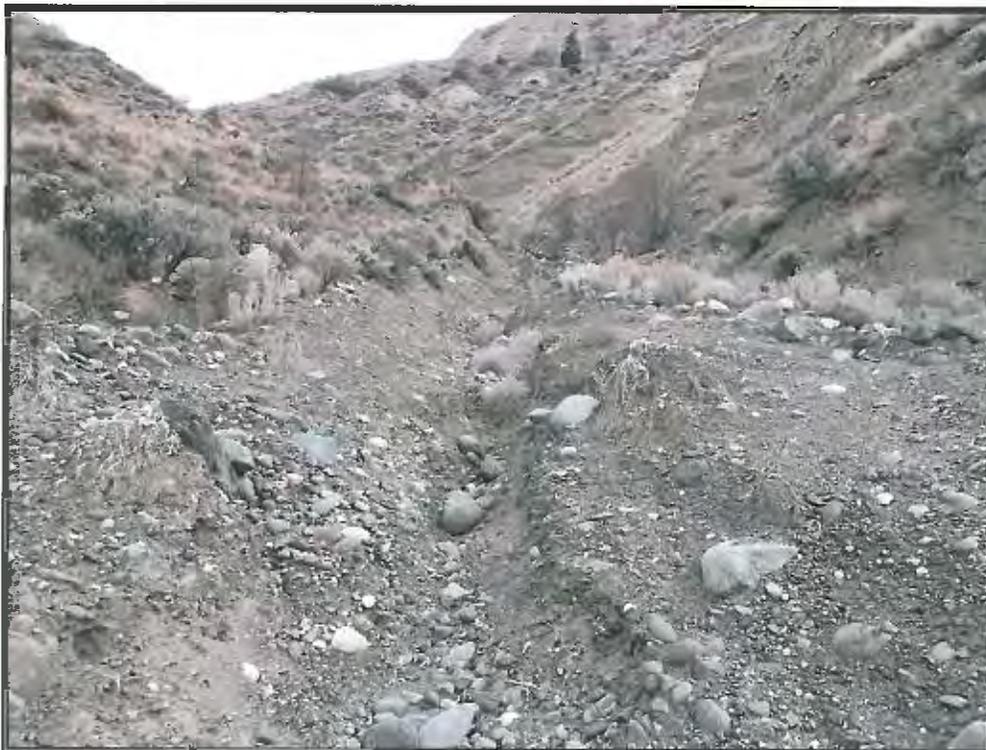
MM 13 1121 254

Plate 4.3.2: Illustration of gully formation and sediment production from eroding areas on the terraces bordering Thompson River.

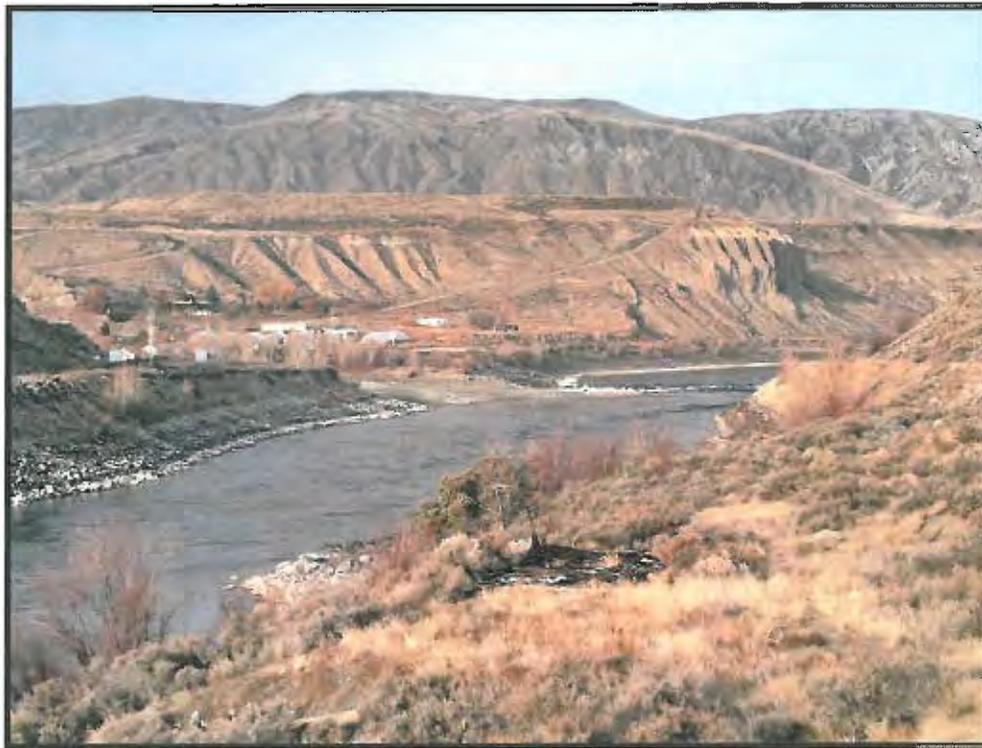
MM 13 1121 202

Plate 4.3.3: Looking upstream illustrating sediment production from one of the two small left bank streams located 2 km upstream of the Ashcroft water supply intake.

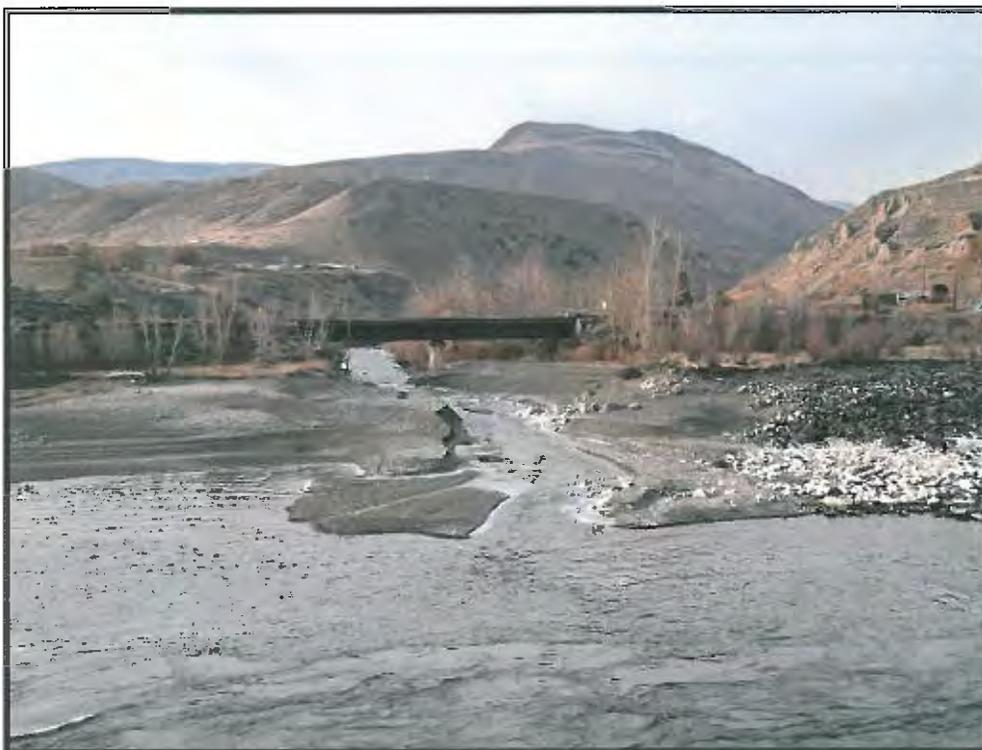
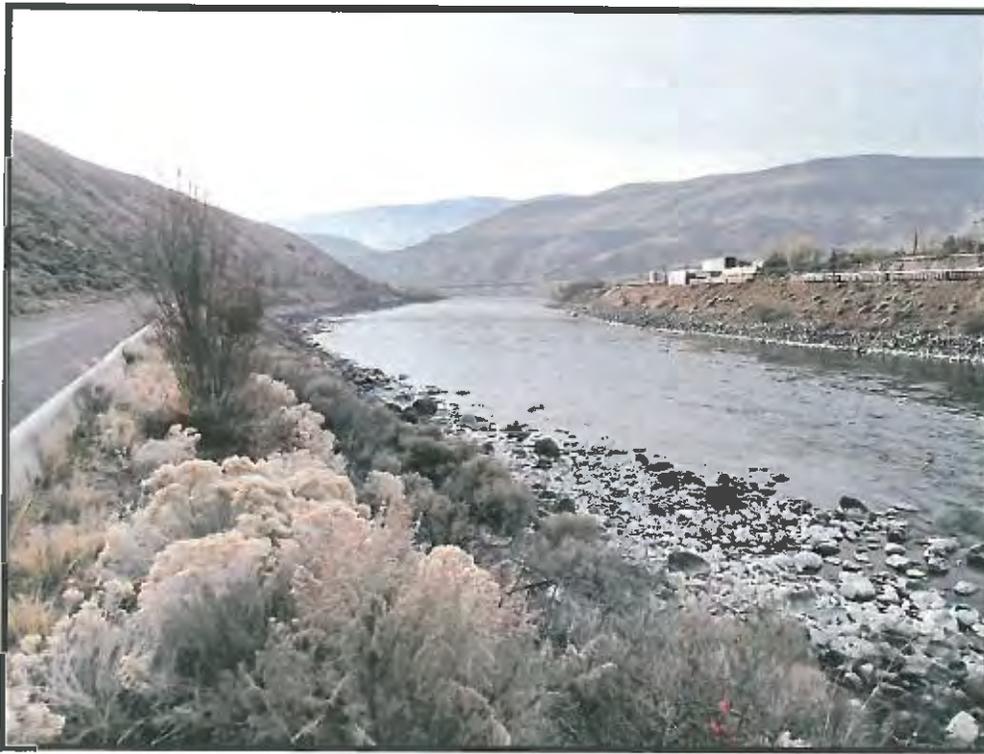
a) Looking upstream to the confluence

b) Looking west illustrating the sediment deposited along the channel banks.

Plate 4.3.4: Photographs of Bonaparte River at the confluence with Thompson River.

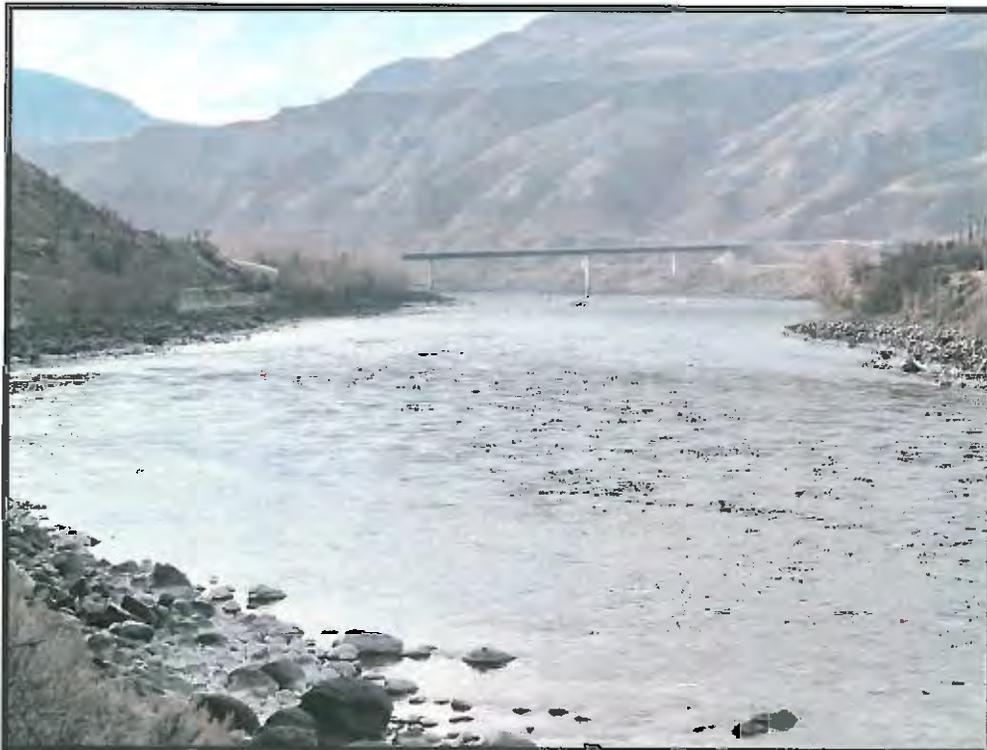
MM 13 1121 194

Plate 4.3.5: Looking downstream to the Highway 97C bridge illustrating the coarse textured material on the channel banks and the limited extent of areas which are susceptible to erosion.

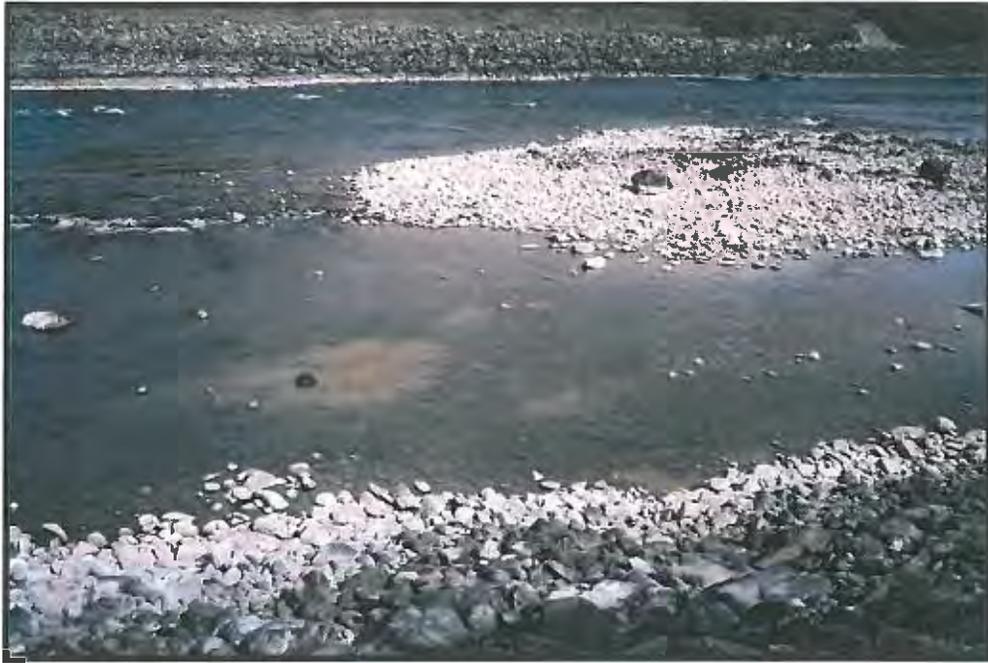
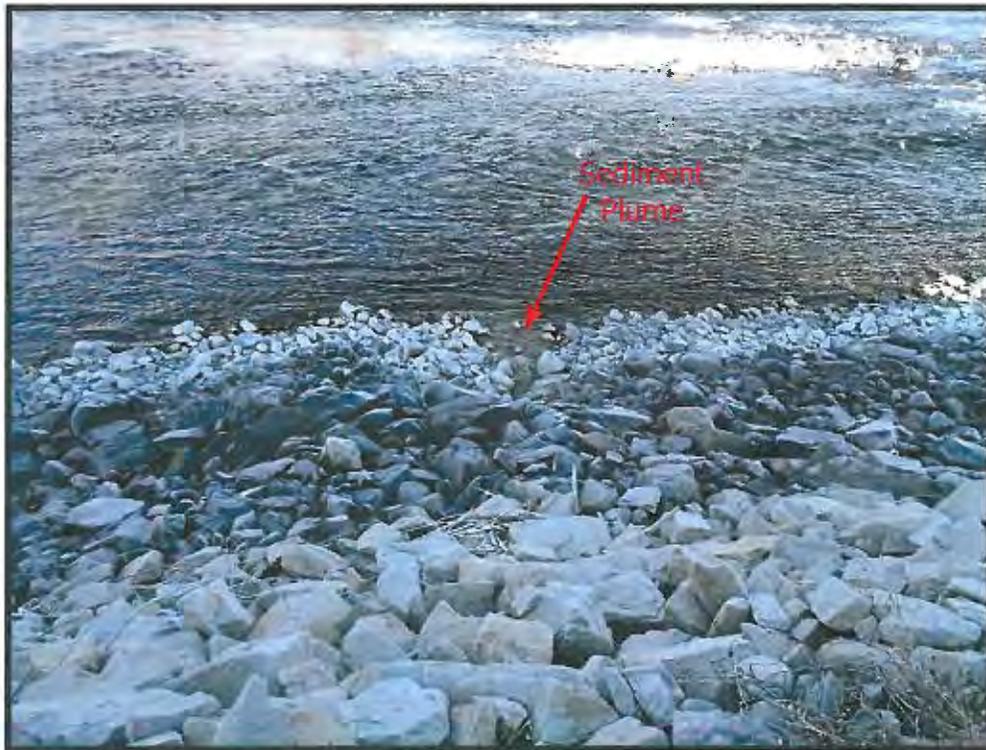
a) Discharge Thompson River near Spences Bridge $\geq 183 \text{ m}^3/\text{s}$.

Plate 5.1.1: Photographs of the infiltration gallery illustrating the fine sediment plumes resulting from back-flushing in March 2003 and November 2013.

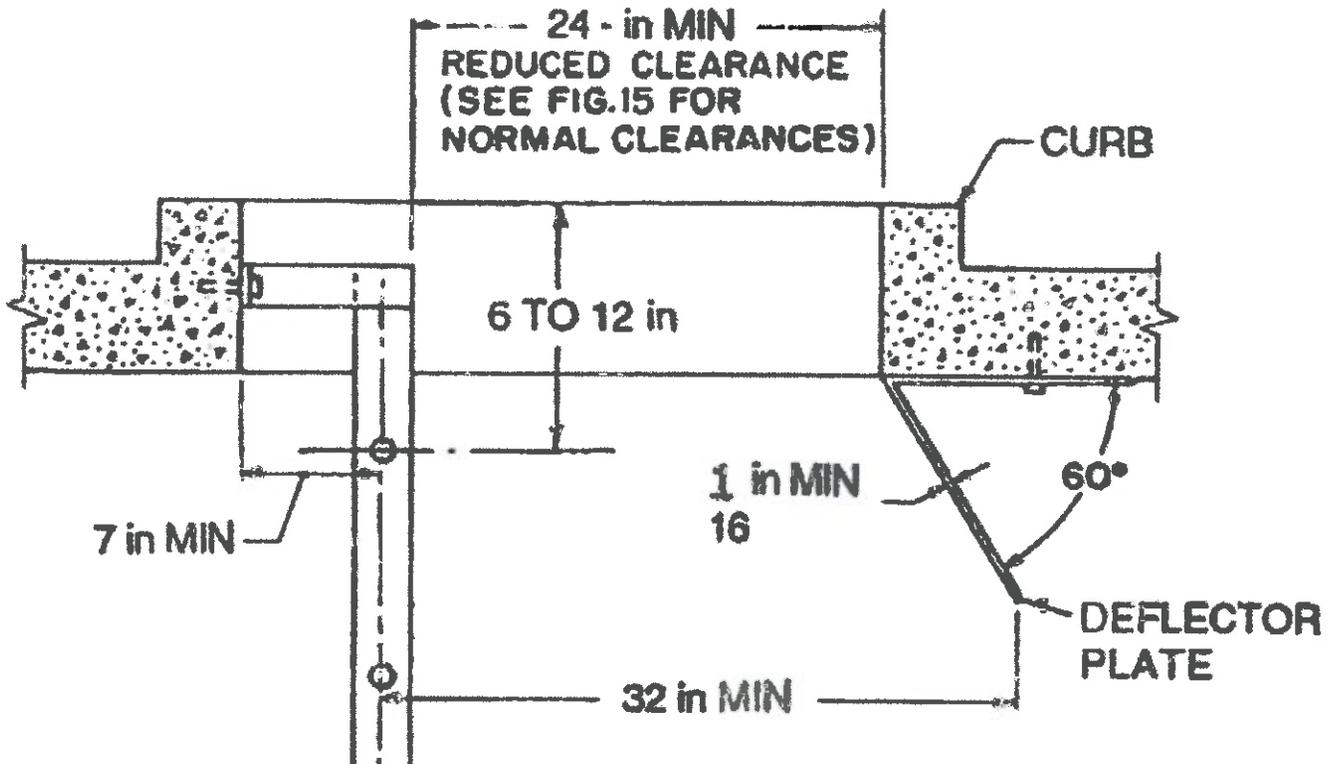
Figure 13: Deflector Plate for Hatch Opening with Reduced Clearance

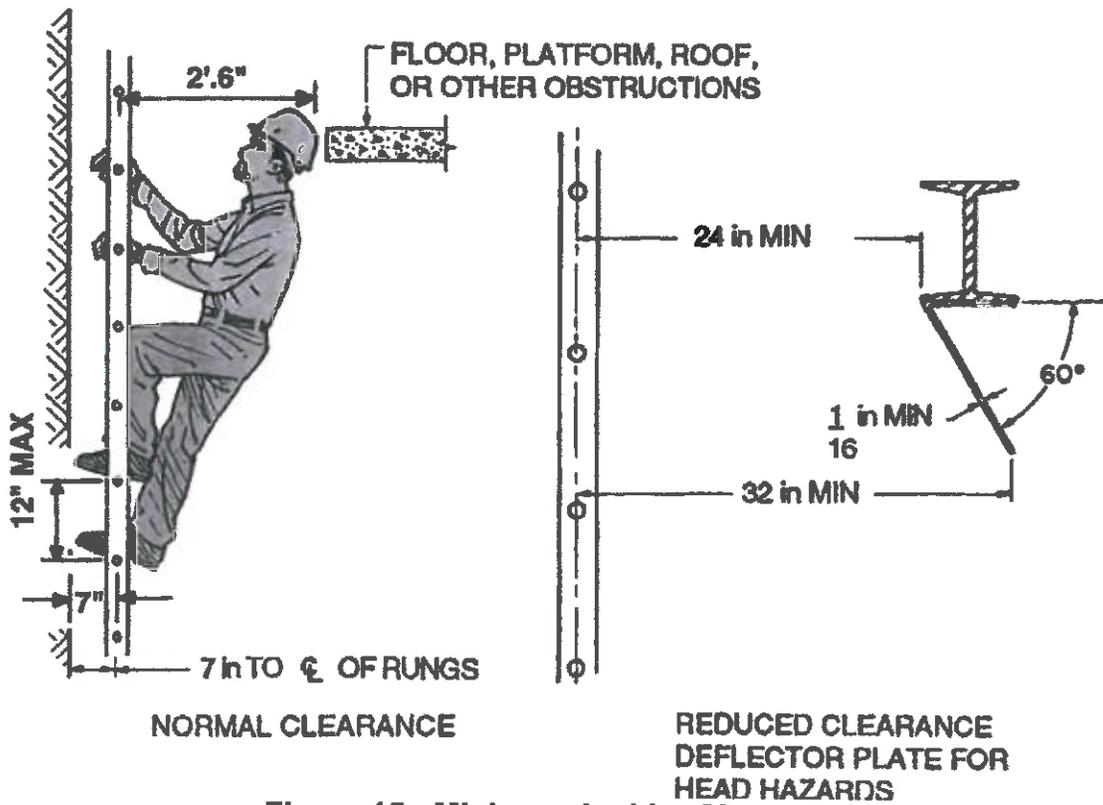
Figure 15 : Minimum Ladder Clearance
